Fact sheet: overview of contaminated ground water leakage at TEPCO's Fukushima Daiichi NPS

Water Leak at a Tank in the H4 area in Fukushima Daiichi NPS Att. 5

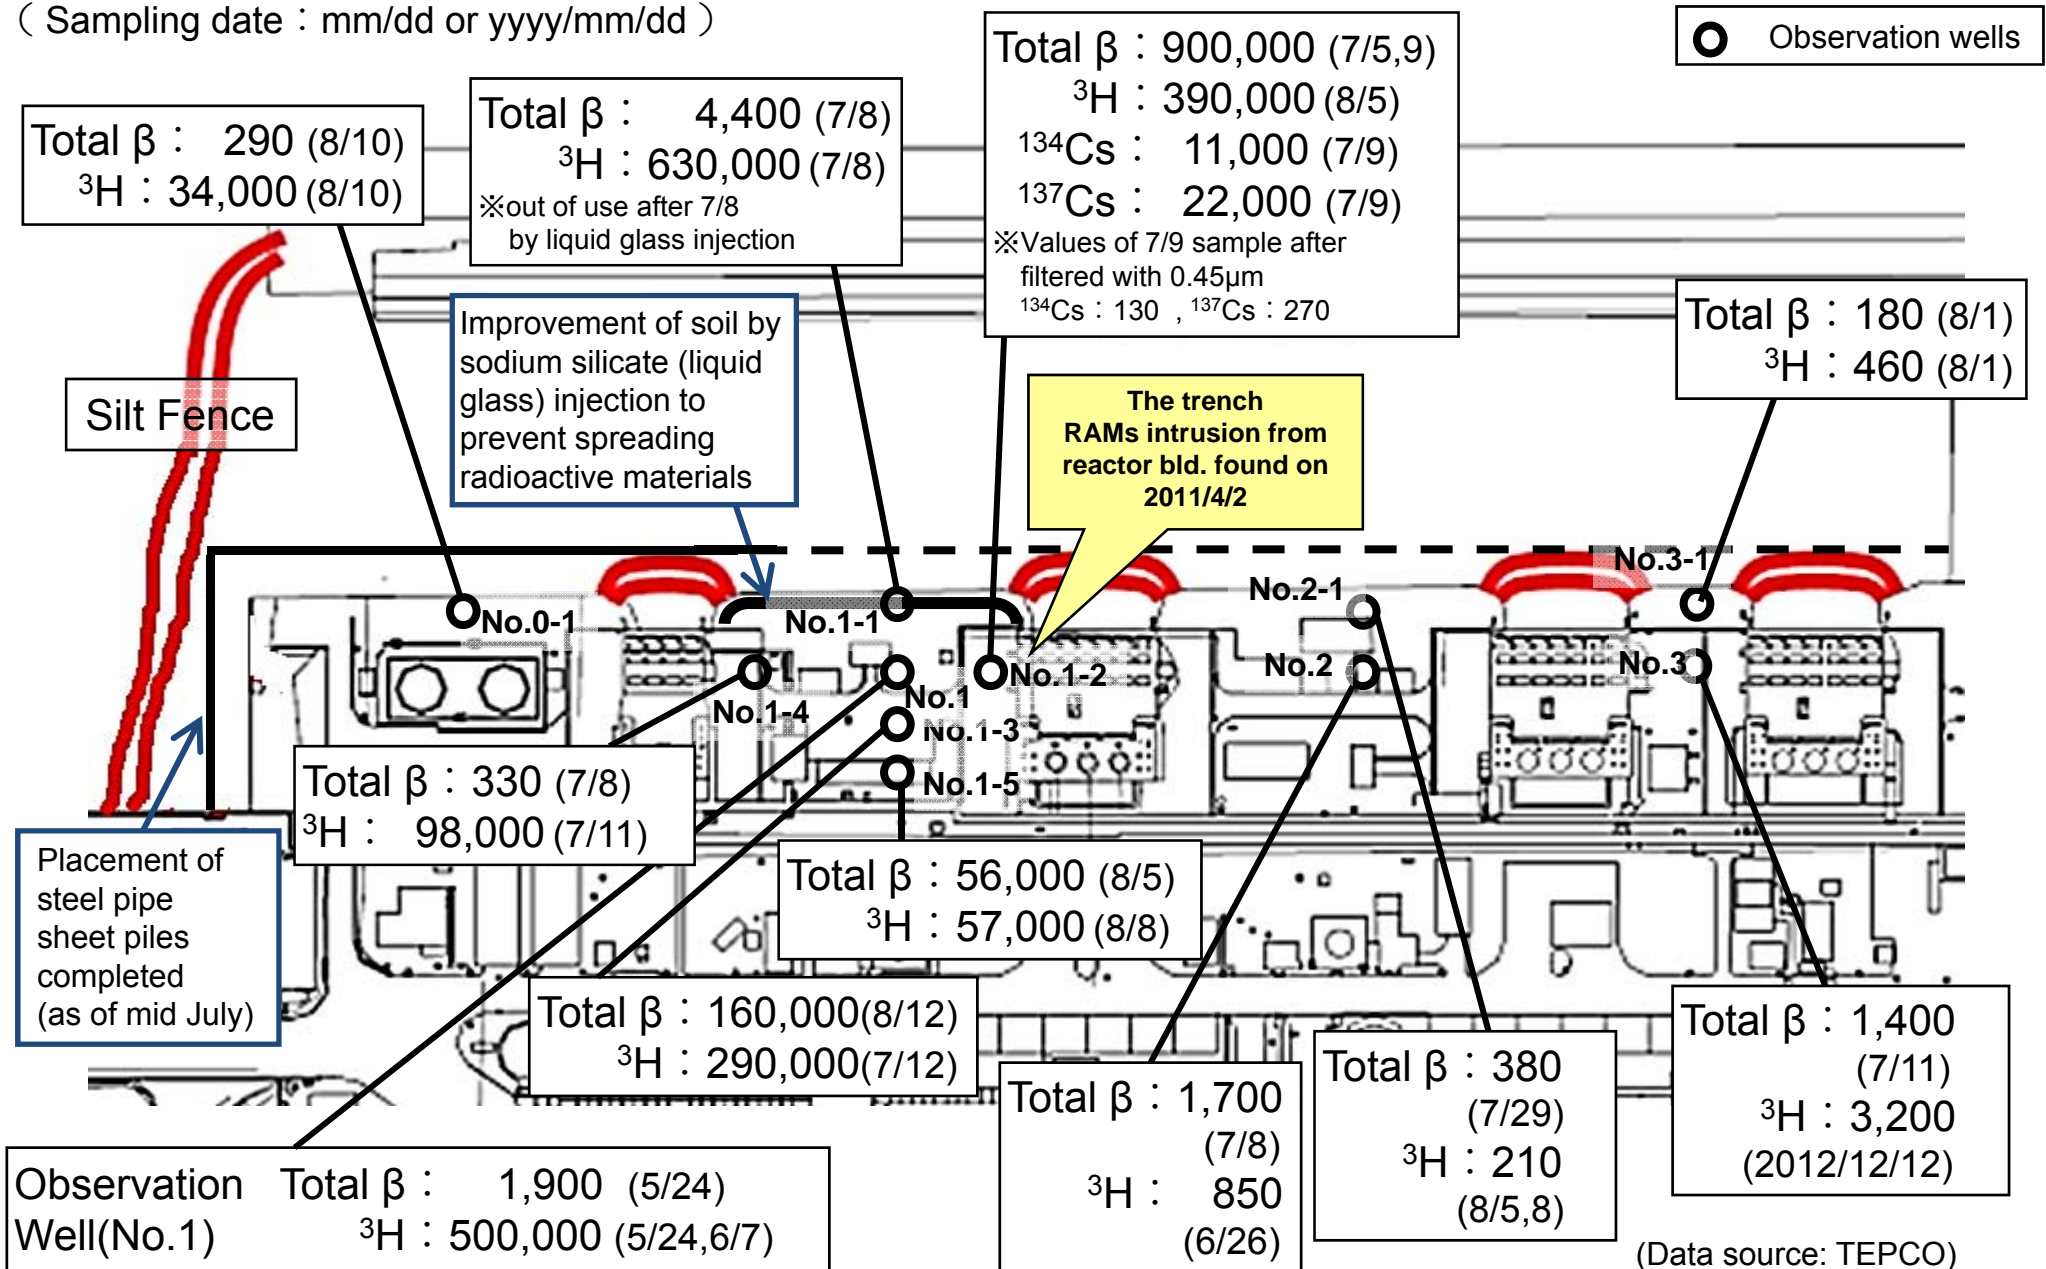
Activities in Ground Water at East Side of Turbine Bld. [Highest] Att. 1

1. On June 19, 2013, TEPCO announced that they had detected contaminated ground water in observation well No. 1 at the eastwards (seawards) area between the turbine buildings and plant port in Fukushima Daiichi NPS. The situation of contaminated ground water is illustrated in Attachment 1 with the highest values and in Attachment 2 with the latest ones. The contaminated ground water was found during the following investigations. TEPCO conducted investigations to identify the cause of that a few points of the plant port contamination stayed at a certain level with setting up an external expert group this April. Against this backdrop, TEPCO had dug observation wells in the eastwards area of the turbine buildings and made radioactive analyses of the ground water in the wells.

Maximum Values since Dec. 2012 as of August 14 [Unit : Bq/liter] Total β: Excluding tritium

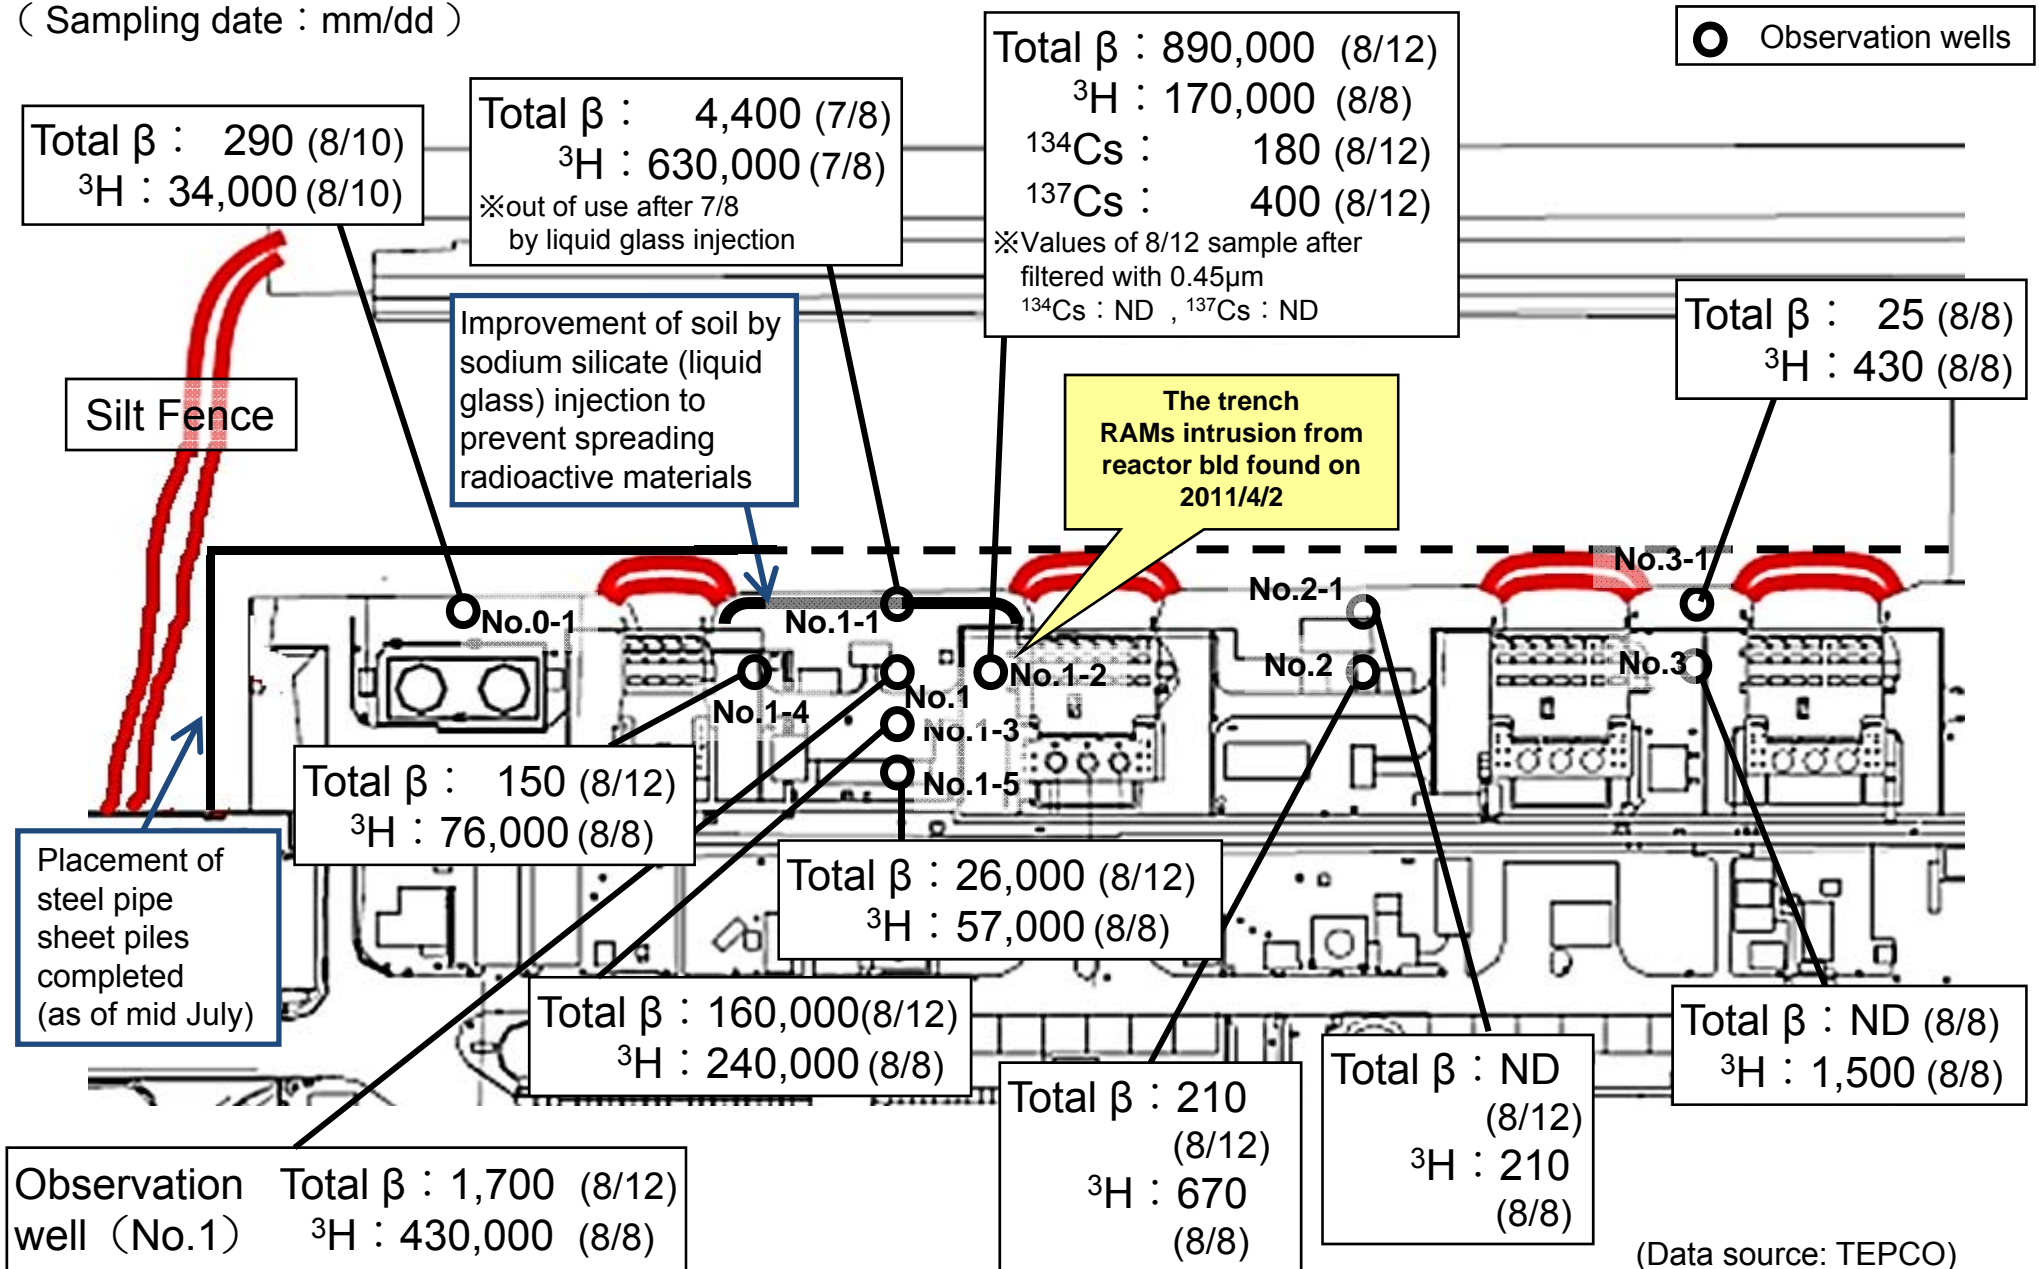
Activities in Ground Water at East Side of Turbine Bld. [Latest] Att. 2

Latest Values as of August 14 [Unit : Bq/liter] Total β: Excluding tritium

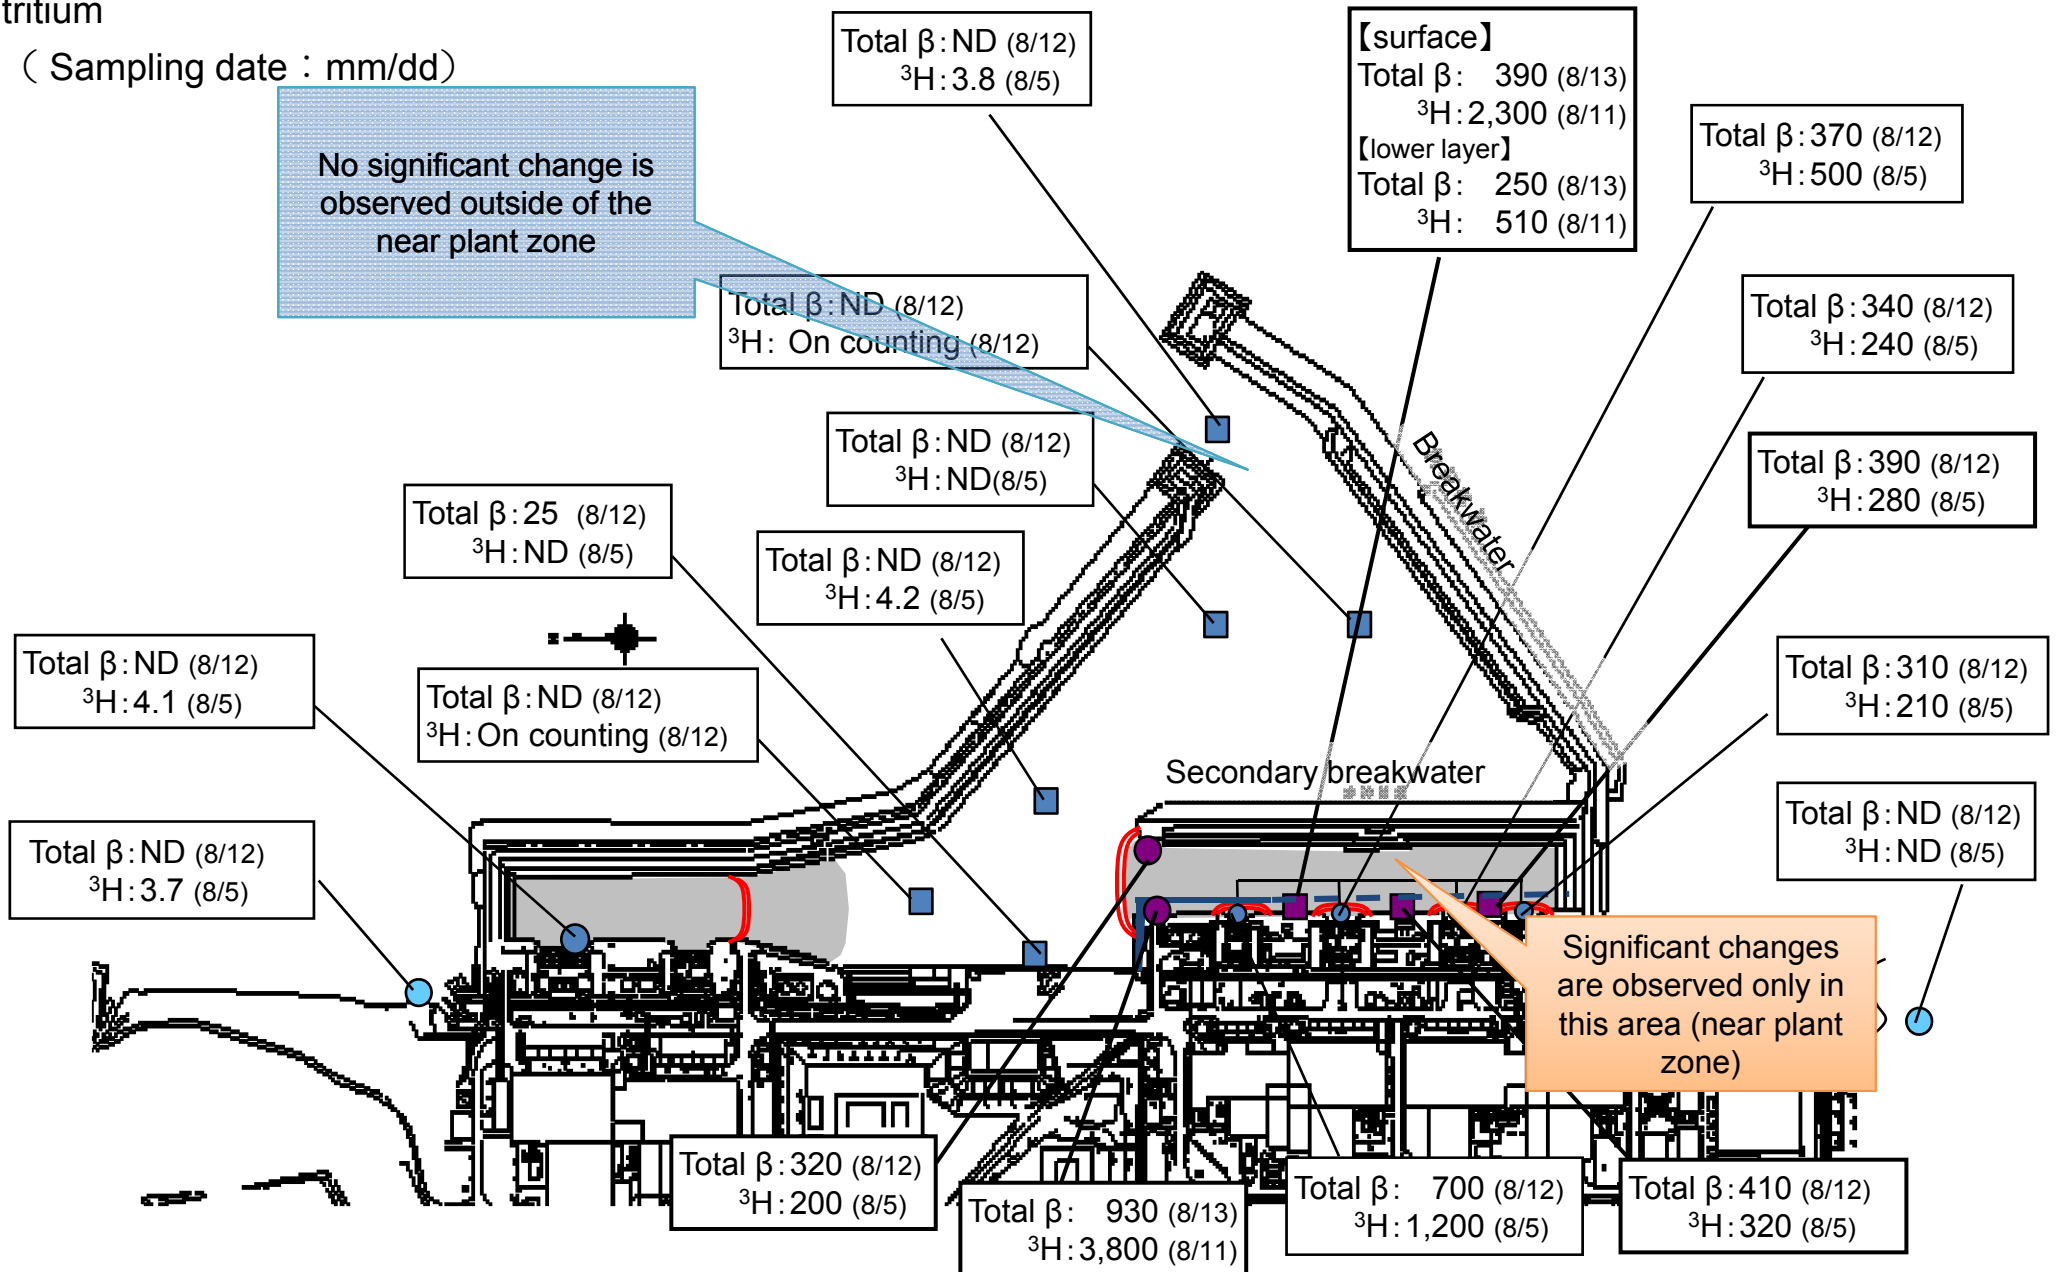
Sea Water Activity Inside and Outside [Latest]

radioactive material concentrations at the port boundary have been below the detection limit or a small number of becquerels per liter (as of August 14). It is considered that no meaningful influence is induced outside the port according to the observation. Attachment 3 illustrates the radioactive material concentrations of sea water both inside and outside the port. According to TEPCO, the amount of tritium leaked in 2 years and 2 months, from May 2011 to July 2013, is estimated to range from 20 trillion to 40 trillion becquerels. For reference, the maximum allowed annual release of tritium for the Fukushima Daiichi normal operation phase is 22 trillion becquerels per year.

Latest Values as of August 14 [Unit : Bq/liter] Total β: Excluding tritium

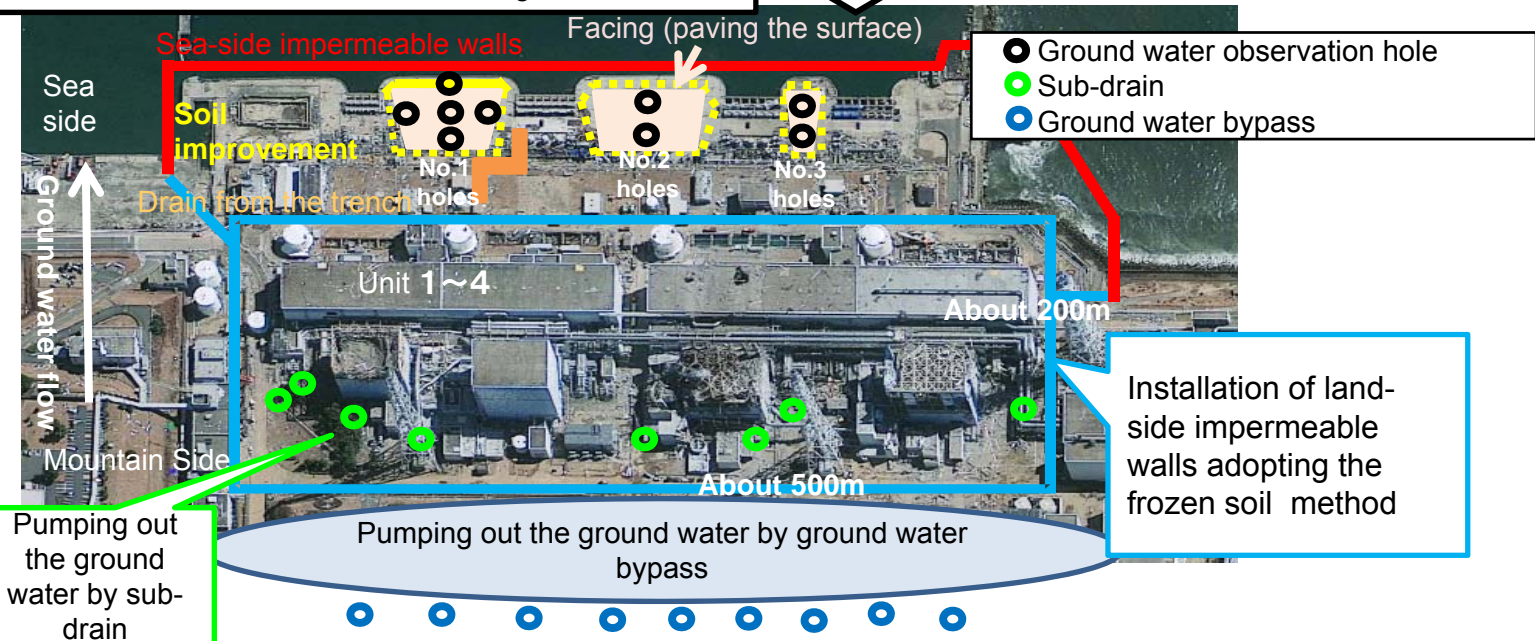
Overview of the countermeasures being or to be taken

TEPCO estimates that the whole area of units 1 to 4 has approx. 1000 m³ of ground water flow every day and 400 m³ of this flows into the basement of the facility buildings. And some part of the remaining water is considered to be contaminated by the water in the trench and flows into the port through the soil.

Pumping out the ground water by sub-drain

Pumping out the ground water by ground water bypass

Installation of land-side impermeable walls adopting the frozen soil method

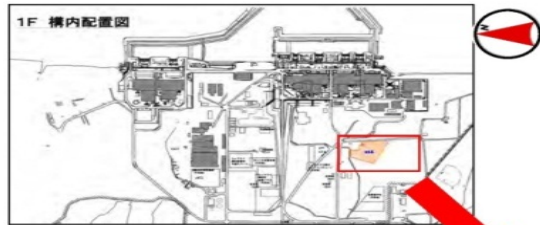
7. On August 19, TEPCO announced that they found water leak from a drain valve of a tank dike in the H4 area which is one of the installation locations of contaminated water tanks in Fukushima Daiichi NPS. Because high radiation dose was detected in the puddle of water having leaked outside the dike, TEPCO determined that the water had leaked from the contaminated water tank. TEPCO found water spread in the neighborhood of the No.5 tank in the H4 area and confirmed that the water level of the No. 5 tank was 3 m lower than its normal level. TEPCO estimates that the amount of the leaked contaminated water was 300 m³. In cooperation with the Government of Japan, TEPCO is making efforts for investigating the cause of this issue and preventing the similar events (refer to Attachment 5).

The place where paddles were found
