Progress Status and Future Challenges of Mid-and-long Term Roadmap toward the Decommissioning of Units 1-4 of TEPCO Fukushima Daiichi Nuclear Power Station (Outline)

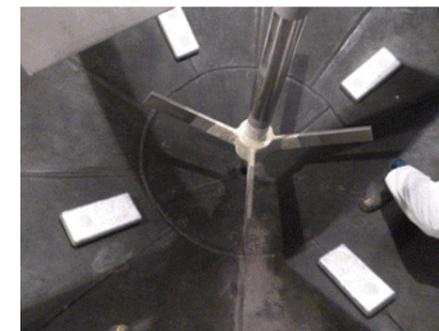
- As for System A, a minor leak was detected from the (batch process) tank used to pretreat the contaminated water. System A was suspended to investigate the leak (June 15) and System B was scheduled to be suspended (August 8). Based on the investigative results, corrosion was detected in the piping flange and within the absorption tower and flanges.

- Factors behind the corrosion and measures to prevent its recurrence are as follows:
 - Combined effects of formation of a crevice environment due to sediment generated by pre-treatment and acceleration of the corrosion environment due to chemical injection (mainly hypochlorous acid).
→ The inside of the batch process tank was rubber-lined (see Figure 1), and the injection of hypochlorous acid was suspended.

Figure 1: Batch process tank 1C
(after applying rubber lining)

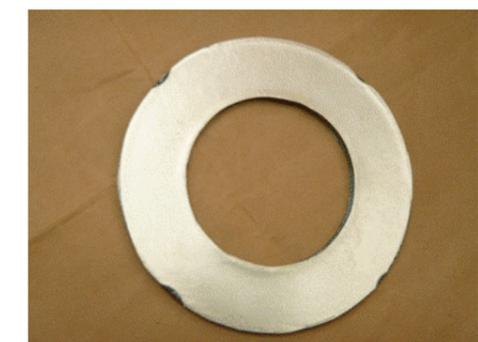
- Within the flange, the low-velocity flow tended to generate local corrosion.
→ Sacrificial electrodes were installed in flanges prone to corrosion (Figure 2).

Figure 2: Gasket-type sacrificial electrodes

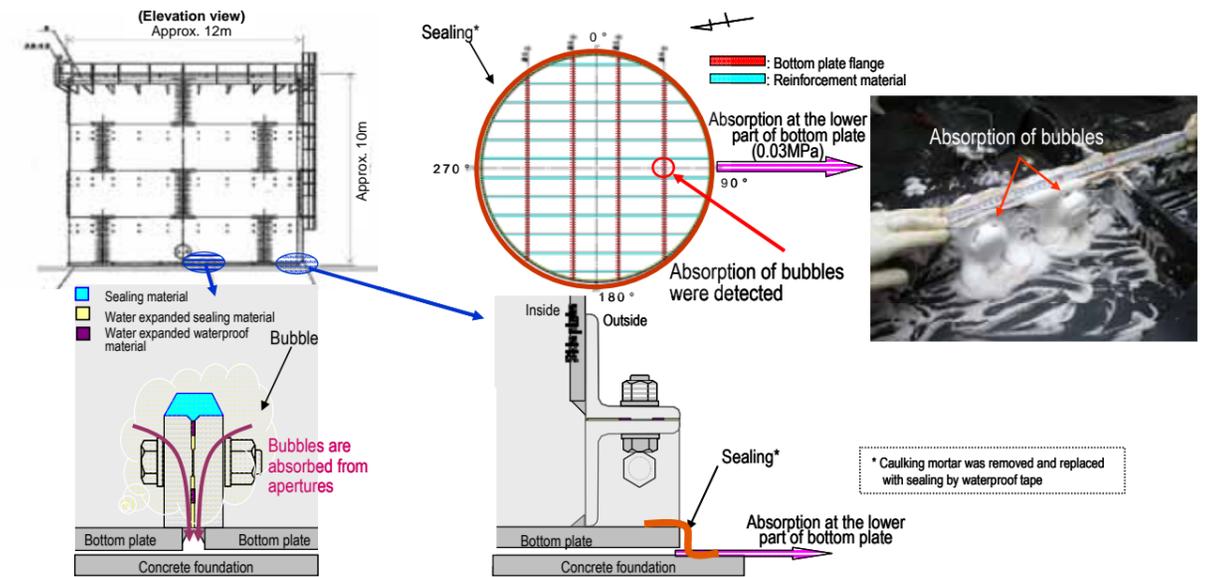
- Air was channeled into the space between the flange surface of the tank bottom plate and the concrete foundation to investigate the leak point, but the attempt to identify this failed (September 5).
- The tank in which a leak was detected was decontaminated and disassembled (from September 17), to conduct the bottom plate vacuum test*. Based on the results, there were two points from which bubbles were absorbed (September 25) (See Figure 3). The investigation concerning the leak will continue.

Figure 3: Investigation results related to leak of tanks

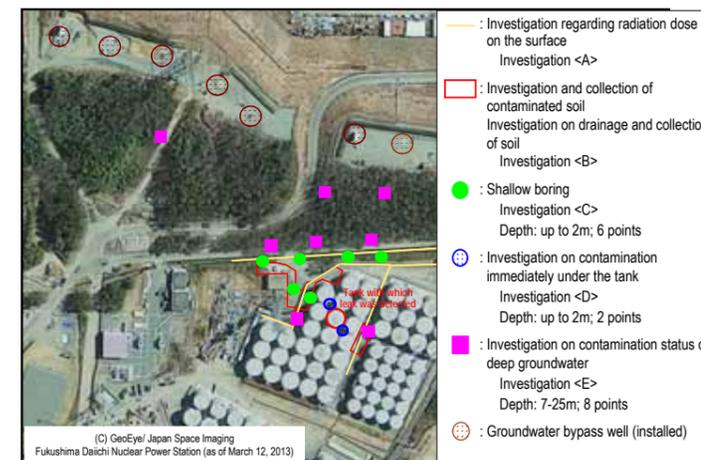
- To identify the contamination scope, an investigation into the radiation dose on the ground surface was conducted (Investigation <A>: August 19-22, 29). Based on the results, the contaminated soil was inspected and collected (Investigation : from August 23), while a boring survey to a depth of approx. 2m was performed (Investigation <C>: September 2-6) to analyze the soil, etc. which is now underway.

Figure 4: Boring survey points

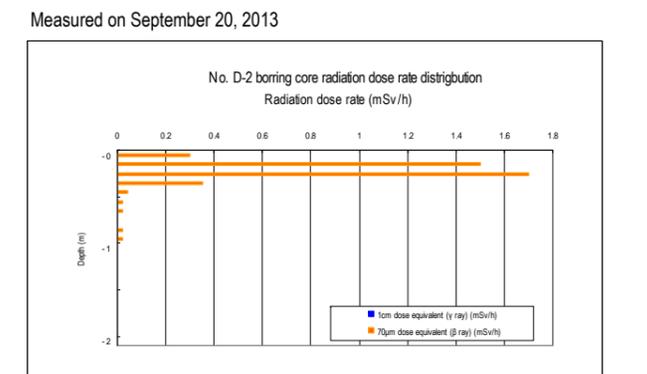
- To check for any contamination immediately under the tank in which a leak was detected, soil analysis by a boring survey is underway (Investigation <D>: The drilling work was completed on September 13). Based on the results of measurement to determine the radiation dose rate of the boring cores, it was confirmed that the contamination had penetrated to a depth of approx. 1m (see Figure 5).

Figure 5: Distribution of boring core radiation dose

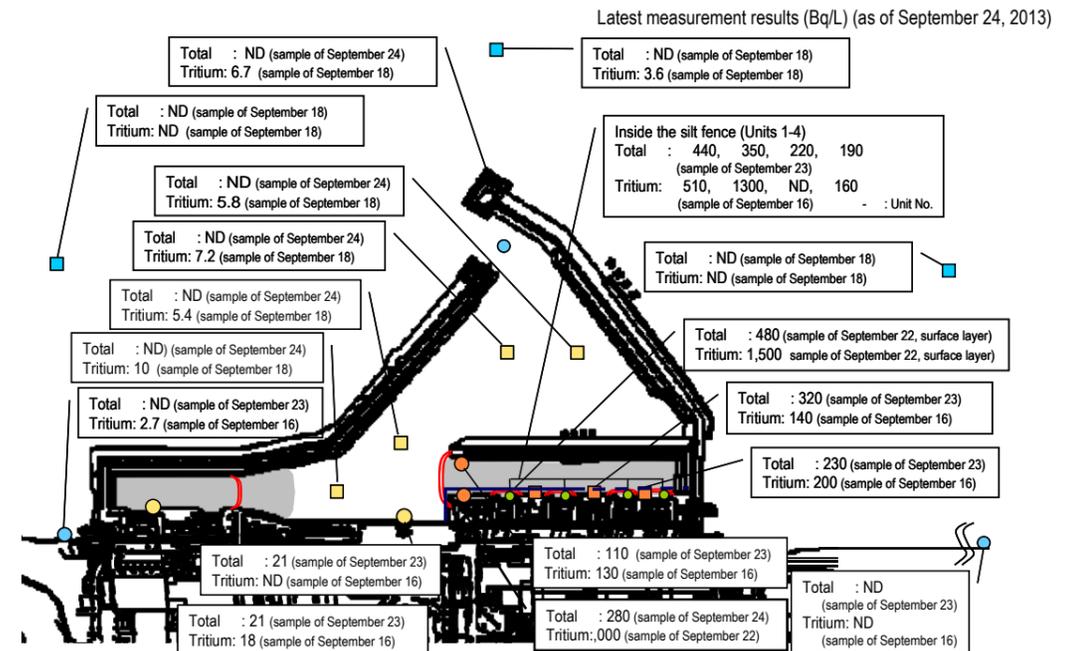
- Measures to address emissions of increased radioactive material density in groundwater on the sea side and in seawater
 - Analytical results of data e.g. concerning density and water levels of groundwater on the east (sea) side of the Reactor Buildings showed that contaminated groundwater had leaked into the seawater.
 - A significant increase in radioactive material density was detected within the intake open channels for Units 1 to 4 only. While the density near the port boundaries (i.e. the port channels and north and south discharge channels) was temporarily increased, it remained approx. below the detection limit level (peaking at several Bq/L) for the past month. No significant increase was detected in the offshore measurement results either. As shown by these observations, little impact was found on the outside of the port (see Figure 7).

Figure 7: Seawater monitoring results

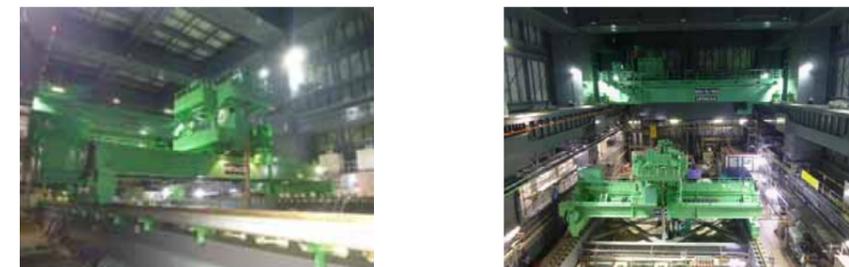
- The cover installation for fuel removal is ongoing (to be completed around October). The works for lifting the overhanging crane (June 7-14), lifting the Fuel Handling Machine (July 10-13), installing the outside walls of the fuel removal covers and exterior roof panels (April 1 – July 20) and the overhanging crane (September 25) were completed. At present, assembly and installation works are underway (see Figure 8).
- Toward the fuel removal start in November, removal of rubbles inside the pool is underway (from August 27).

Figure 8: Status of installation of the Unit 4 Fuel Handling Machine and overhead crane

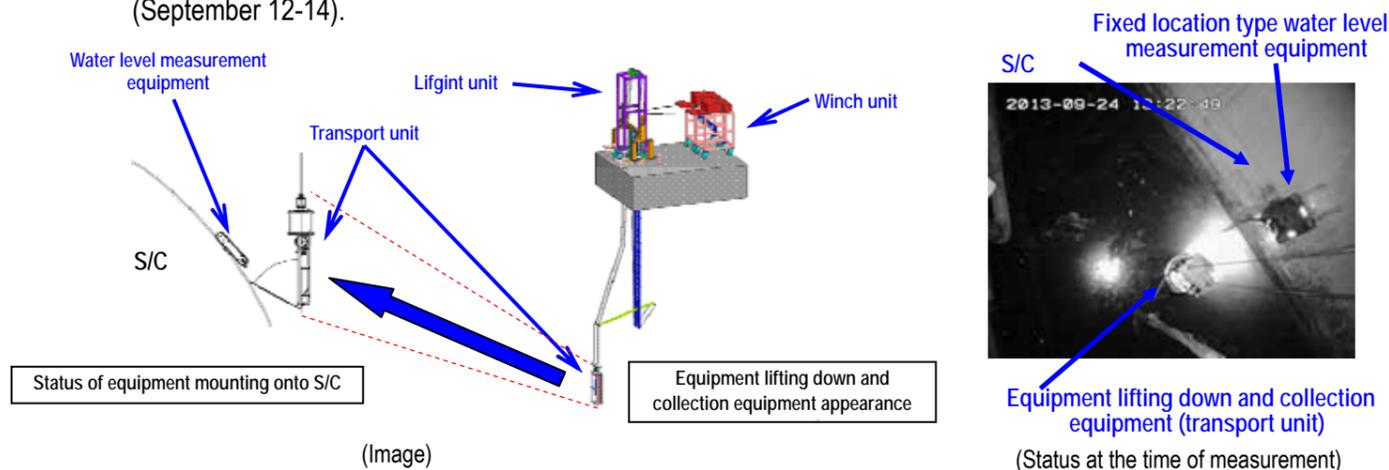
- As for Unit 2, aiming to investigate and repair the leaking parts with PCV, a demonstration test for technology measuring water levels in the suppression chamber (S/C) via remote control from outside S/C using ultrasound waves (September 20, 24) (see Figure 9). This technology was developed by the FY2012 technology infrastructure development project related to measures for accidents in nuclear power generation reactors (development of a remote-control infrastructure to measure the water level inside cylindrical containers. At present, the collected data is being analyzed.
- As for Unit 5, a demonstration of the developed equipment confirmed that it could measure water levels inside S/C (September 12-14).

Figure 9: Demonstration test of Unit 2 S/C water level measurement robot
