白馬ウインドファームの ブレード折損事故について (中間報告)

2019年3月11日

白馬ウインドファーム株式会社

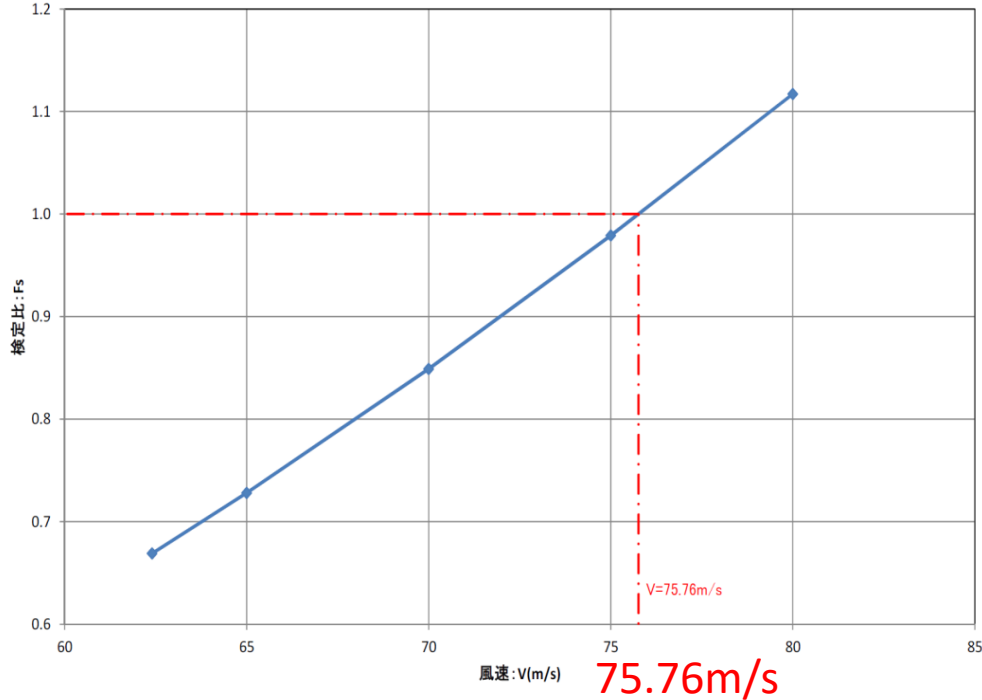
引抜きせん断耐力(風に正対する場合)

- ・風車が風に正対する場合は、風速75m/s以上の引抜き耐力を有する。
- ・風車が風を横から受ける場合は、風速65m/s以下で引抜き耐力が超過する。

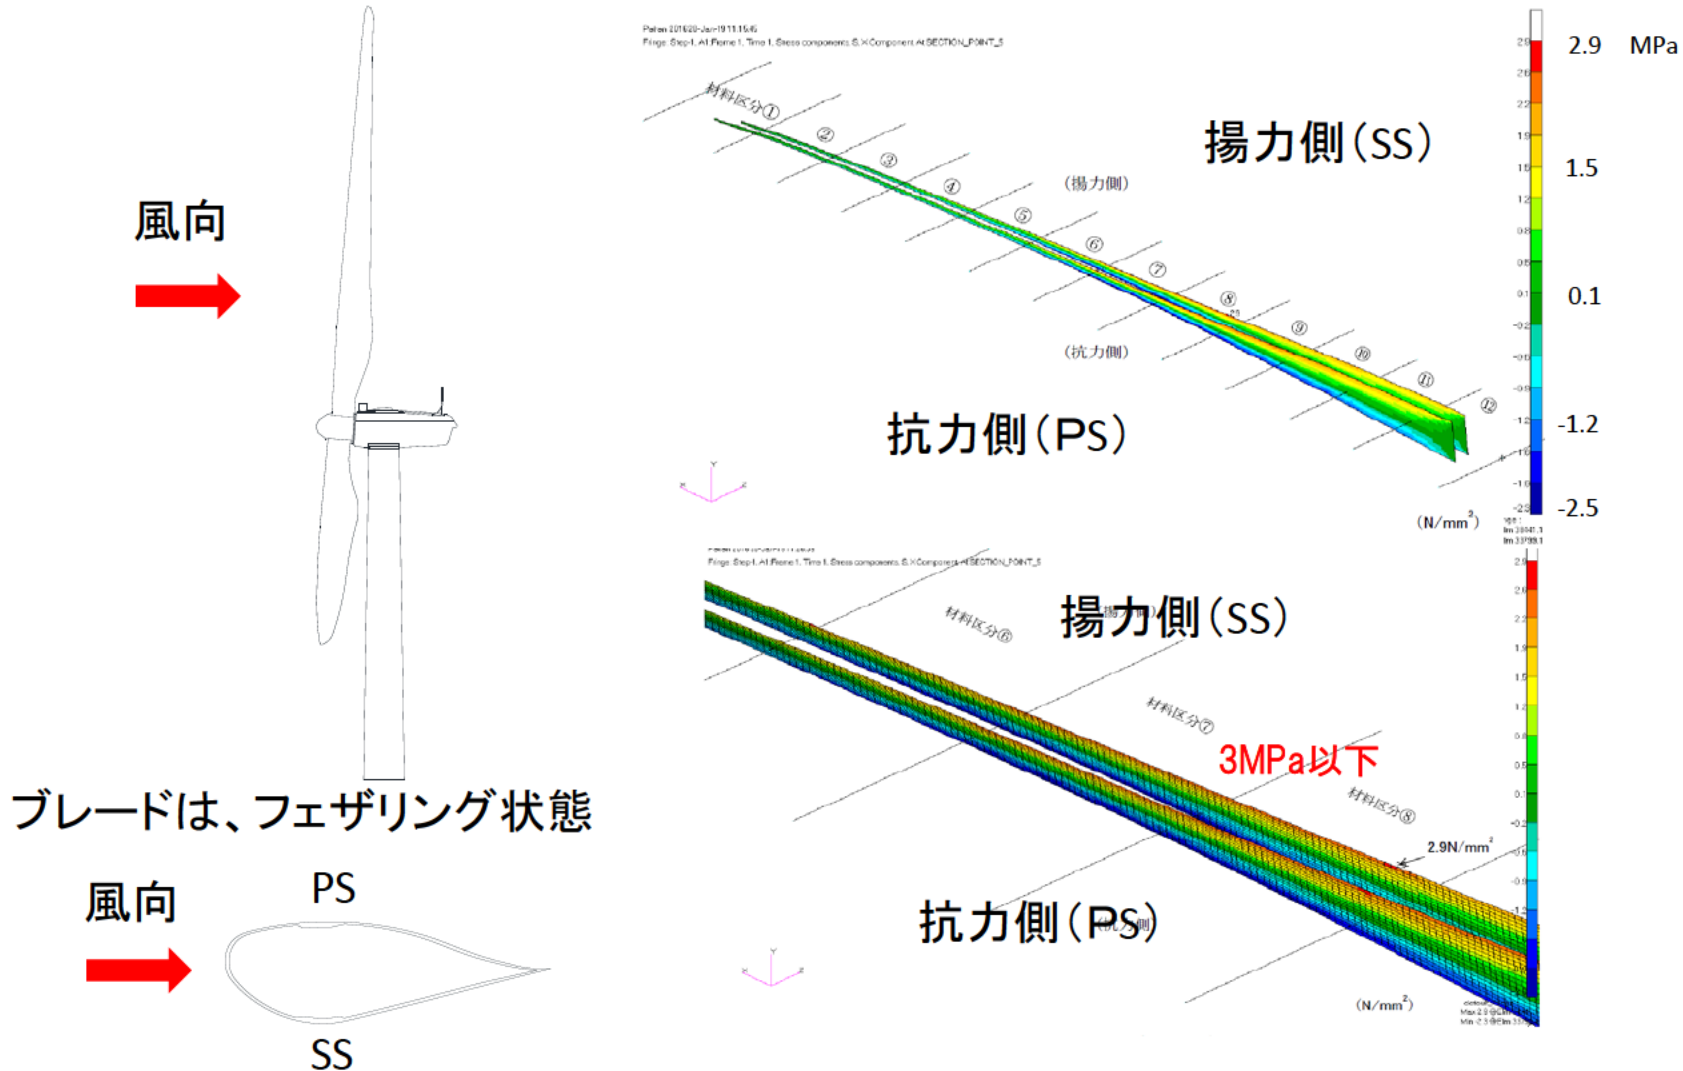
風車が風速70m/sの一樣流に正対する場合のブレードに発生する応力を求めた。
風に正対する場合、抗力側、揚力側も3MPaとなり材料強度に比べ小さい応力となっている。

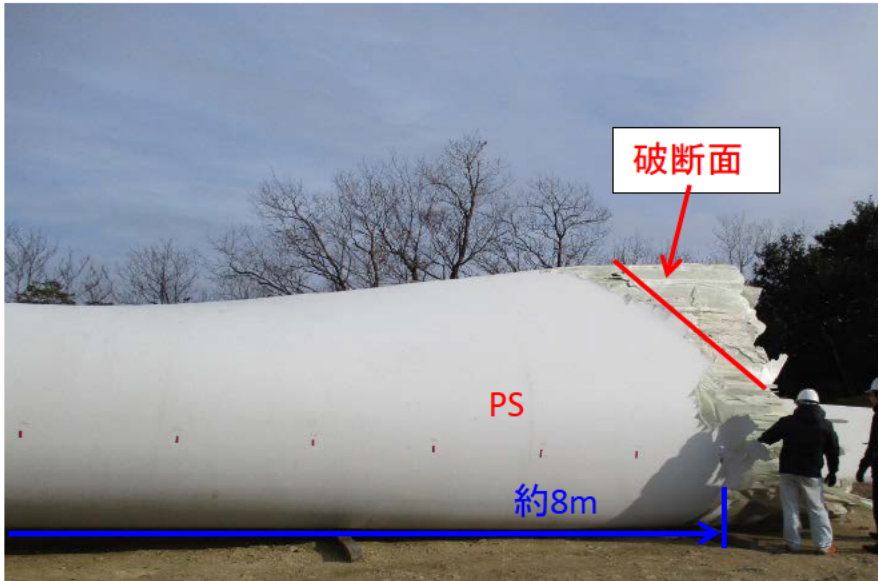
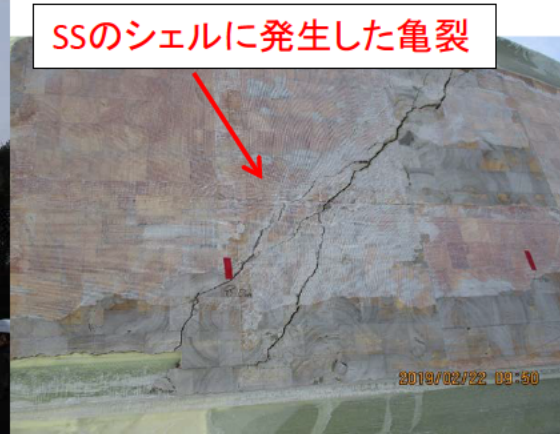
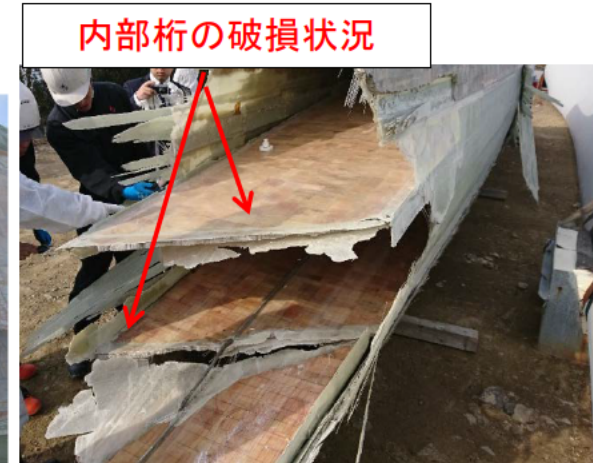
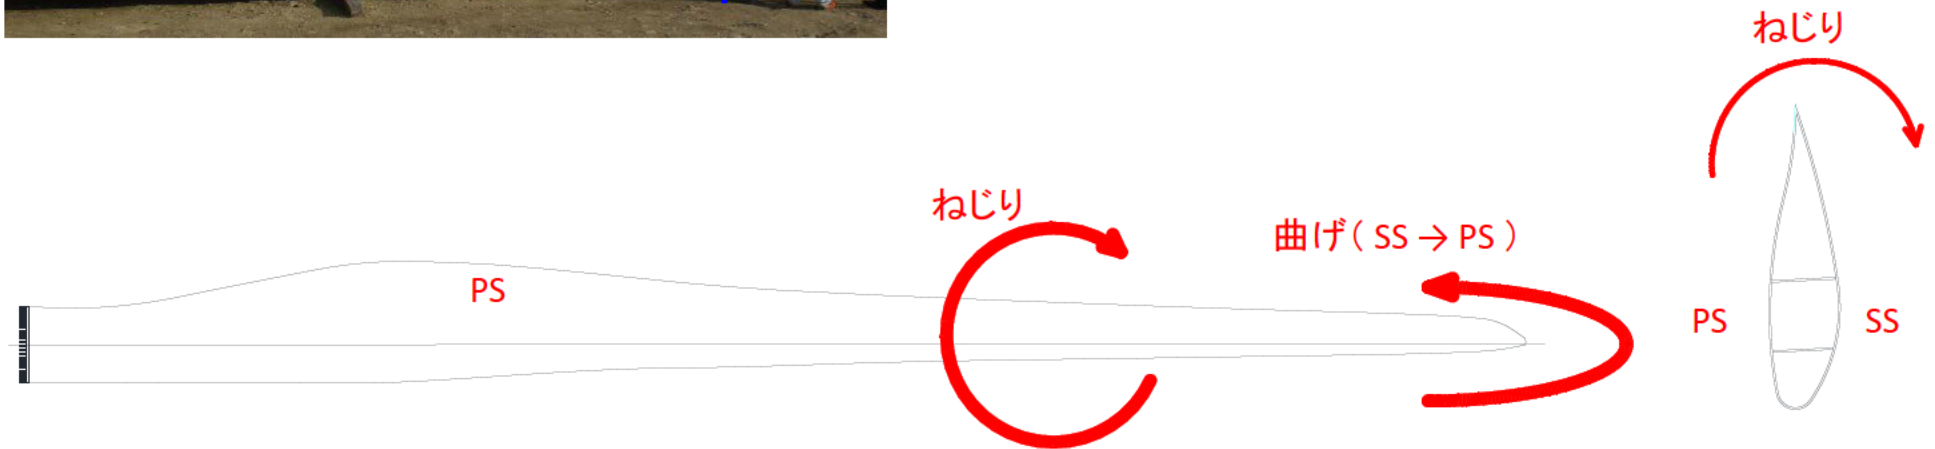
8. 17号機のブレード破損状況

17号機のNo.1ブレードは、現地確認の結果、破断面が斜めになっており、曲げとねじりを同時に受けて破断したものと推測される。

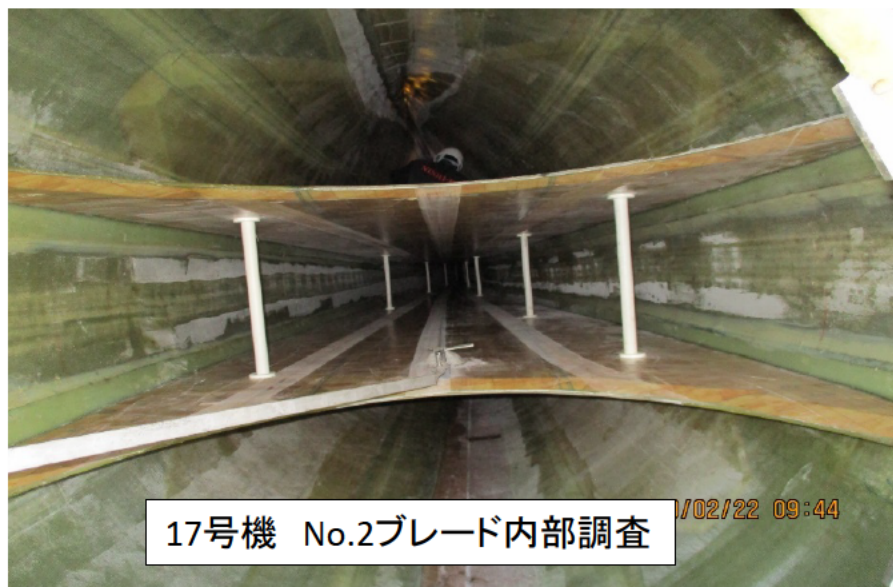
17号機のNo.2とNo.3ブレードについて内部点検を実施したが、桁とシェルの接合部の異常や桁の白化現象は発見されなかった。

10号機においても、UT検査で異常が発見されたブレードを解体し、状況確認を行ったが、接着部に僅かな空隙はあったが、接着面は確保されており異常は認められなかった。

UT検査では、この空隙部分を接着部の損傷と判断した可能性が高い。

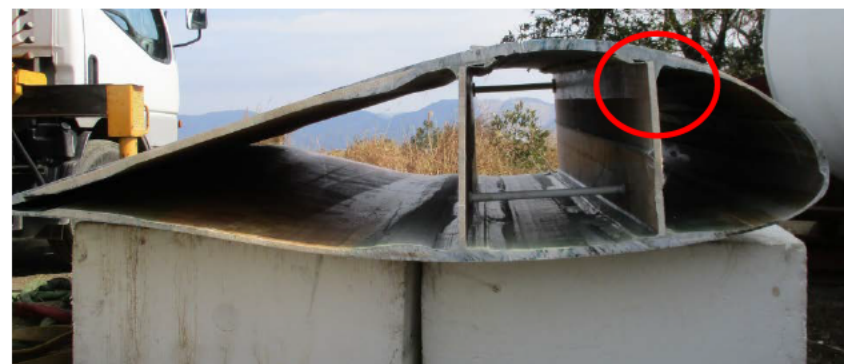
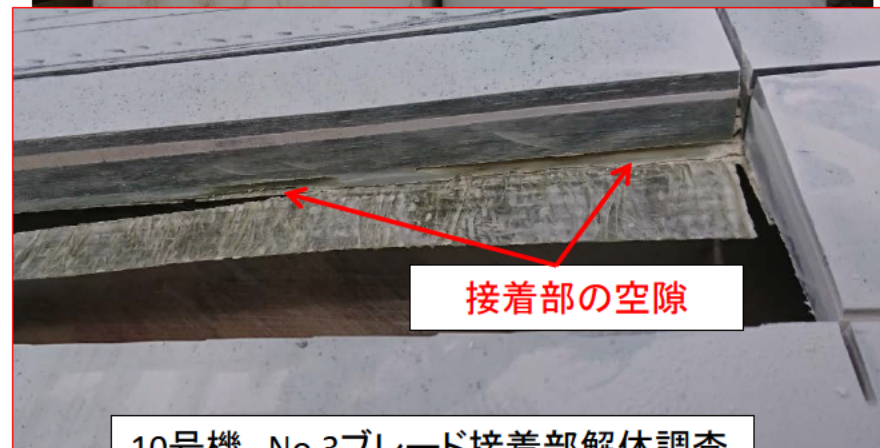
10号機 No.3ブレード接着部解体調査

このことより、ブレードの折損は、桁とシェルの接合部から発生したものではないと推測される。

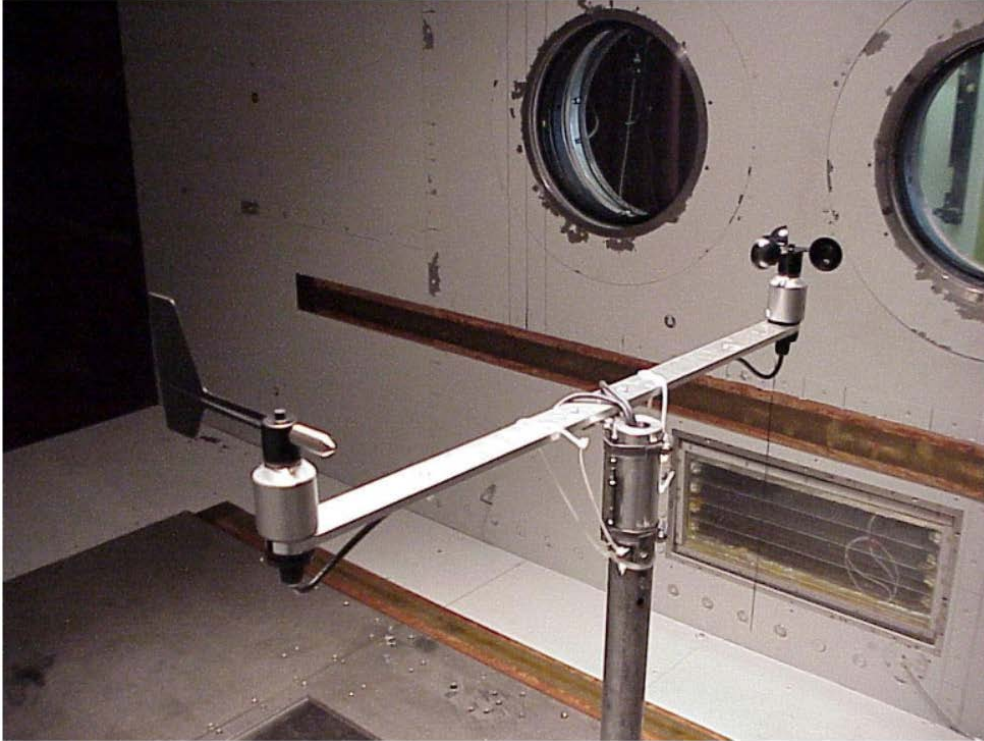
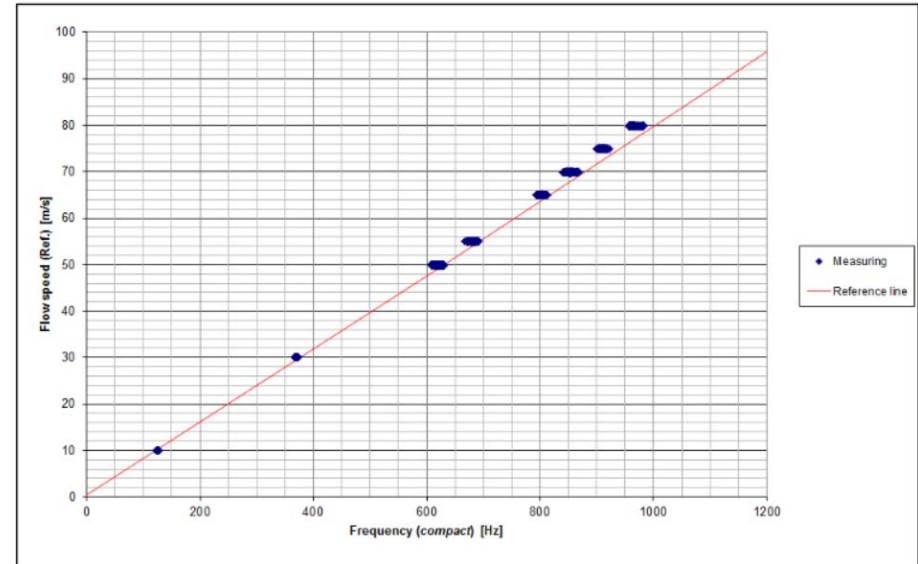
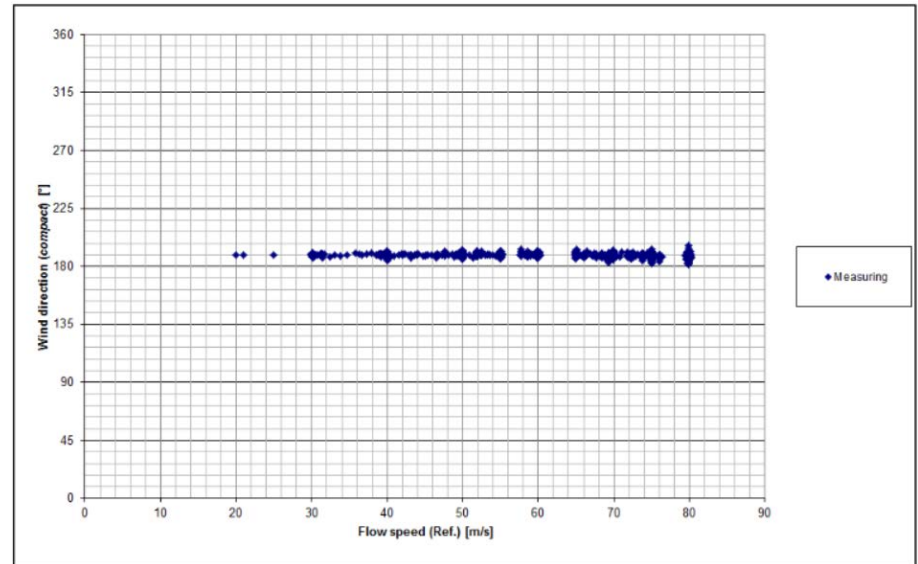
11. 風向計の台風強度

風向計、風速計ともに風洞試験によって80m/sまで耐風速が確認されている
