# Progress Status of Mid-and-long-Term Roadmap towards the Decommissioning of Fukushima Daiichi Nuclear Power Units 1-4, TEPCO

## 1. Past One Month Summary and Future Plans

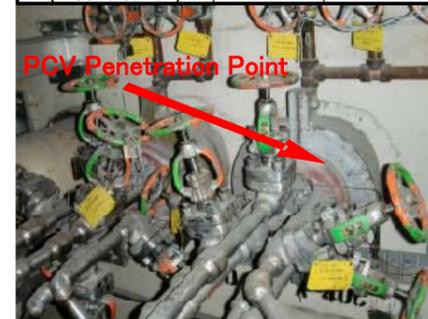
Fig.2: Field Survey Results of Unit 2's RPV Alternative Thermometers

- Installation of Alternative Thermometers at the Unit 2 RPV  
 We are considering an alternative way in light of the broken Unit 2's RPV bottom thermometers. From Mar. 15 to 22, we selected the most feasible piping locations where the thermometers can be installed, and conducted field surveys such as measuring the ambient radiation dosage. In light of the installation work, we will conduct measurements of the dimensions and the piping surface temperature of the Jet Pump Instrument System B, SLC differential pressure detection system, and the Traversing In-core Probe System, which were the candidate systems selected via the aforementioned surveys (scheduled from Mar. 28) (refer to Fig. 2).

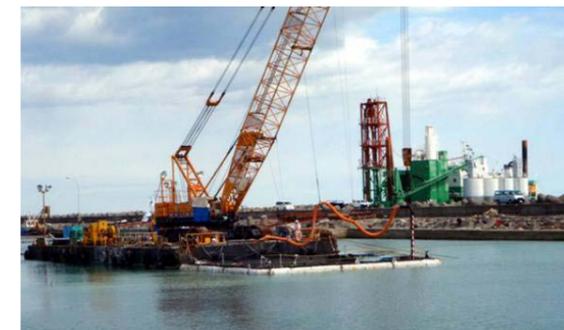
Fig. 3: Implementing Seabed Covering Work in front of the Units 1~4's Intake

- Additional Countermeasures for Mitigating Contamination  
 We will cover and harden the seabed soil in front of the intake channel. We conducted a field test from Feb. 28 to Mar. 13 and the full-fledged implementation scheduled from Mar. 14 to Jun.

after changed the composition of the fixation agent on the base of the results (refer to Fig. 3). Although we had planned to install silt-fences in front of Units 5 and 6 in Mar, a decision has been made to do the work from late Apr. to May in step with the progress of the covering work.

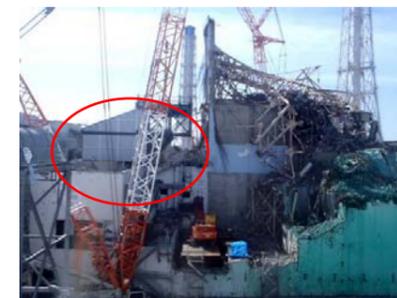
- Rubble Clearing from the Upper Part of the Reactor Buildings of Units 3 and 4 (ongoing) (refer to Fig. 5).

Unit 3 Reactor Building  
 Installed a gantry for upper rubble clearing (eastside)

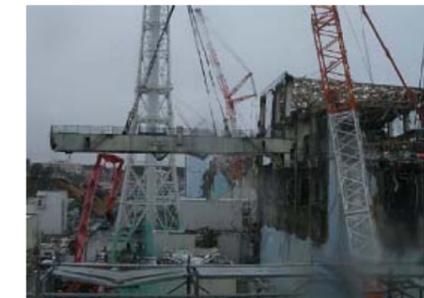
Unit 4 Reactor Building  
 Removing Overhead Crane Garter

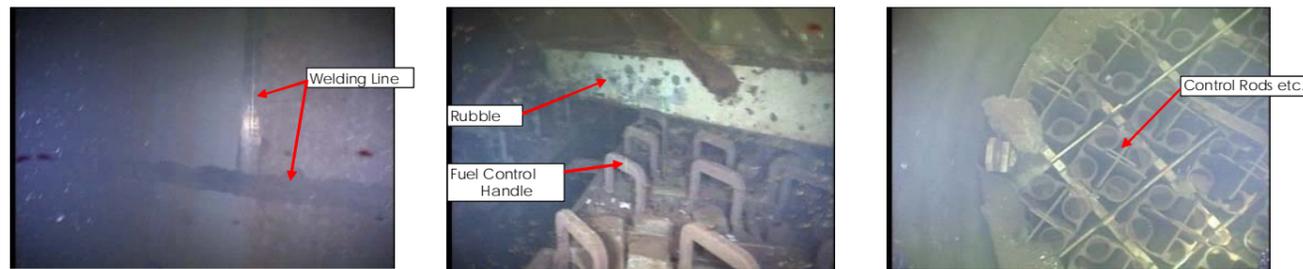
Fig. 6: Investigation Results of Dispersed Rubble Conditions inside Unit 4's Spent Fuel Pool

From Mar. 19 to 21, in order to develop a plan to remove the fuels from the spent fuel pool, we investigated the dispersed rubble conditions inside the pool using a remote operated vehicle (refer to Fig. 6).

① Southern Wall Surface    ② Rubble and Upper Part of Spent Fuels    ③ Cask Pit Inside

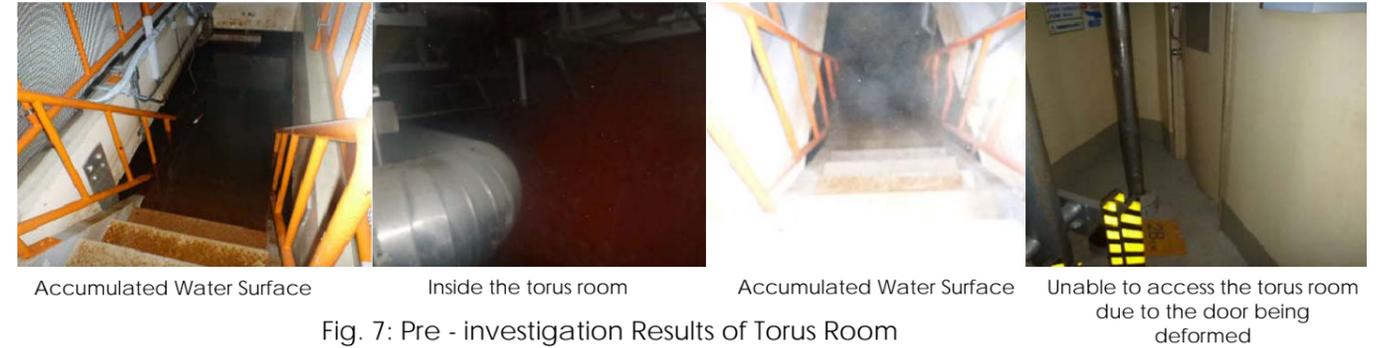
Fig. 7: Pre - investigation Results of Torus Room

- On Mar. 14, we investigated the access route to the torus room at Units 2 and 3 (refer to Fig. 7).
- Fuel Debris Removal  
We are considering investigating the details of the inspection points and methods of the PCV internal in each Unit.
