## Progress Status of Mid-and-long Term Roadmap towards the Decommissioning of Units 1-4 of TEPCO Fukushima Daiichi Nuclear Power Station (Outline)

### 1. Past One Month Summary and Future Plans

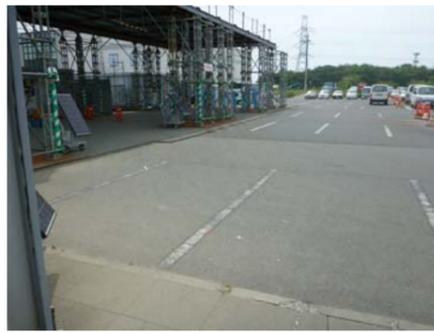
### 3. Iron plate installation in the bus standby area

Before iron plate installation

In addition to the iron plate installation at the bus stop in front of the Main Anti-earthquake Building in May 2011 (in order to mitigate radiation exposure), iron plates were installed in the bus standby area in front of the Main Anti-earthquake Building to further mitigate radiation exposure. As a result, the radiation dose inside the bus has been decreased from 60 μ Sv/h to 15 μ Sv/h (August 20 - September 26) (See 3 below).

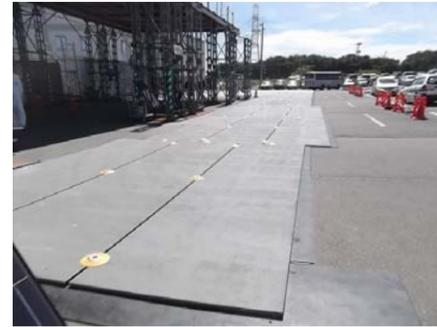
After iron plate installation

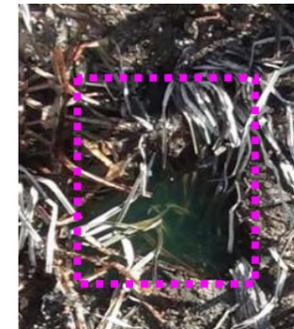
### 4. Debris removal from Unit 3 operation floor

Before debris removal (November 12, 2011)

- Debris removal from the upper part of Unit 3-4 Reactor Buildings
  - At Unit 3, debris removal from the upper part of the Reactor Building is ongoing (planned to be completed around March 2013) (See 4 below) and the protective platform is being installed (planned to be completed around December 2012).
  - At Unit 4, large equipments have been removed from the Reactor Building operation floor (July 24 - October 2). The cover for fuel removal is being installed (to be completed in mid FY 2013).
- Steel beam falling into Unit 3 spent fuel pool

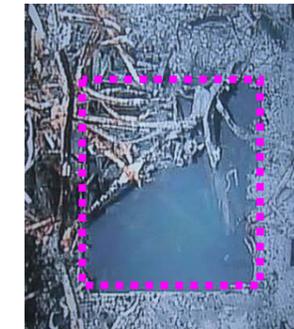
During debris removal (September 20, 2012)
