Outline of Decommissioning, Contaminated Water and Treated Water Management

Main decommissioning work and steps

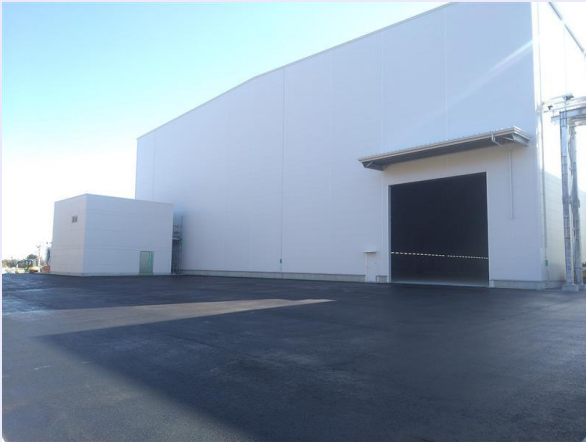
External appearance of the 10-C Facility (February 17, 2025)

For C Facility, installation work commenced from October 2023. An inspection prior-to-use certificate dated April 25, 2025 was granted and operation commenced, and the entire 10th Solid Waste Storage Facility was completed.

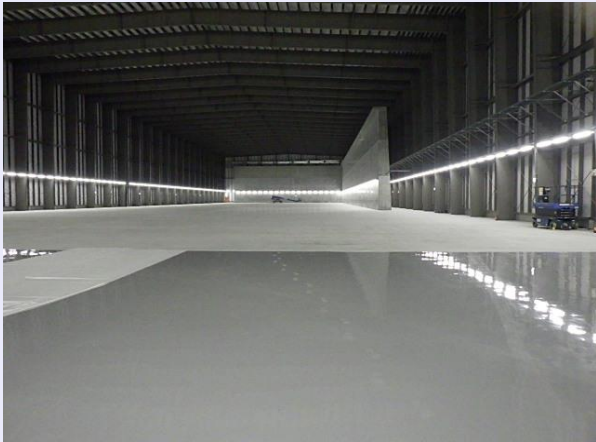
Inside the 10-C Facility (April 7, 2025)
