# Outline of Decommissioning, Contaminated Water and Treated Water Management

## Main decommissioning work and steps

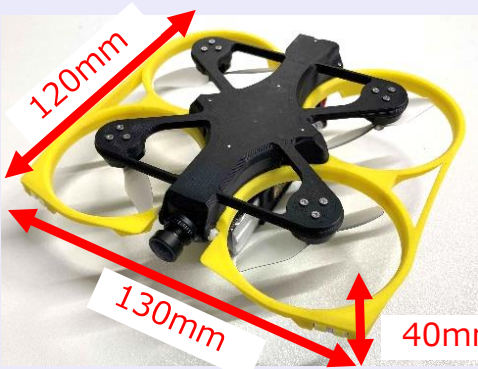
Purpose: Acquiring images by camera (2.7K)  
Size: 130×120×40 [mm]  
Weight: 95 [g] (including battery)  
Flight time: Approx. 13 min  
(investigation will be conducted in 10 min)

To match the small-diameter X-53 penetration, an investigation inside the PCV using an “ultra-small” but “highly maneuverable” “micro-drone” with high “photographic ability” is planned.

In this investigation, within the scope where the micro-drone can fly, work to acquire images inside the D/W 1FL and the pedestal is planned. In particular, the main purpose is information collection around X-6 penetration and inside the pedestal which are important for future investigation and horizontal access to fuel debris retrieval. Moreover, as in the drone investigation in Unit 1, work to acquire point cloud data from images and estimate the dose rate using radiation noise is scheduled.
