Outline of Decommissioning, Contaminated Water and Treated Water Management

Main decommissioning work and steps

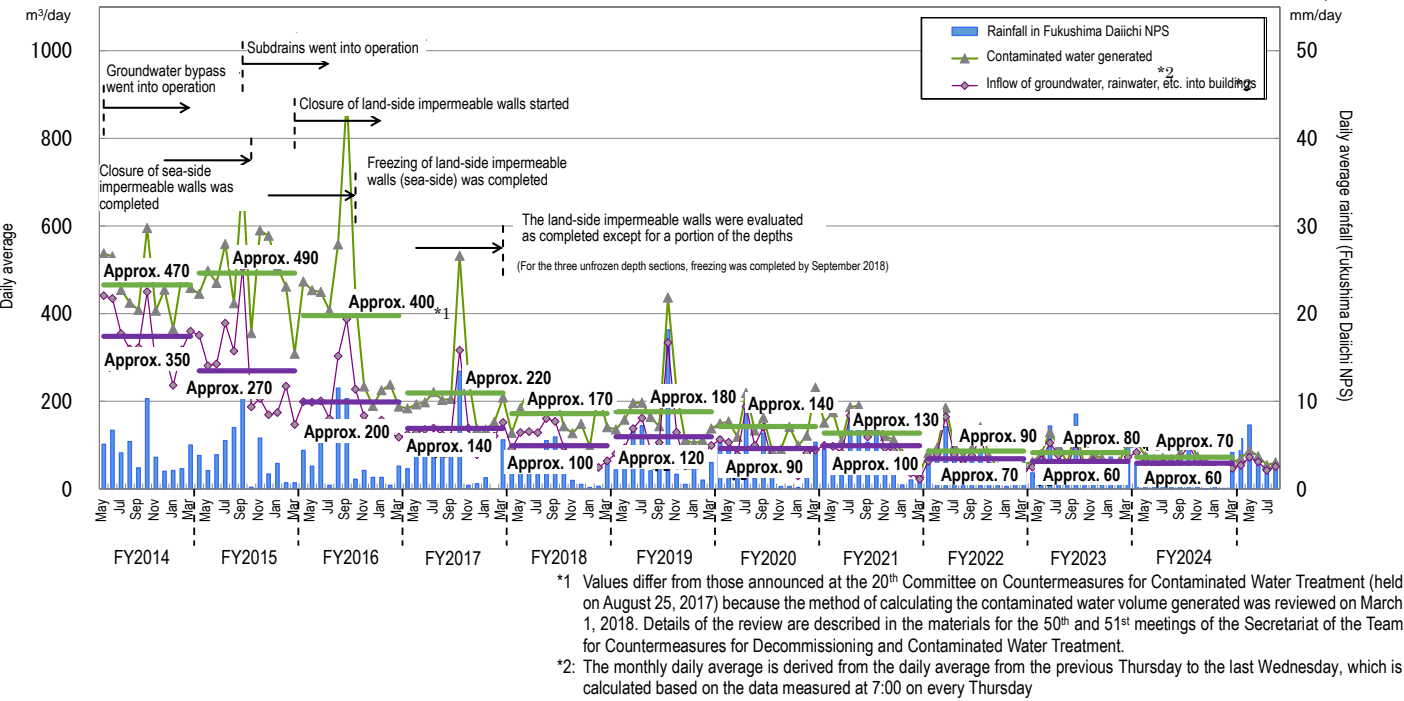
Figure 1: Changes in contaminated water generated and inflow of groundwater and rainwater into buildings

- Status of contaminated water generated
 - Multi-layered contaminated water management measures, including land-side impermeable walls and subdrains, have stabilized the groundwater at a low level and the increased contaminated water generated during rainfall is being suppressed by repairing damaged portions of building roofs facing onsite. Through these measures, the generation of contaminated water has been suppressed and reduced from approx. 540 m³/day (in May 2014) before implementing measures to approx. 70 m³/day (in FY2024). It was confirmed that the milestone of “suppressing the amount of contaminated water generated to 100 m³/day or less during average rainfall within FY2025,” which was achieved in FY2023, has been maintained in FY2024.
 - Measures will proceed to further reduce the amount of contaminated water generated and suppress to approx. 50-70 m³/day by FY2028.

*1 Values differ from those announced at the 20th Committee on Countermeasures for Contaminated Water Treatment (held on August 25, 2017) because the method of calculating the contaminated water volume generated was reviewed on March 1, 2018. Details of the review are described in the materials for the 50th and 51st meetings of the Secretariat of the Team for Countermeasures for Decommissioning and Contaminated Water Treatment.
*2: The monthly daily average is derived from the daily average from the previous Thursday to the last Wednesday, which is calculated based on the data measured at 7:00 on every Thursday

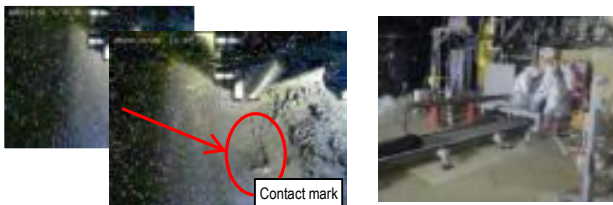
<Conditions of deposits before and after contact>

- In October 2020, a deposits contact investigation at the PCV penetration (X-6 penetration) was conducted. This confirmed that deposits inside the penetration had not deformed and come unstuck.
