Outline of Decommissioning, Contaminated Water and Treated Water Management

Main decommissioning work and steps

Progress status

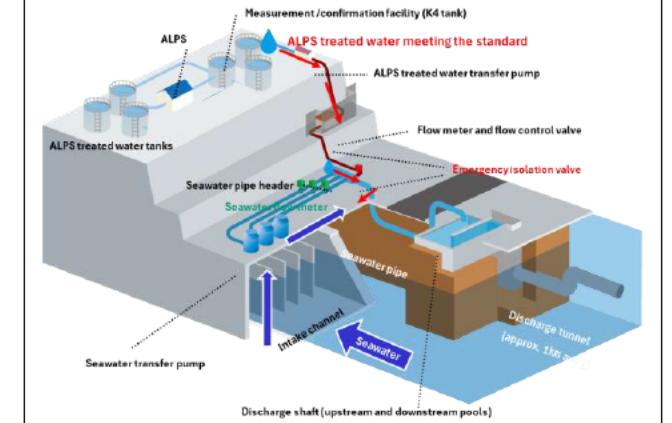
Flow of discharge of ALPS treated water into the sea

Regarding the discharge of ALPS treated water into the sea, TEPCO must comply with regulatory and other safety standards to safeguard the public, the surrounding environment and agricultural, forestry and fishery products. To minimize adverse impacts on reputation, ongoing efforts will continue, including enhanced monitoring, ensuring objectivity and transparency by engaging with third-party experts and having safety checked by the IAEA. Moreover, accurate information will be disseminated with full transparency.

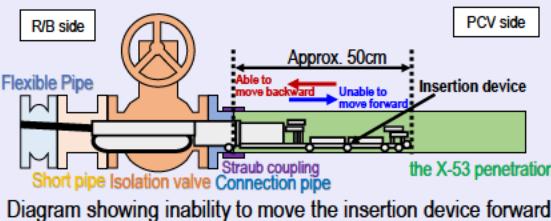
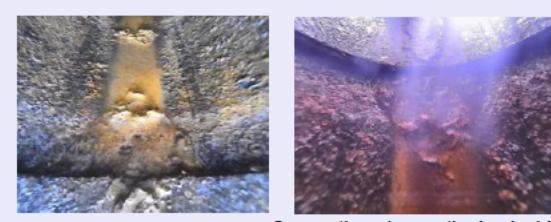
Two cameras were added to the end of the insertion device in order to perform a detailed inspection of the inside of the insertion pipe.

Analysis of obtained footage shows that the center axes of the connection pipe and the X-53 penetration are slightly misaligned. Based on these results, we assume the reasons why the insertion device cannot move past this point are because “the cross-sectional area of the pathway becomes smaller” and “the crawler loses grip”.

the X-53 penetration on the back side Connection pipe on the back side

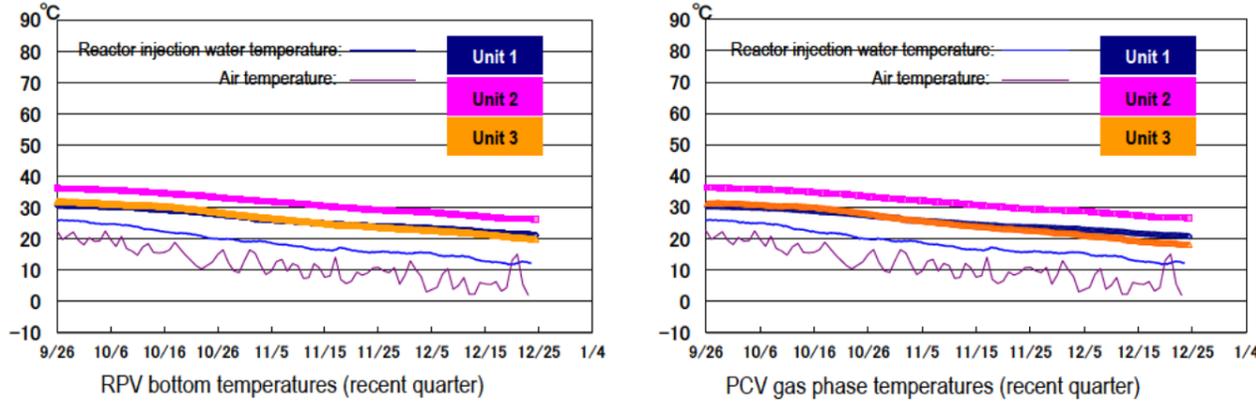
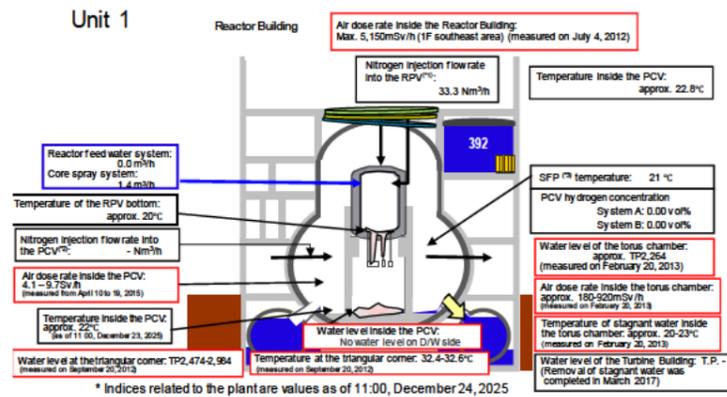
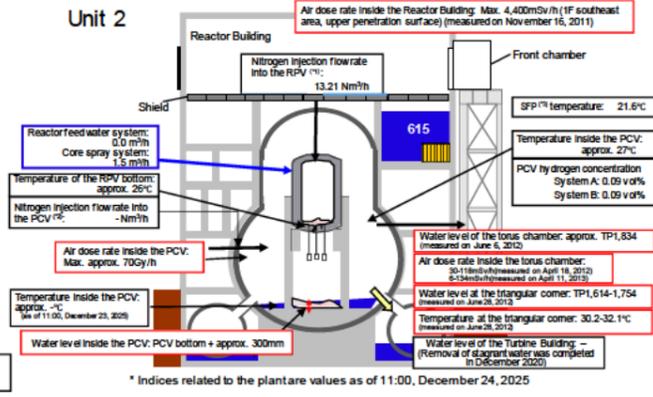
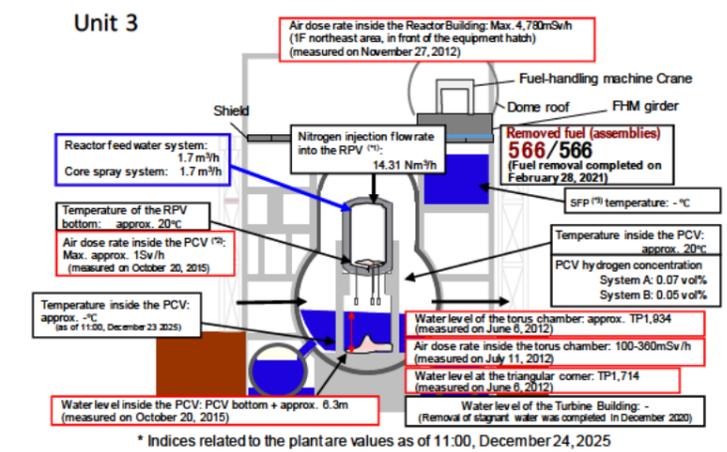
Through continuous reactor cooling by water injection, the temperatures of the Reactor Pressure Vessel (RPV) bottom and the Primary Containment Vessel (PCV) gas phase were maintained as shown below for recent, though they varied depending on the unit and location of the thermometer.

*1 The trend graphs show part of the temperature data measured at multiple points.
*2 A part of data could not be measured due to maintenance and inspection of the facility and other work.

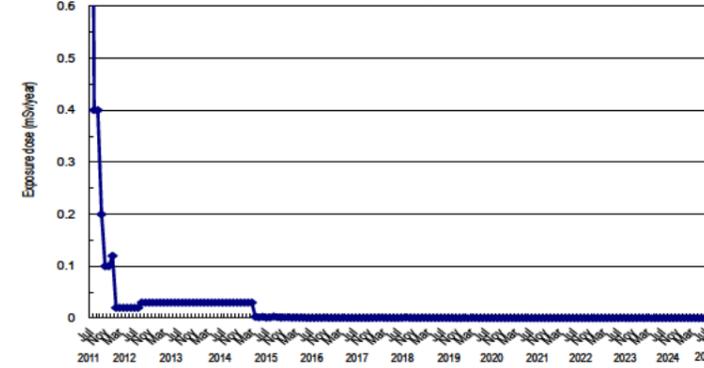
Annual radiation dose at site boundaries by radioactive materials (cesium) released from Reactor Building Units 1-4

As of November 2025, the concentration of radioactive materials newly released from Reactor Building Units 1-4 into the air and measured at the site boundary was evaluated at approx. 5.1×10^{-12} Bq/cm³ and 1.1×10^{-11} Bq/cm³ for Cs-134 and -137 respectively, while the radiation exposure dose due to the release of radioactive materials there was less than 0.00003 mSv/year.

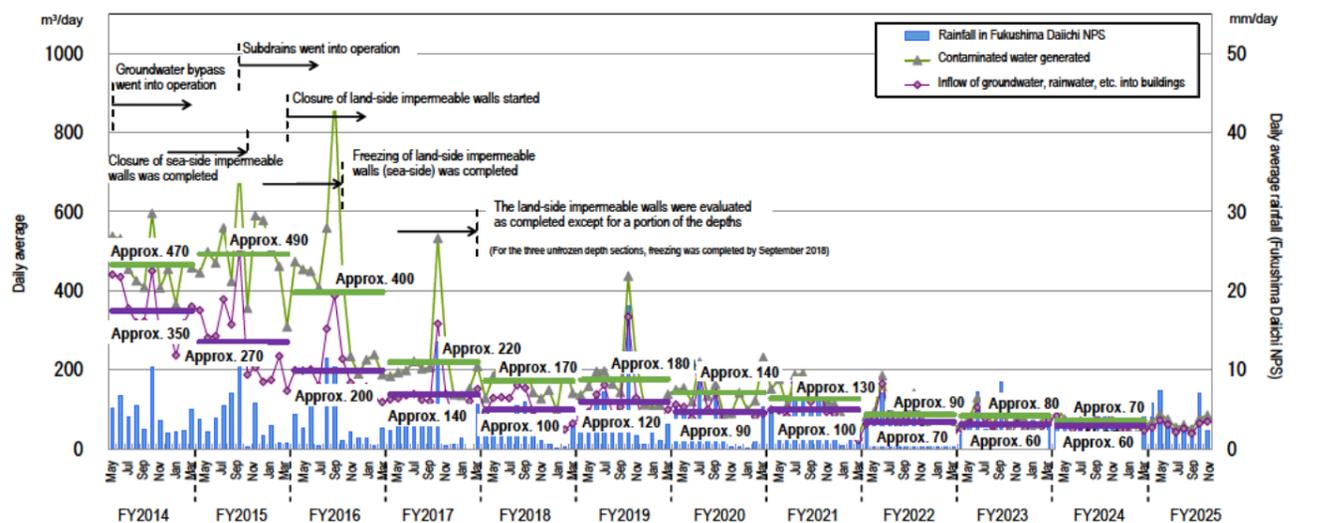
Figure 1: Changes in contaminated water generated and inflow of groundwater and rainwater into buildings

- Multi-layered contaminated water management measures, including land-side impermeable walls and subdrains, have stabilized the groundwater at a low level and the increased contaminated water generated during rainfall is being suppressed by repairing damaged portions of building roofs facing onsite. Through these measures, the generation of contaminated water has been suppressed and reduced from approx. 540 m³/day (in May 2014) before implementing measures to approx. 70 m³/day (in FY2024). It was confirmed that the milestone of “suppressing the amount of contaminated water generated to 100 m³/day or less during average rainfall within FY2025,” which was achieved in FY2023, has been maintained in FY2024.
- Measures will proceed to further reduce the amount of contaminated water generated and suppress to approx. 50-70 m³/day by FY2028.

*1 Values differ from those announced at the 20th Committee on Countermeasures for Contaminated Water Treatment (held on August 25, 2017) because the method of calculating the contaminated water volume generated was reviewed on March 1, 2018. Details of the review are described in the materials for the 50th and 51st meetings of the Secretariat of the Team for Countermeasures for Decommissioning and Contaminated Water Treatment.

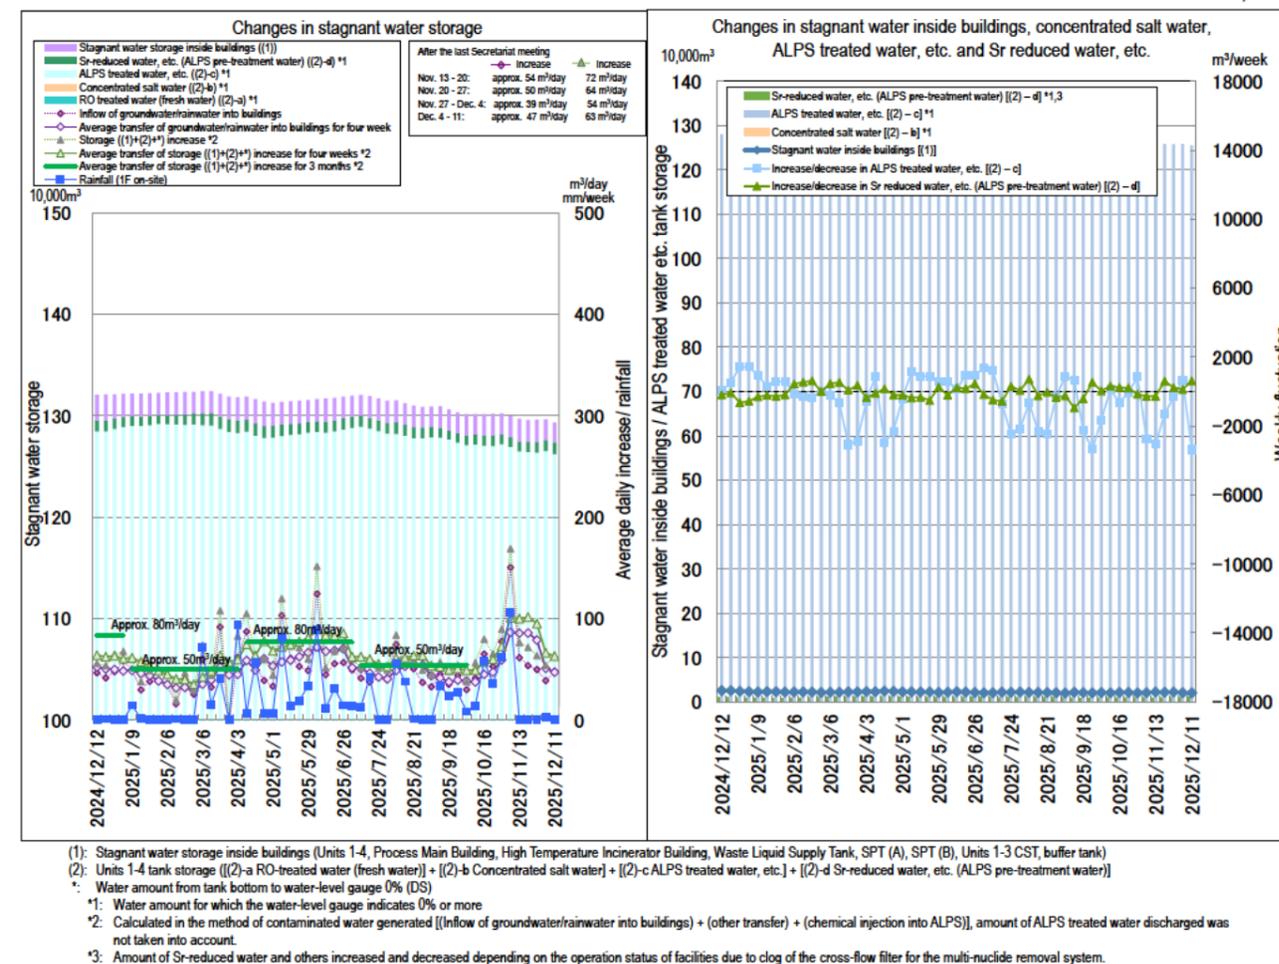
Figure 3: Status of stagnant water storage

As of December 11, 2025

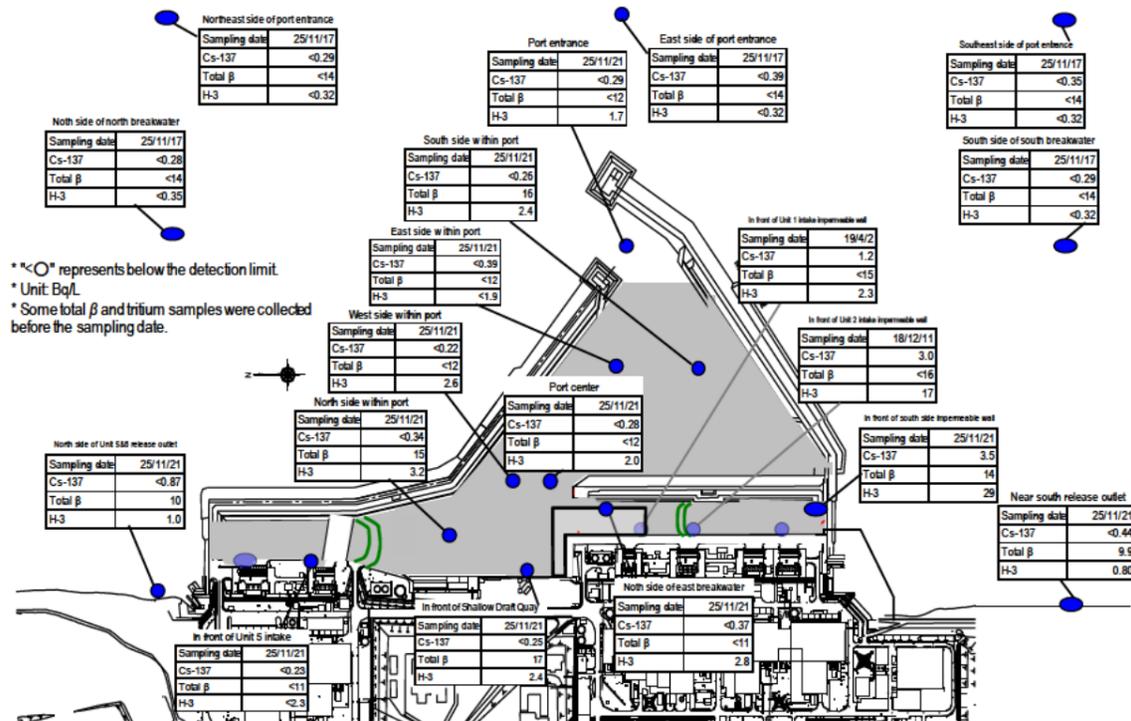
Figure 5: Seawater concentration around the port

- In the port area, the concentration of radioactive materials in seawater has remained below the legal discharge limit and been declining long term, despite temporary increases in Cs-137 and Sr-90 observed during rainfall. They have remained below the level of those in the Units 1-4 intake open channel area and been declining following the completed installation and connection of steel pipe sheet piles for the sea-side impermeable walls.

- In the area outside the port, regarding the concentration of radioactive materials in seawater, those of Cs-137 and Sr-90 declined and remained low after steel pipe sheet piles for the sea-side impermeable walls were installed and connected. For Cs-137 concentrations, a temporary increase was sometimes observed on the north side of the Units 5 and 6 outlets and near the south outlet due to the influence of weather, marine meteorology and other factors. For Sr-90 concentrations, variation was observed in FY2021 in the area outside the port (north and south outlets). Monitoring of the tendency continues, including the potential influence of weather, marine meteorology and others. During the period for which ALPS treated water was discharged, the tritium concentration increased at the sampling point near the discharge side outlet, but this was considered within the assumed range based on the oceanic dispersion simulation results.

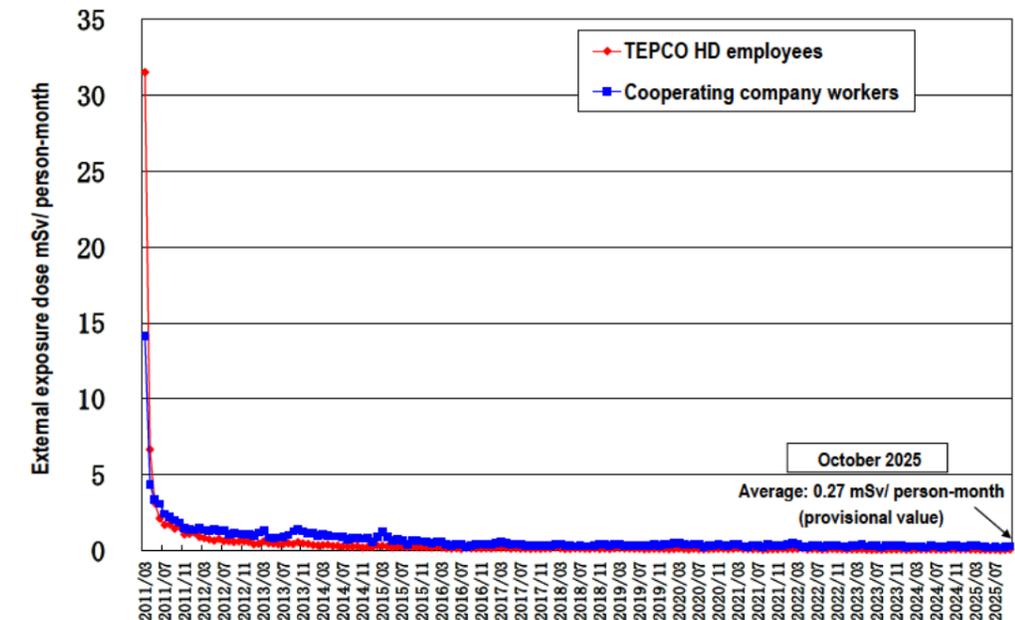
Figure 7: Changes in monthly average exposure dose of individual worker (monthly exposure dose since March 2011)

- For most workers, the exposure dose remained sufficiently within the limit and allowed them to continue engaging in radiation work.

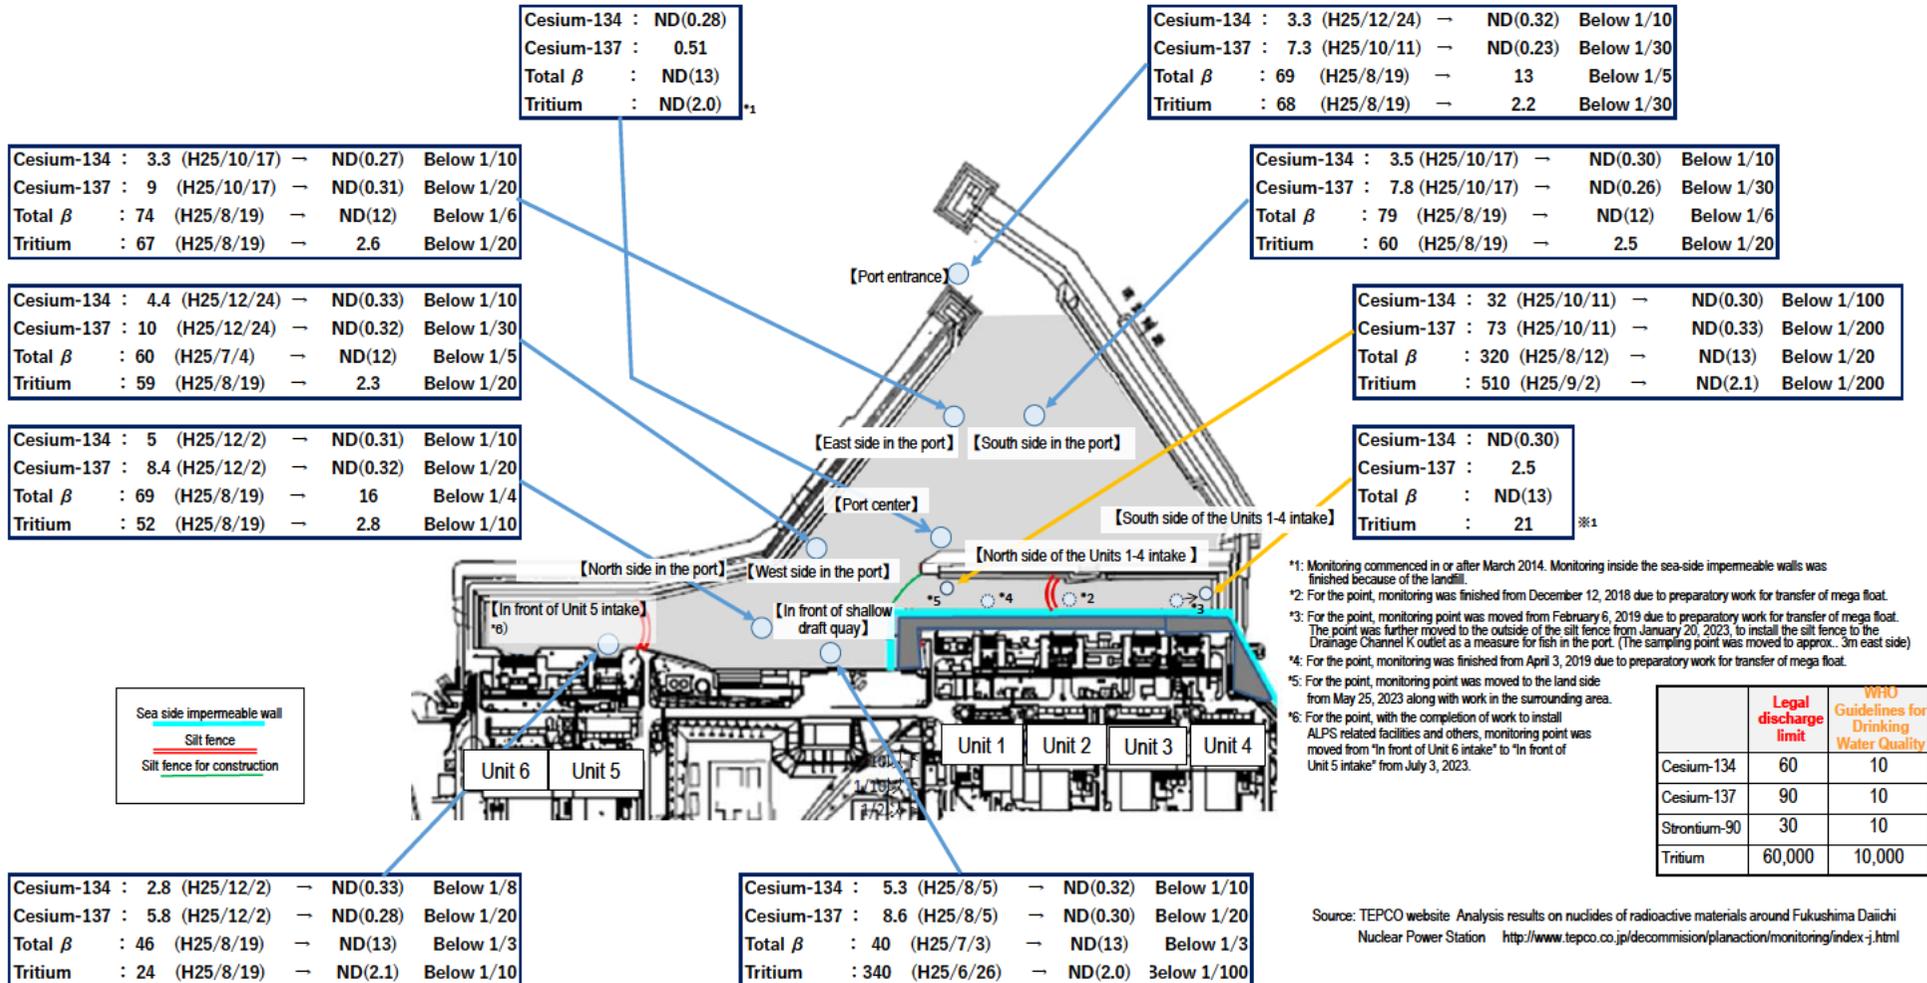
*1: Monitoring commenced in or after March 2014. Monitoring inside the sea-side impermeable walls was finished because of the landfill.
 *2: For the point, monitoring was finished from December 12, 2018 due to preparatory work for transfer of mega float.
 *3: For the point, monitoring point was moved from February 6, 2019 due to preparatory work for transfer of mega float. The point was further moved to the outside of the silt fence from January 20, 2023, to install the silt fence to the Drainage Channel K outlet as a measure for fish in the port. (The sampling point was moved to approx. 3m east side)
 *4: For the point, monitoring was finished from April 3, 2019 due to preparatory work for transfer of mega float.
 *5: For the point, monitoring point was moved to the land side from May 25, 2023 along with work in the surrounding area.
 *6: For the point, with the completion of work to install ALPS related facilities and others, monitoring point was moved from "in front of Unit 6 intake" to "in front of Unit 5 intake" from July 3, 2023.

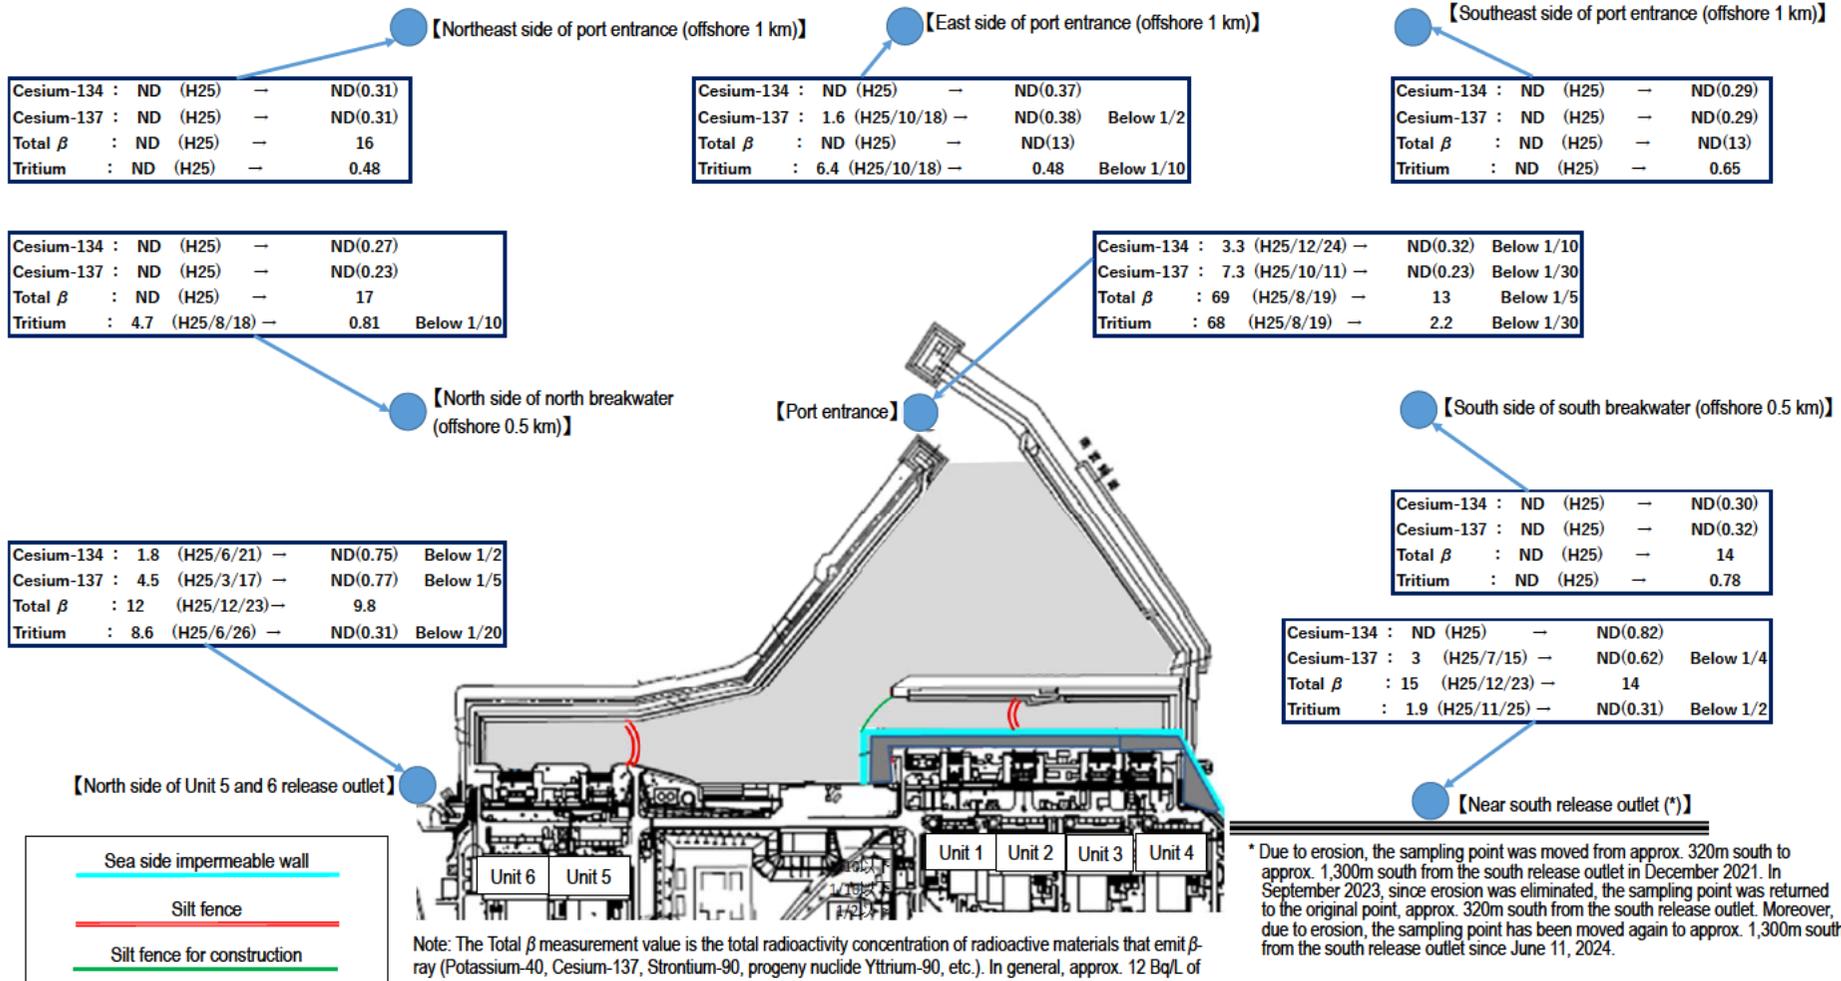
Status of seawater monitoring around outside of the port (comparison between the highest values in 2013 and the latest values)

* Due to erosion, the sampling point was moved from approx. 320m south to approx. 1,300m south from the south release outlet in December 2021. In September 2023, since erosion was eliminated, the sampling point was returned to the original point, approx. 320m south from the south release outlet. Moreover, due to erosion, the sampling point has been moved again to approx. 1,300m south from the south release outlet since June 11, 2024.

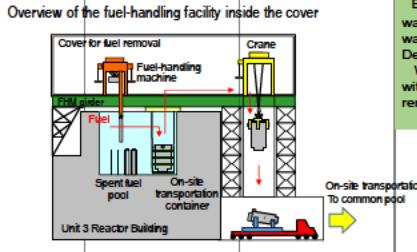
<p>Overview of the fuel-handling facility inside the cover</p>	<p>Before installing a cover for fuel removal, the process of removing large rubble from the spent fuel pool was completed in November 2015. To ensure safe and steady fuel removal, training via remote control was conducted at the factory using the actual fuel-handling machine to be installed on site (February – December 2015). Installation of the fuel removal cover was completed on February 23, 2018. With fuel removal in mind, rubble retrieval training inside the pool, which was scheduled in conjunction with fuel removal training, started from March 15, 2019 and fuel removal started from April 15, 2019. Fuel removal was completed on February 28, 2021.</p>

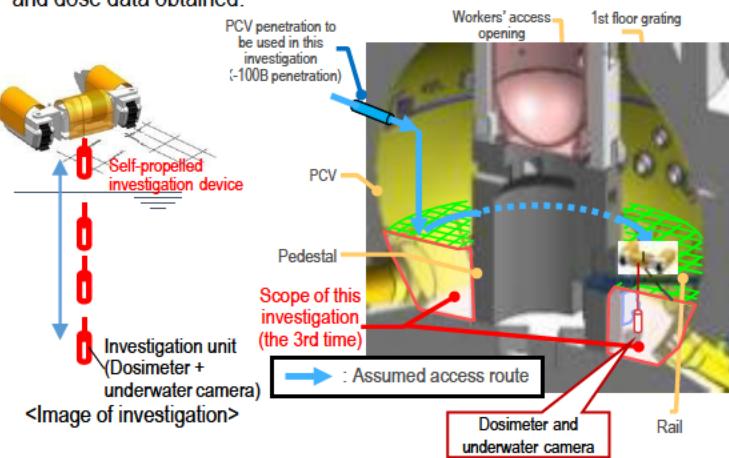
- In April 2015, a device having entered the inside of the PCV via a narrow opening (bore:φ100 mm) collected information such as images and airborne dose inside the PCV 1st floor.
- In March 2017, an investigation using a self-propelled investigation device was conducted to inspect the spreading of debris to the basement floor outside the pedestal, with images taken of the PCV bottom status for the first time. The conditions inside the PCV will continue to be examined, based on the imagery and dose data obtained.

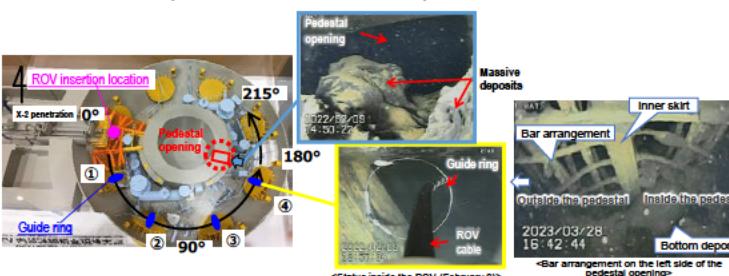
- In February 2022, "the guide ring" was installed to facilitate the investigation. From March 28, 2023, the investigation inside the pedestal by ROV-A2 started and confirmed that a portion of the bar arrangement was exposed. Regarding the soundness of the pedestal, based on the past earthquake resistant evaluation by the International Research Institute for Nuclear Decommissioning (IRID), it was evaluated that even though a portion of the pedestal was lost, there would be no serious risk. However, as the present information is very limited, the investigation will continue to acquire as much information as possible for continued evaluation.

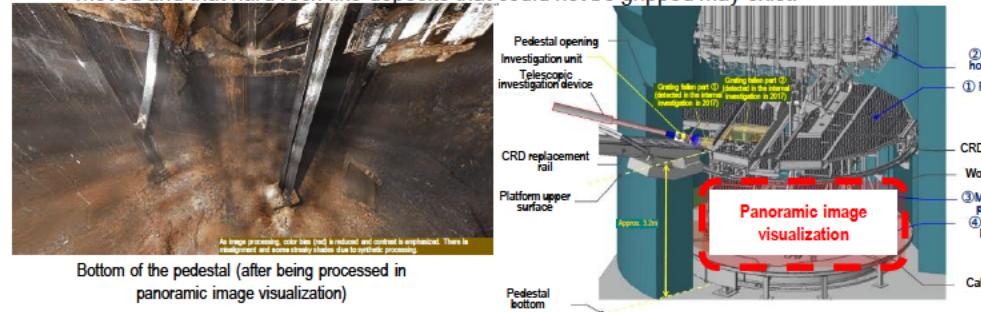
- In February 2019, an investigation touching the deposits at the bottom of the pedestal and on the platform was conducted and confirmed that the pebble-shaped deposits, etc. could be moved and that hard rock-like deposits that could not be gripped may exist.

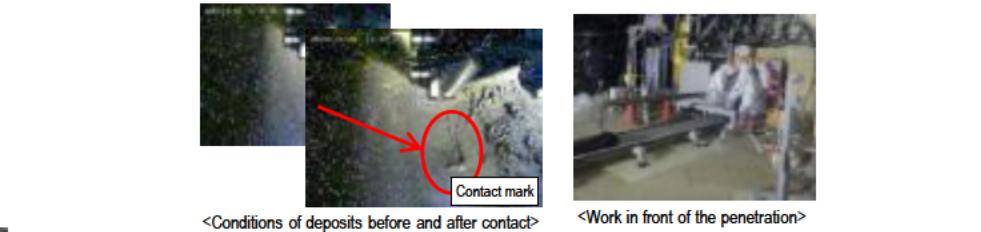
- In October 2020, a deposits contact investigation at the PCV penetration (X-6 penetration) was conducted. This confirmed that deposits inside the penetration had not deformed and come unstuck.

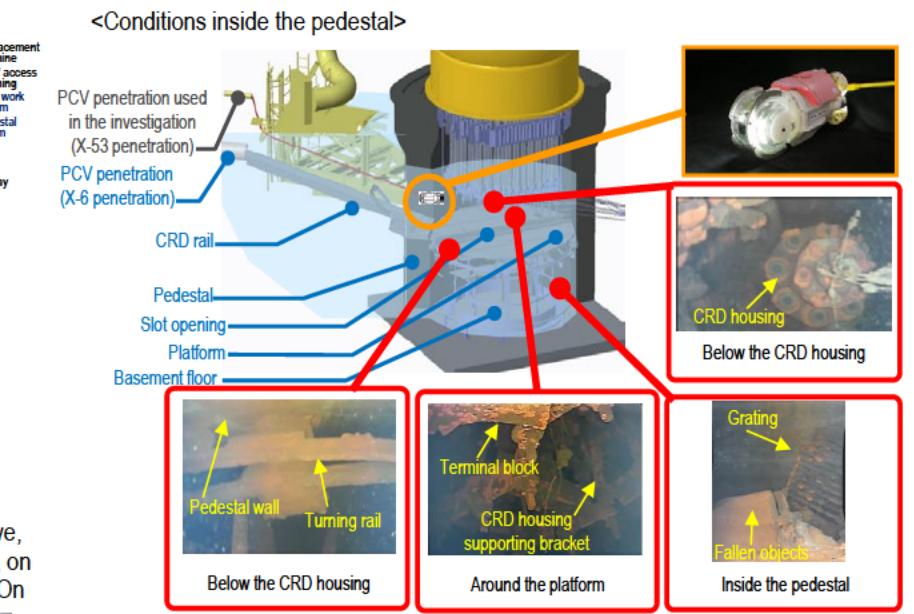
- Videos obtained in the investigation were reproduced in 3D. Based on the reproduced images, the relative positions of the structures, such as the rotating platform slipping off the rail with a portion buried in deposits, were visually understood.

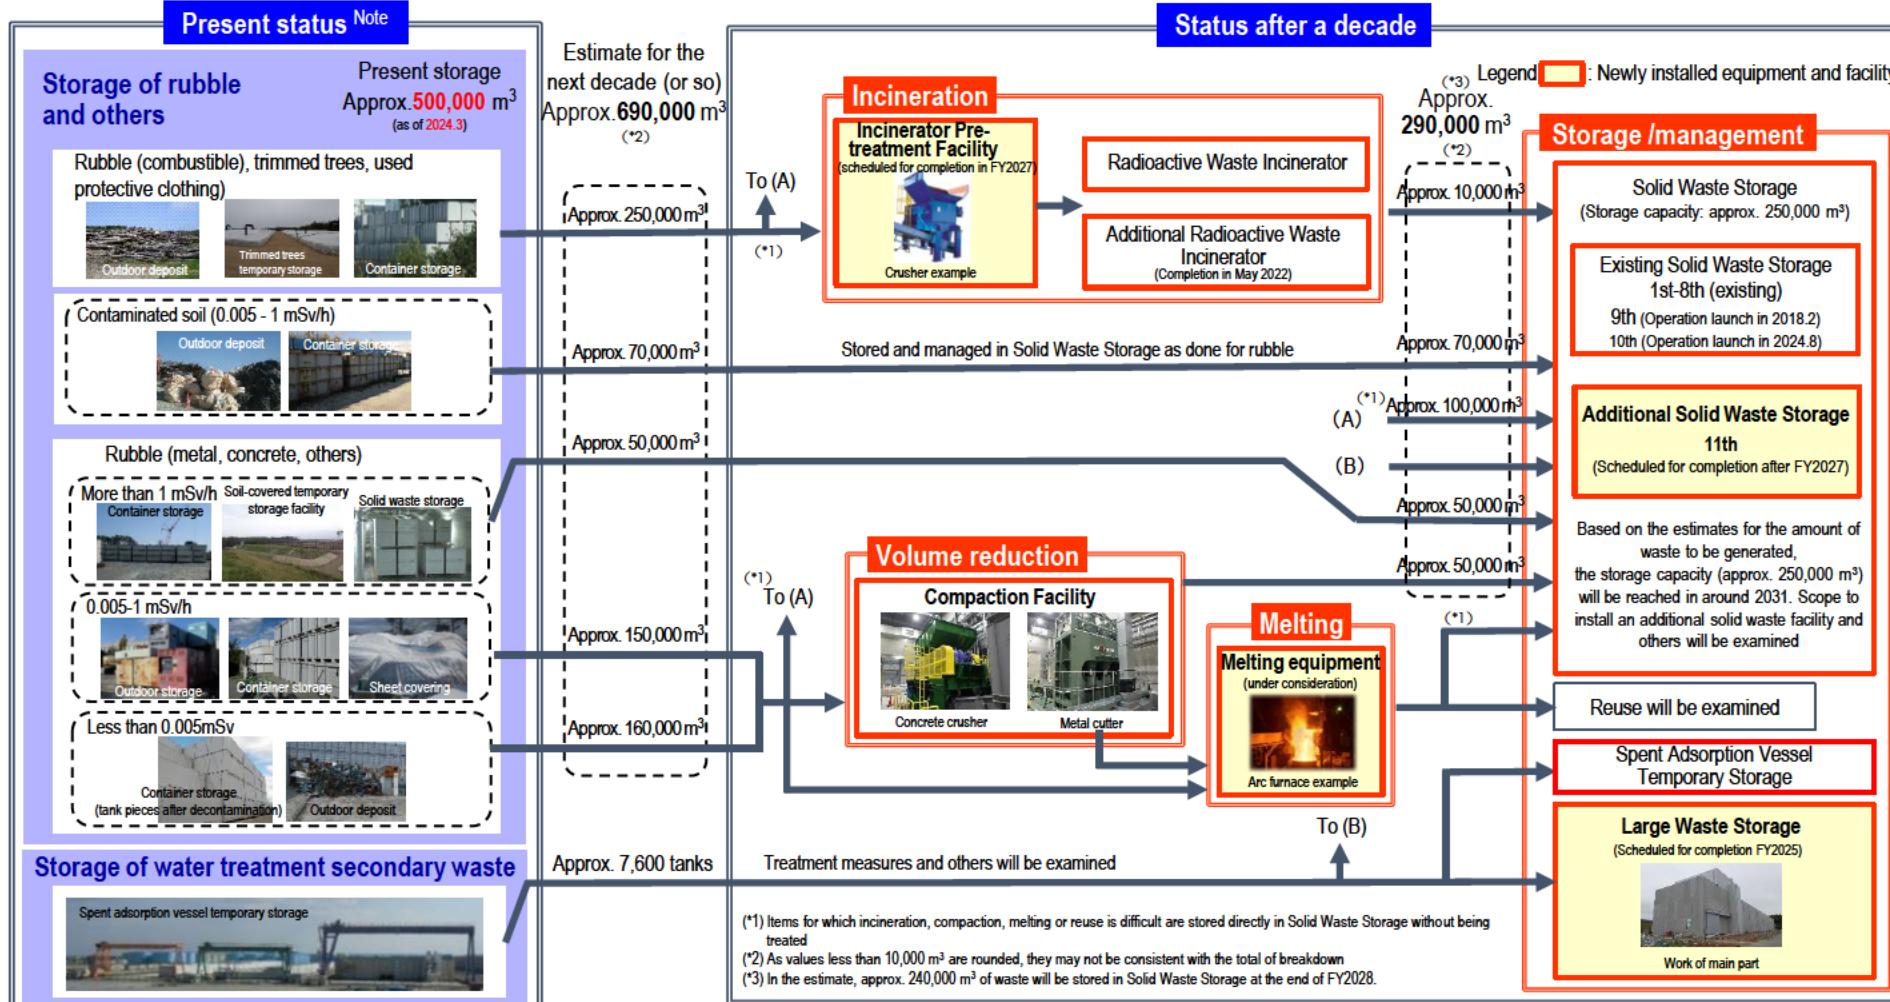
● Solid Waste Storage Management Plan for the Fukushima Daiichi Nuclear Power Station (Revision in December 2024)

Note: Used protective clothing before incineration and BG-level concrete waste for which treatment and reuse is decided at present are not included.
