# Outline of Decommissioning, Contaminated Water and Treated Water Management

## Main decommissioning work and steps

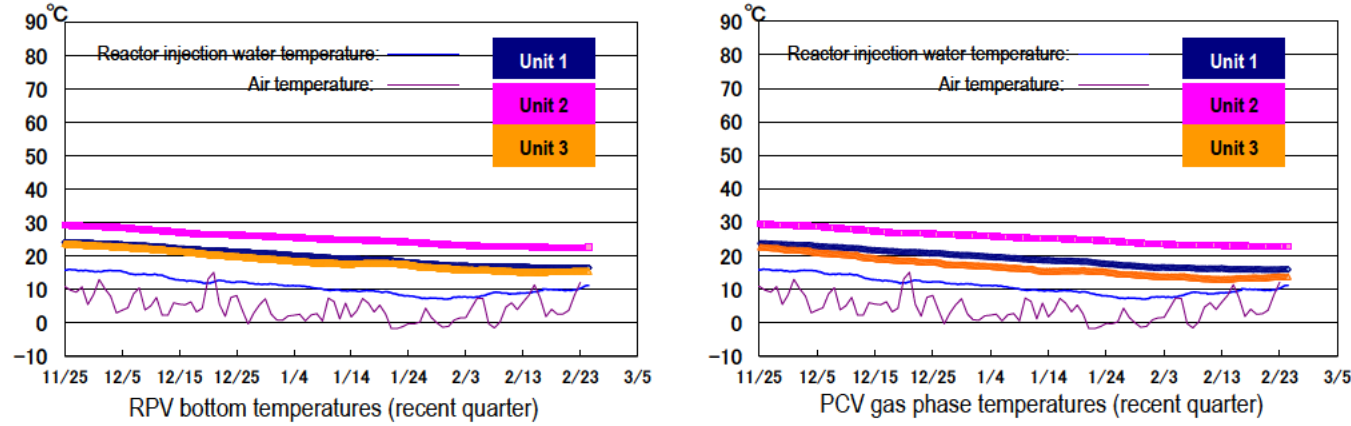
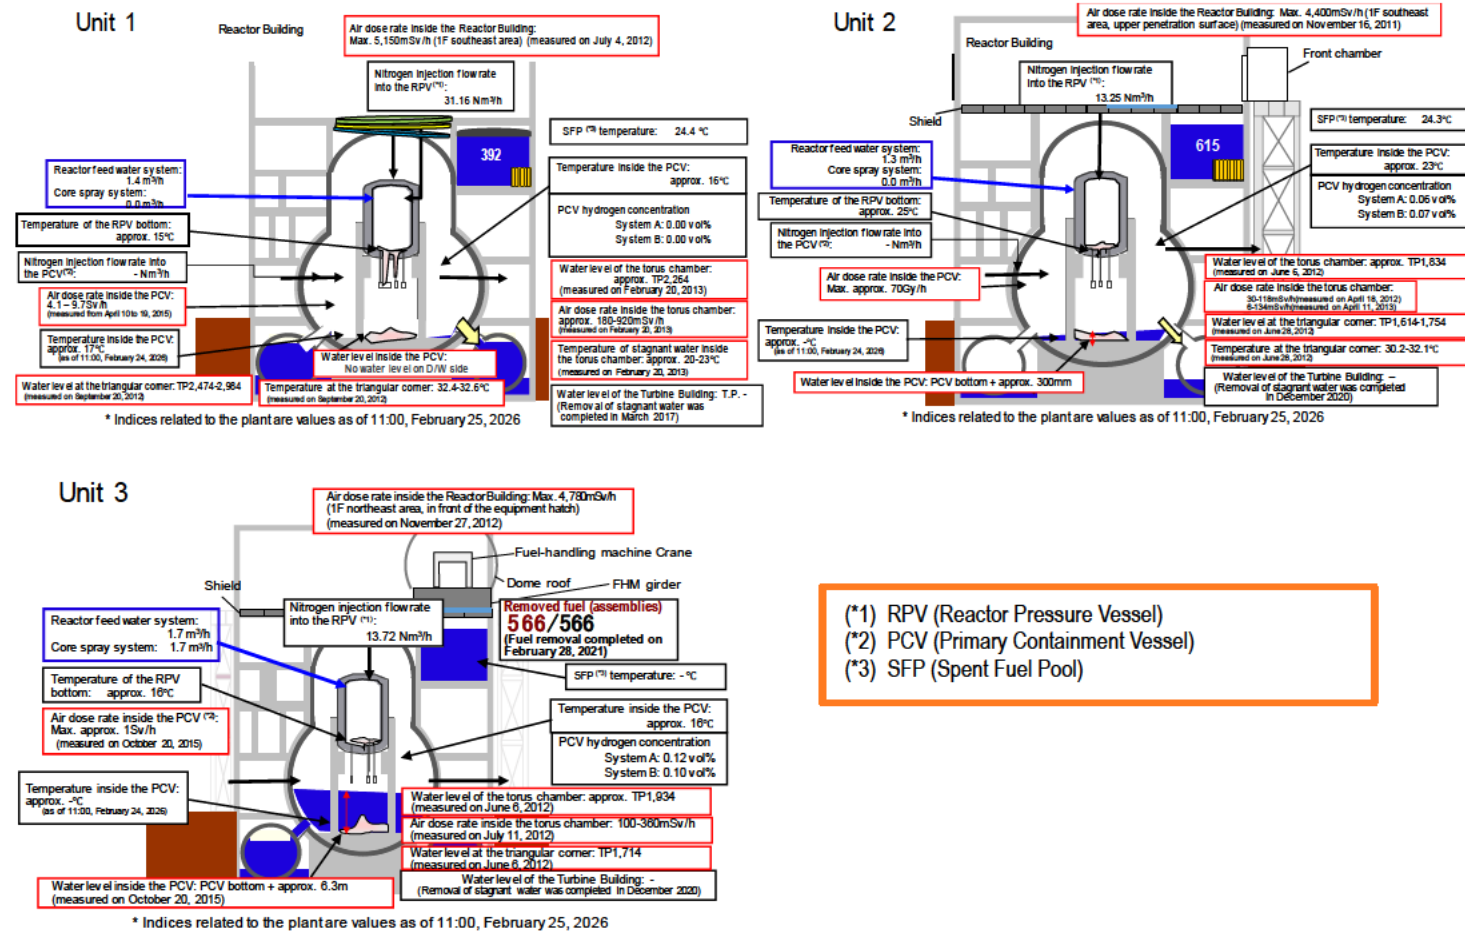
Through continuous reactor cooling by water injection, the temperatures of the Reactor Pressure Vessel (RPV) bottom and the Primary Containment Vessel (PCV) gas phase were maintained as shown below for recent, though they varied depending on the unit and location of the thermometer.

\*1 The trend graphs show part of the temperature data measured at multiple points.  
\*2 A part of data could not be measured due to maintenance and inspection of the facility and other work.

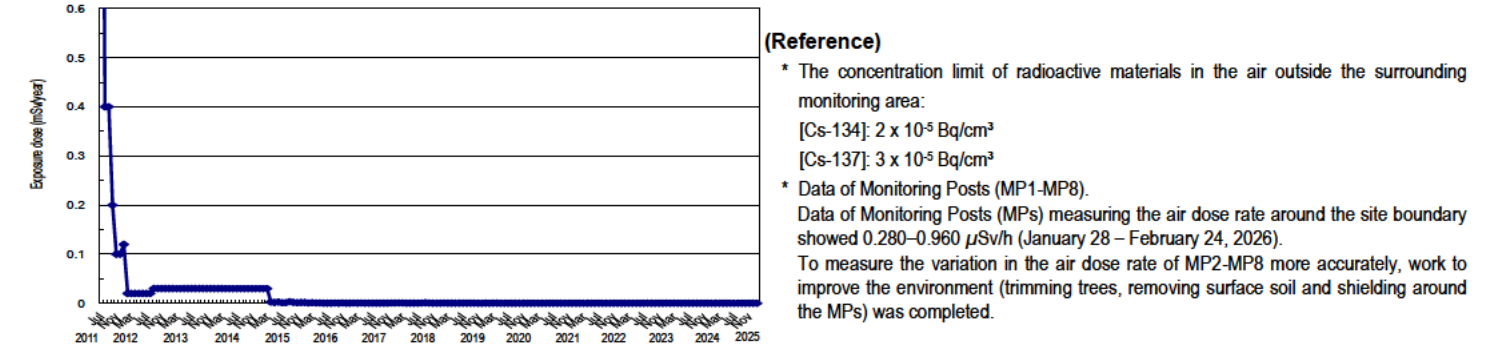
## Annual radiation dose at site boundaries by radioactive materials (cesium) released from Reactor Building Units 1-4

As of January 2026, the concentration of radioactive materials newly released from Reactor Building Units 1-4 into the air and measured at the site boundary was evaluated at approx.  $6.1 \times 10^{-12}$  Bq/cm<sup>3</sup> and  $7.8 \times 10^{-12}$  Bq/cm<sup>3</sup> for Cs-134 and -137 respectively, while the radiation exposure dose due to the release of radioactive materials there was less than 0.00003 mSv/year.

- Note 1: Different formulas and coefficients were used to evaluate the radiation dose in the facility operation plan and monthly report. The evaluation methods were integrated in September 2012. As the fuel removal from the spent fuel pool (SFP) commenced for Unit 4, the radiation exposure dose from Unit 4 was added to the items subject to evaluation since November 2013. The evaluation has been changed to a method considering the values of continuous dust monitors since FY2015, with data to be evaluated monthly and announced the following month.

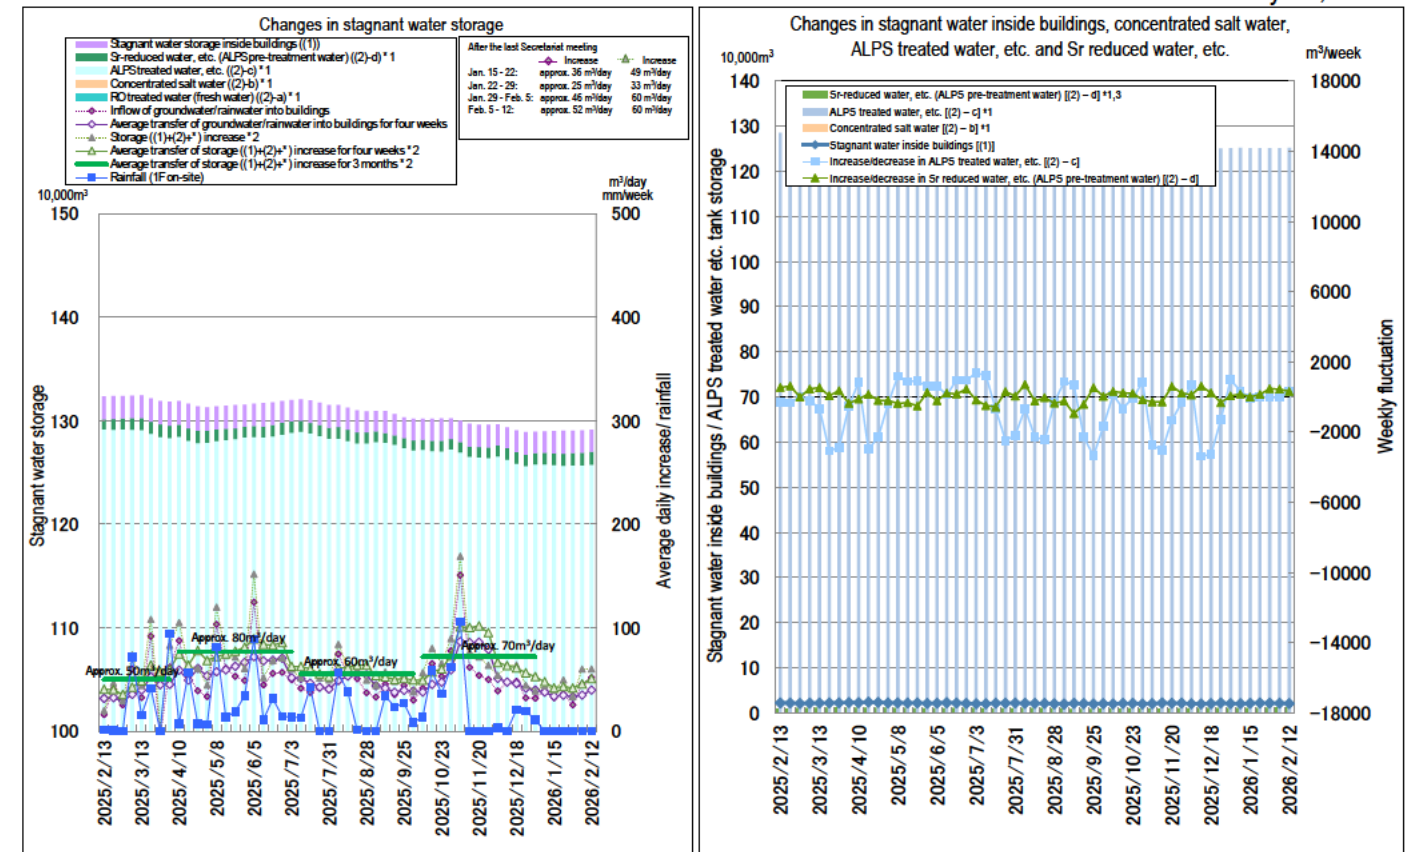
Figure 3: Status of stagnant water storage

(1): Stagnant water storage inside buildings (Units 1-4, Process Main Building, High Temperature Incinerator Building, Waste Liquid Supply Tank, SPT (A), SPT (B), Units 1-3 CST, buffer tank)

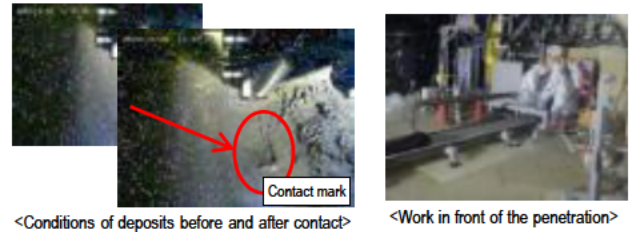
- From September 10, 2024, the end tool of the telescopic equipment passed through the isolation valve, and the trial fuel debris retrieval commenced. On October 30, fuel debris was gripped with the end tool, on November 2, the guide pipe was pulled off, and the telescopic equipment was stored in the enclosure. On November 7, fuel debris was carried out from the hatch on a side of the enclosure, and the trial retrieval was completed.
