Outline of Decommissioning, Contaminated Water and Treated Water Management

March 26, 2026
Secretariat of the Team for Countermeasures for Decommissioning, Contaminated Water and Treated Water

Progress Status and Future Challenges of the Mid-and-Long-Term Roadmap toward Decommissioning of TEPCO Holdings Fukushima Daiichi Nuclear Power Station (Outline)

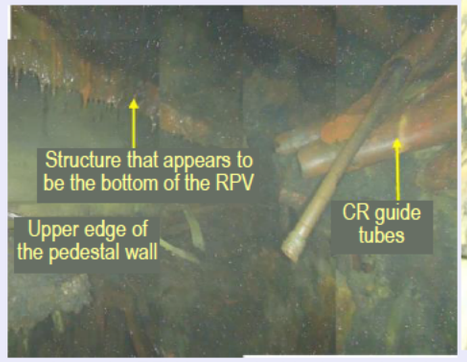
No significant increase in dust levels within the PCV occurred during the investigation period, and no drone crashes took place. No major damage or obstructions were observed outside the pedestal. Inside the pedestal, structural detachment and deformation were observed. Near the bottom of the RPV, what appeared to be structural components and a CR guide tube were found lying on the ground.

Near the RPV bottom inside the pedestal

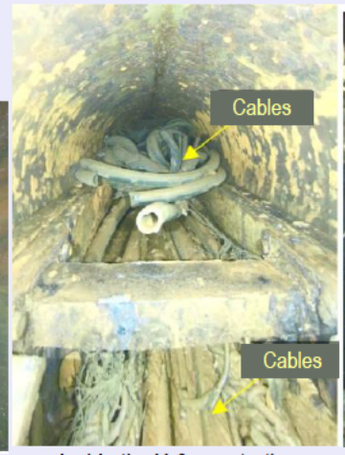
Investigations were conducted over 11 days as planned from March 5 to 19, with a total of 21 flights carried out. Important data required for determining fuel debris retrieval methods was obtained, including conditions around the X-6 penetration, the CRD replacement opening and inside the pedestal.

Inside the X-6 penetration (view from inside the PCV)

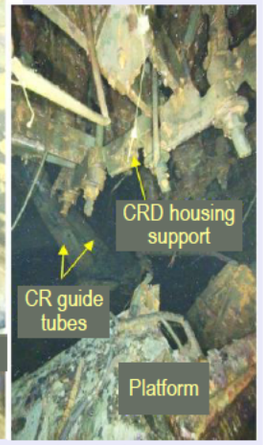
Inside the pedestal (view near the opening)

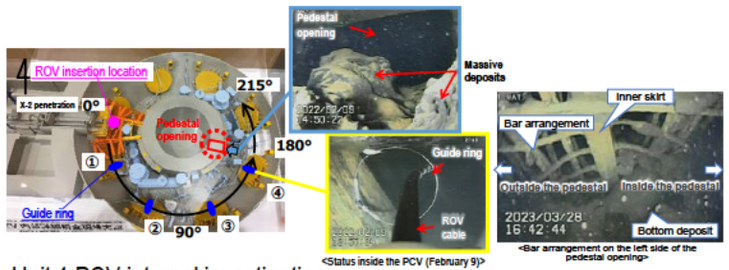
• In February 2022, "the guide ring" was installed to facilitate the investigation. From March 28, 2023, the investigation inside the pedestal by ROV-A2 started and confirmed that a portion of the bar arrangement was exposed. Regarding the soundness of the pedestal, based on the past earthquake resistant evaluation by the International Research Institute for Nuclear Decommissioning (IRID), it was evaluated that even though a portion of the pedestal was lost, there would be no serious risk. However, as the present information is very limited, the investigation will continue to acquire as much information as possible for continued evaluation.

<Status inside the PCV (February 9)>
<Bar arrangement on the left side of the pedestal opening>

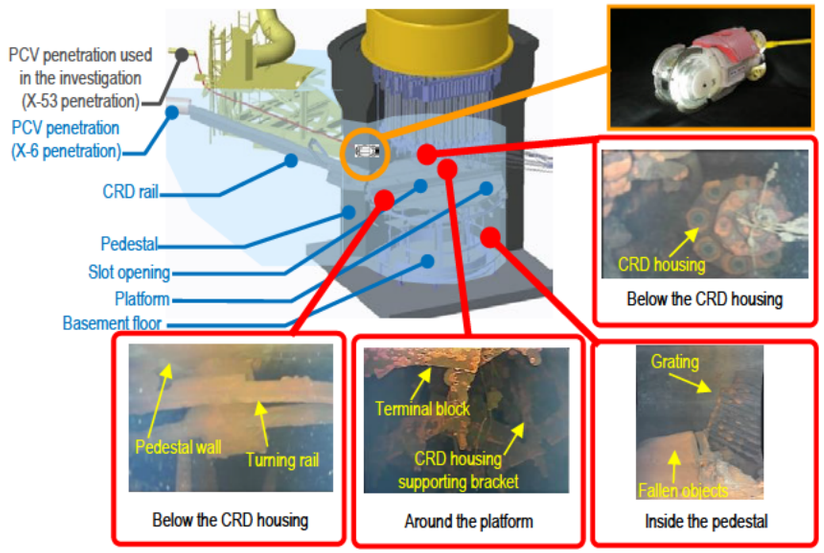
• In July 2017, the inside of the PCV was investigated using the underwater ROV (remotely operated underwater vehicle) to inspect the inside of the pedestal. Analysis of the imagery obtained in the investigation identified damage to multiple structures and the supposed core internals.

<Conditions inside the pedestal>
