Fact sheet: overview of contaminated ground water leakage at TEPCO's Fukushima Daiichi NPS

Water Leak at a Tank in the H4 area in Fukushima Daiichi NPS Att. 5

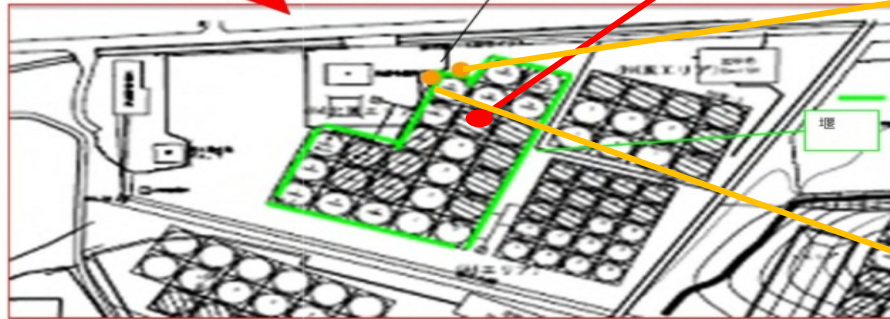
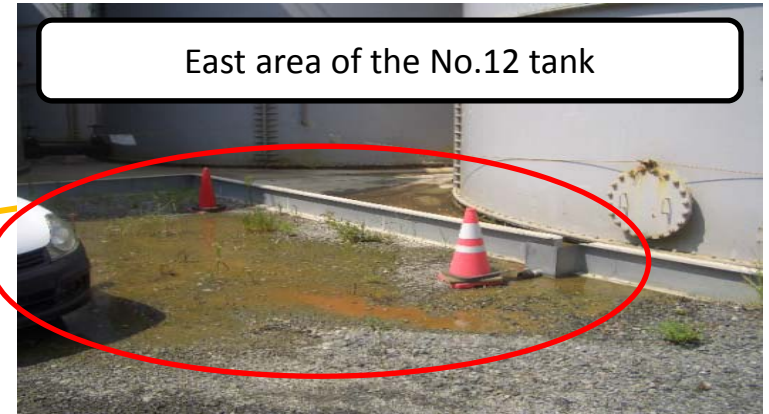
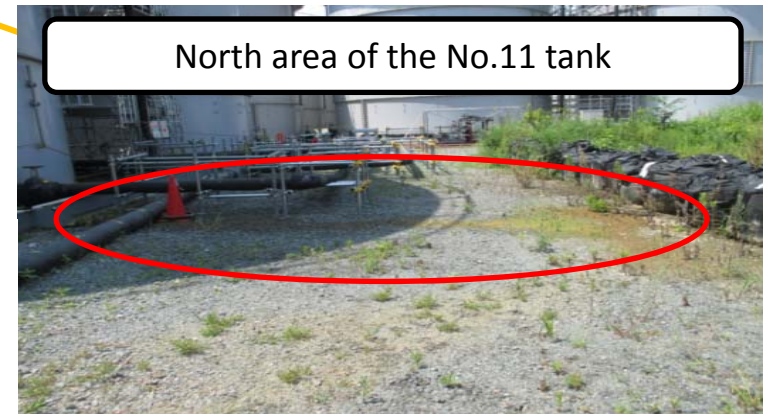
7. On August 19, TEPCO announced that they found water leak from a drain valve of a tank dike in the H4 area which is one of the installation locations of contaminated water tanks in Fukushima Daiichi NPS. Because high radiation dose was detected in the puddle of water having leaked outside the dike, TEPCO determined that the water had leaked from the contaminated water tank. TEPCO found water spread in the neighborhood of the No.5 tank in the H4 area and confirmed that the water level of the No. 5 tank was 3 m lower than its normal level. TEPCO estimates that the amount of the leaked contaminated water was 300 m³. In cooperation with the Government of Japan, TEPCO is making efforts for investigating the cause of this issue and preventing the similar events (refer to Attachment 5).

The place where paddles were found
