Progress Status and Future Challenges of Mid-and-long Term Roadmap toward the Decommissioning of Units 1-4 of TEPCO Fukushima Daiichi Nuclear Power Station (Outline)

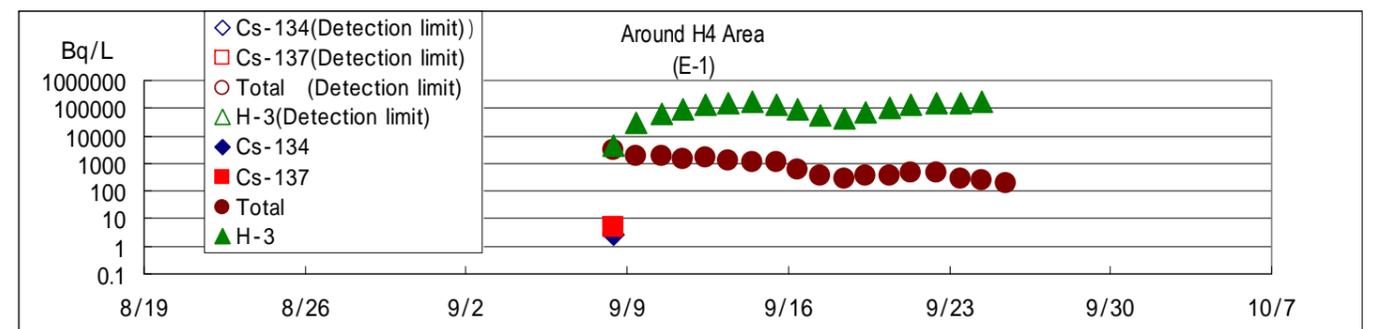
Figure 6: Groundwater analysis data

- A boring survey to a depth beyond groundwater level (7 to 25m) (Investigation <E>: from August 28) was conducted to continuously measure the radiation material density of the groundwater. At sampling point E-1 near the tank, the density of tritium had risen, although the values subsequently fluctuated over the announced density (60,000Bq/L) (see Figure 6). At other sampling points (E-2 to E-6), tritium was also detected, but the values remained under the announced density with little fluctuation. The trend will be continuously monitored to identify the contamination status and conduct an impact assessment.
