## Main decommissioning works and steps

# Progress Status and Future Challenges of the Mid- and Long-Term Roadmap toward Decommissioning of TEPCO Holdings' Fukushima Daiichi Nuclear Power Station Units 1-4 (Outline)

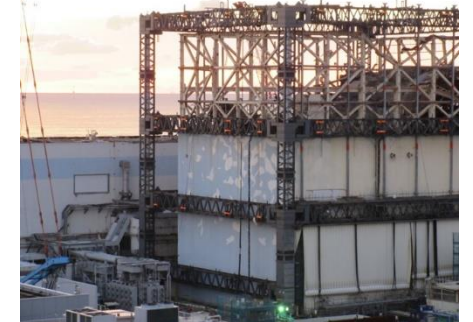
Dismantling of the building cover started in July 2015 and dismantling of wall panel was completed in November 2016. The work is being conducted steadily, with anti-scattering measures fully implemented and the density of radioactive materials monitored.

(Dismantling of Unit 1 building cover wall panels)

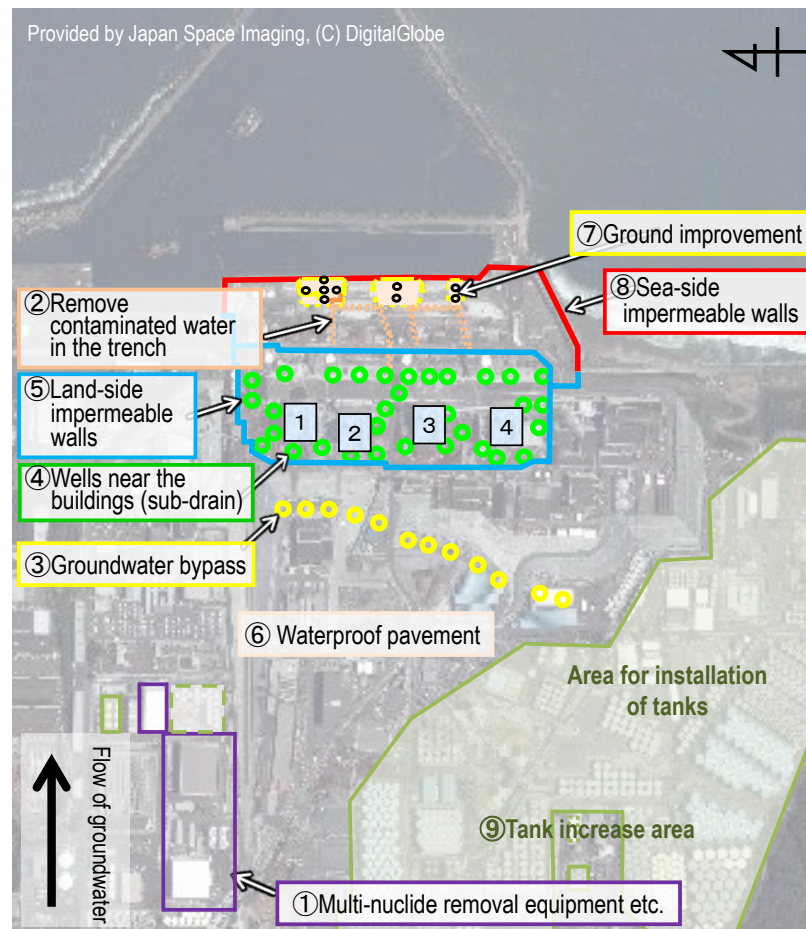
Countermeasures for contaminated water are implemented in accordance with the following three principles:

### 1. Eliminate contamination sources

- ① Multi-nuclide removal equipment, etc.
  - ② Remove contaminated water in the trench (Note 3)
- (Note 3) Underground tunnel containing pipes.

### 2. Isolate water from contamination

- ③ Pump up groundwater for bypassing
- ④ Pump up groundwater near buildings
- ⑤ Land-side impermeable walls
- ⑥ Waterproof pavement

### 3. Prevent leakage of contaminated water

- ⑦ Soil improvement by sodium silicate
- ⑧ Sea-side impermeable walls
- ⑨ Increase tanks (welded-joint tanks)

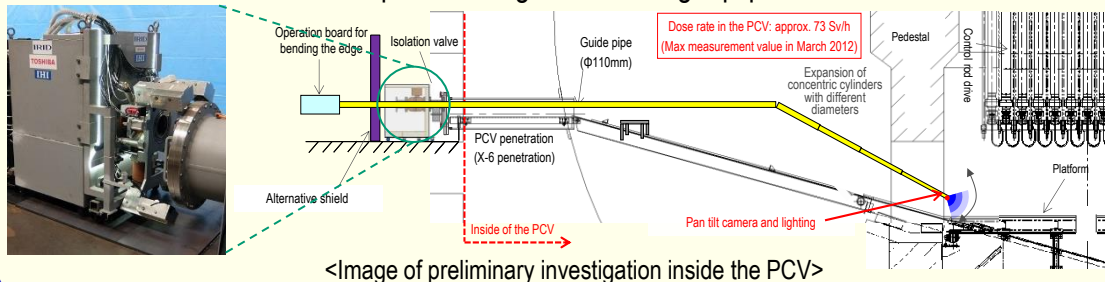
Toward an investigation inside the Unit 2 Primary Containment Vessel (PCV), after making a hole at the pipe penetration from which a robot will be inserted, a prior investigation will be conducted using a camera mounted on the edge of an expansible pipe in January 2017 to check for deposits which may impact on the operation of the self-traveling equipment and the damage status of the platform inside the pedestal. Following the preliminary investigation, the status inside the PCV will be inspected using self-travelling equipment.

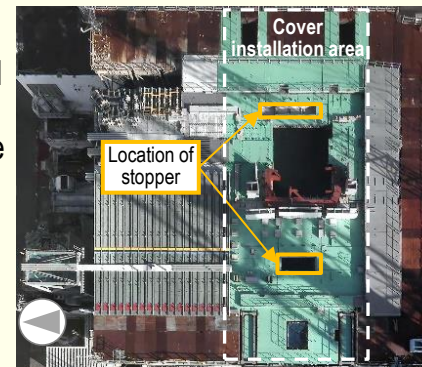
Toward fuel removal from Unit 3, the installation of shields was completed on December 2 as a measure to reduce the dose on the Reactor Building (R/B) top floor. Based on the dose gaging results after the installation of shields, measures will be implemented to reduce exposure and ensure safety while the cover for fuel removal will be installed.

<Status of the R/B top floor (operation floor)>
