Main decommissioning work and steps

Progress status

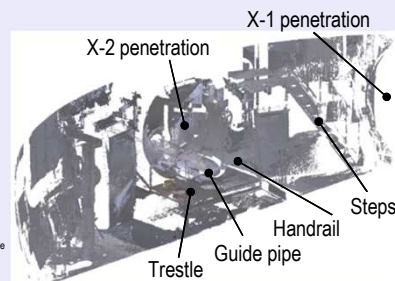
< Laser scan measurement results around X-2 penetration >

Based on laser scan data acquired in this investigation, a mockup training facility resembling the site more closely will be manufactured to utilize in effective tests and training.

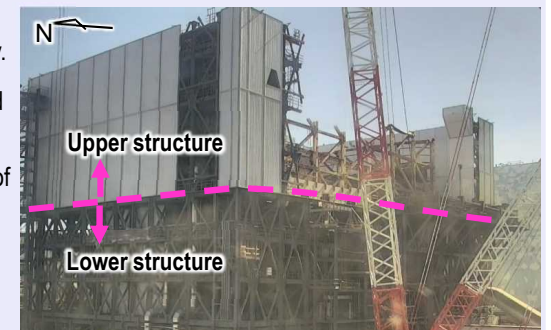
< On-site status (northwest side) (February 25) >

In the off-site yard, ground assembly of the temporary gantry, upper and lower structures and box ring was completed. At present, ground assembly of three of eight blocks for the moving roof was completed. On-site, installation of nine of a total dozen blocks for the upper structure was completed.

To reduce the risk of coming into contact with the large cover and enhance seismic safety, a portion of the perimeter steel frames is being removed. No significant increase in dust concentration was detected during removal. Work to spray anti-scattering agents and monitoring will continue.

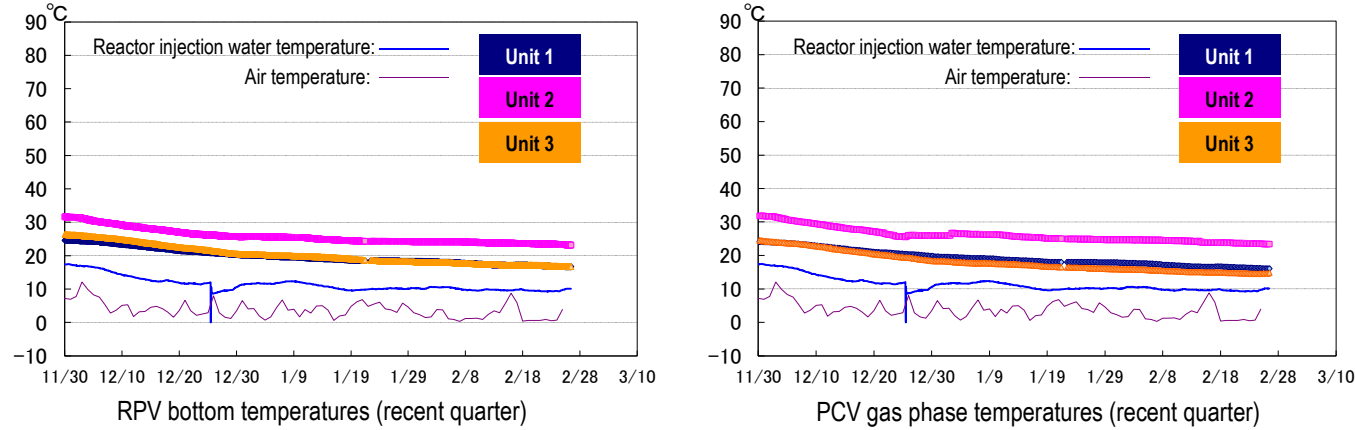
Through continuous reactor cooling by water injection, the temperatures of the Reactor Pressure Vessel (RPV) bottom and the Primary Containment Vessel (PCV) gas phase were maintained as shown below for recent, though they varied depending on the unit and location of the thermometer.

*1 The trend graphs show part of the temperature data measured at multiple points.
*2 A part of data could not be measured due to maintenance and inspection of the facility and other work.

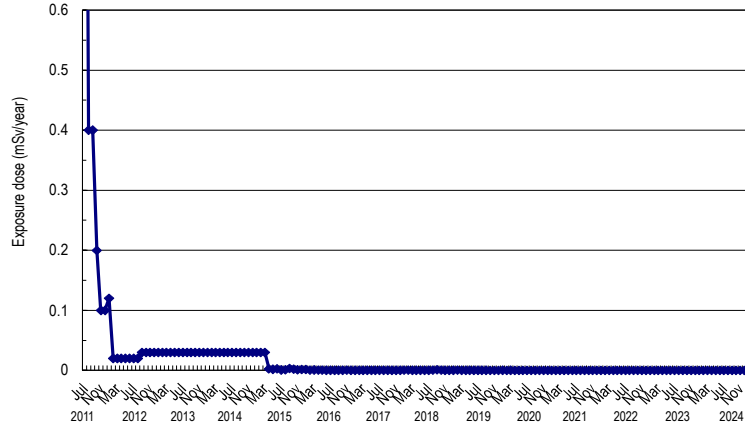
Annual radiation dose at site boundaries by radioactive materials (cesium) released from Reactor Building Units 1-4

As of January 2025, the concentration of radioactive materials newly released from Reactor Building Units 1-4 into the air and measured at the site boundary was evaluated at approx. 1.0×10^{-11} Bq/cm³ and 1.2×10^{-11} Bq/cm³ for Cs-134 and -137 respectively, while the radiation exposure dose due to the release of radioactive materials there was less than 0.00005 mSv/year.

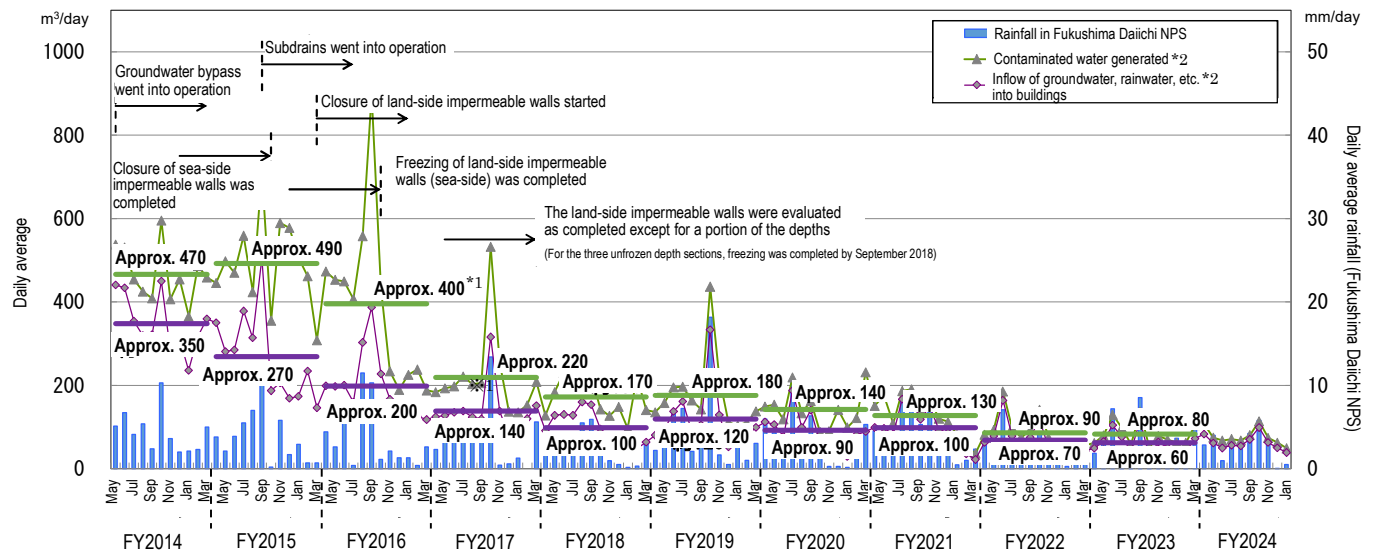
- Multi-layered contaminated water management measures, including land-side impermeable walls and subdrains, have stabilized the groundwater at a low level and the increased contaminated water generated during rainfall is being suppressed by repairing damaged portions of building roofs facing onsite. Through these measures, the generation of contaminated water has been suppressed and reduced from approx. 540 m³/day (in May 2014) before implementing measures to approx. 80 m³/day (in FY2023), achieving the milestone to “suppress the amount of contaminated water generated to 100 m³/day or less during average rainfall within FY2025.”
- Measures will proceed to further reduce the amount of contaminated water generated and suppress to approx. 50-70 m³/day by FY2028.

*1 Values differ from those announced at the 20th Committee on Countermeasures for Contaminated Water Treatment (held on August 25, 2017) because the method of calculating the contaminated water volume generated was reviewed on March 1, 2018. Details of the review are described in the materials for the 50th and 51st meetings of the Secretariat of the Team for Countermeasures for Decommissioning and Contaminated Water Treatment.

*2: The monthly daily average is derived from the daily average from the previous Thursday to the last Wednesday, which is calculated based on the data measured at 7:00 on every Thursday

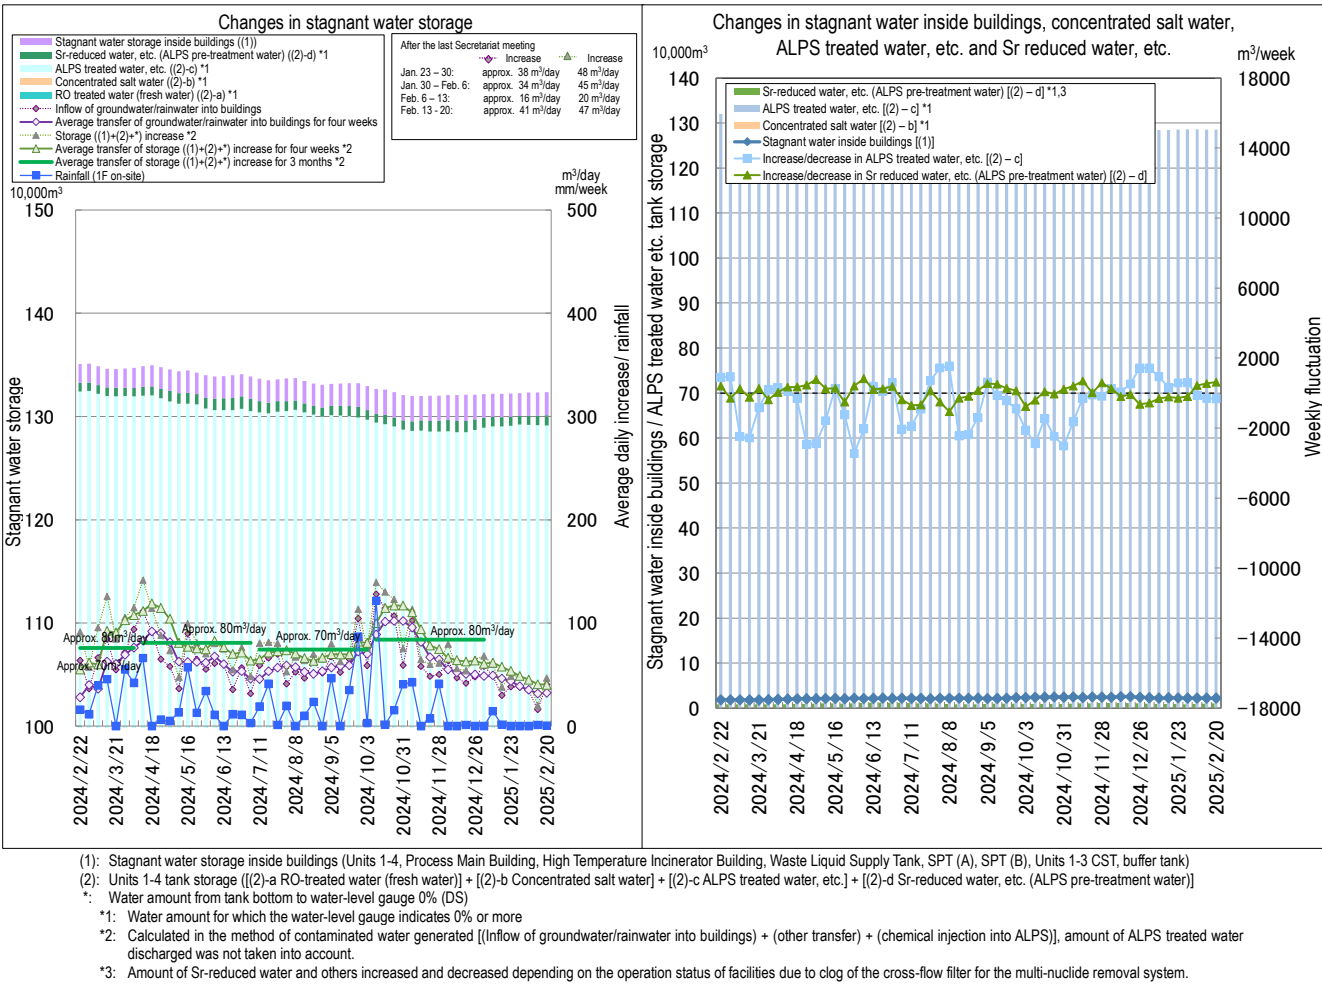
Figure 3: Status of stagnant water storage

- The volume of ALPS treated water, etc. was approx. 1,287,680 m³ as of February 20, 2025.
- The total volume of ALPS treated water discharged into the sea since the discharge commenced on August 24, 2023 was approx. 78,285 m³ as of February 26, 2025.

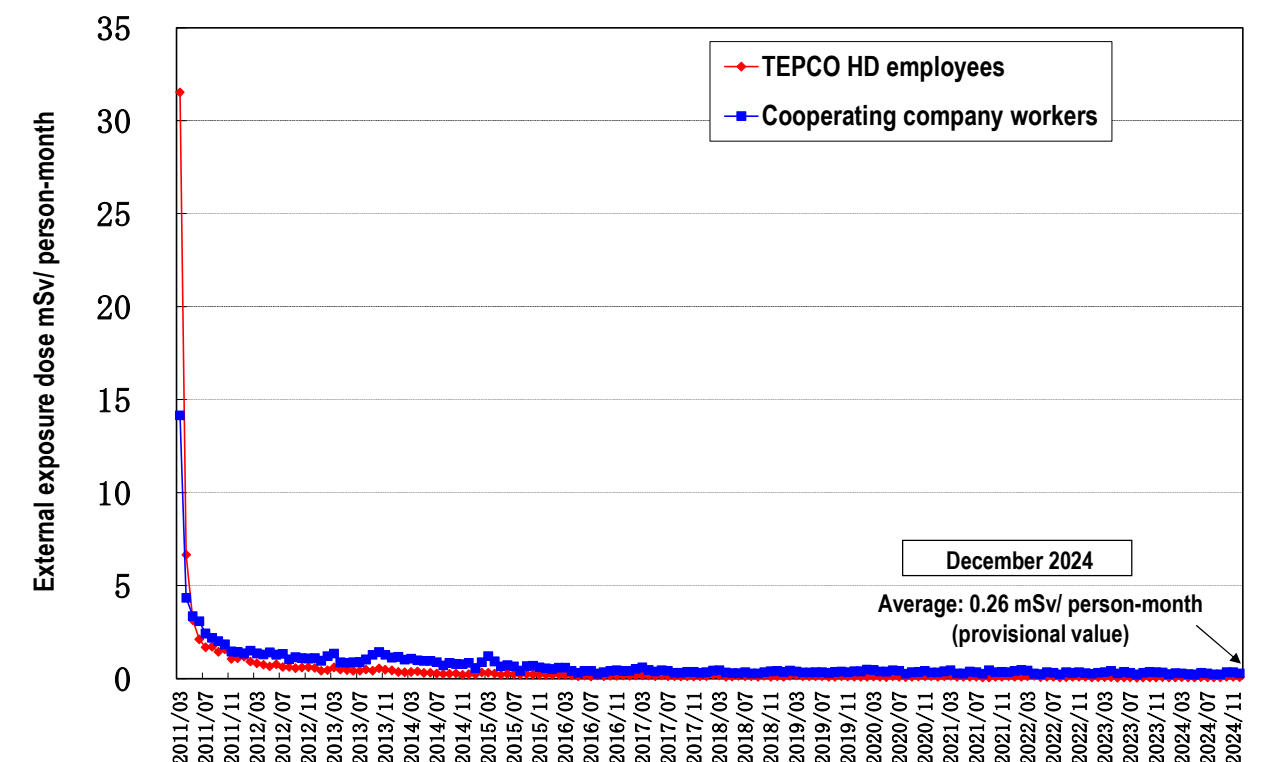
Figure 7: Changes in monthly average exposure dose of individual worker (monthly exposure dose since March 2011)

- The average exposure doses of workers were approx. 2.51, 2.16 and 2.18 mSv/person-year during FY2021, 2022 and 2023, respectively (The legal exposure dose limits are 100 and 50 mSv/person-year respectively over five years, the TEPCO HD management target is 20 mSv/person-year).

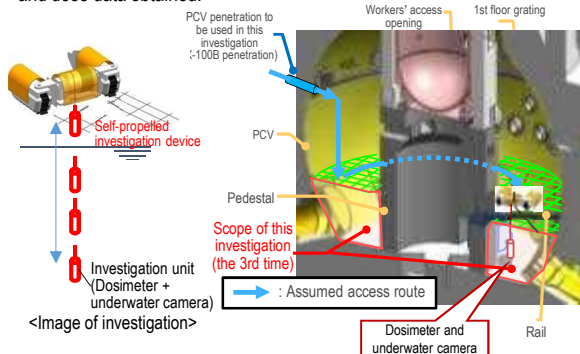
- In April 2015, a device having entered the inside of the PCV via a narrow opening (bore:φ100 mm) collected information such as images and airborne dose inside the PCV 1st floor.
- In March 2017, an investigation using a self-propelled investigation device was conducted to inspect the spreading of debris to the basement floor outside the pedestal, with images taken of the PCV bottom status for the first time. The conditions inside the PCV will continue to be examined, based on the imagery and dose data obtained.

In February 2022, "the guide ring" was installed to facilitate the investigation. From March 28, 2023, the investigation inside the pedestal by ROV-A2 started and confirmed that a portion of the bar arrangement was exposed. Regarding the soundness of the pedestal, based on the past earthquake resistant evaluation by the International Research Institute for Nuclear Decommissioning (IRID), it was evaluated that even though a portion of the pedestal was lost, there would be no serious risk. However, as the present information is very limited, the investigation will continue to acquire as much information as possible for continued evaluation.

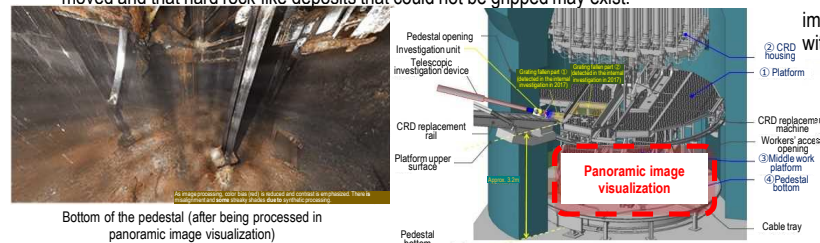
- In January 2017, a camera was inserted from the PCV penetration to inspect the conditions of the rail on which the robot traveled. The results of a series of investigations confirmed some gratings had fallen and deformed as well as a quantity of deposit inside the pedestal.

- In January 2018, the conditions below the platform inside the pedestal were investigated. Based on the analytical results of images obtained in the investigation, deposits, probably including fuel debris, were found at the bottom of the pedestal. Moreover, multiple parts exceeding the surrounding deposits were also detected. We presumed that there were multiple instances of fuel debris falling.

- In February 2019, an investigation touching the deposits at the bottom of the pedestal and on the platform was conducted and confirmed that the pebble-shaped deposits, etc. could be moved and that hard rock-like deposits that could not be gripped may exist.
