**Current status of the decommissioning in
Fukushima Daiichi Nuclear Power Station**

Sep. 26, 2023

**Executive Vice President
Fukushima Daiichi Decontamination and
Decommissioning Engineering Company,
Tokyo Electric Power Company Holdings, Inc.**

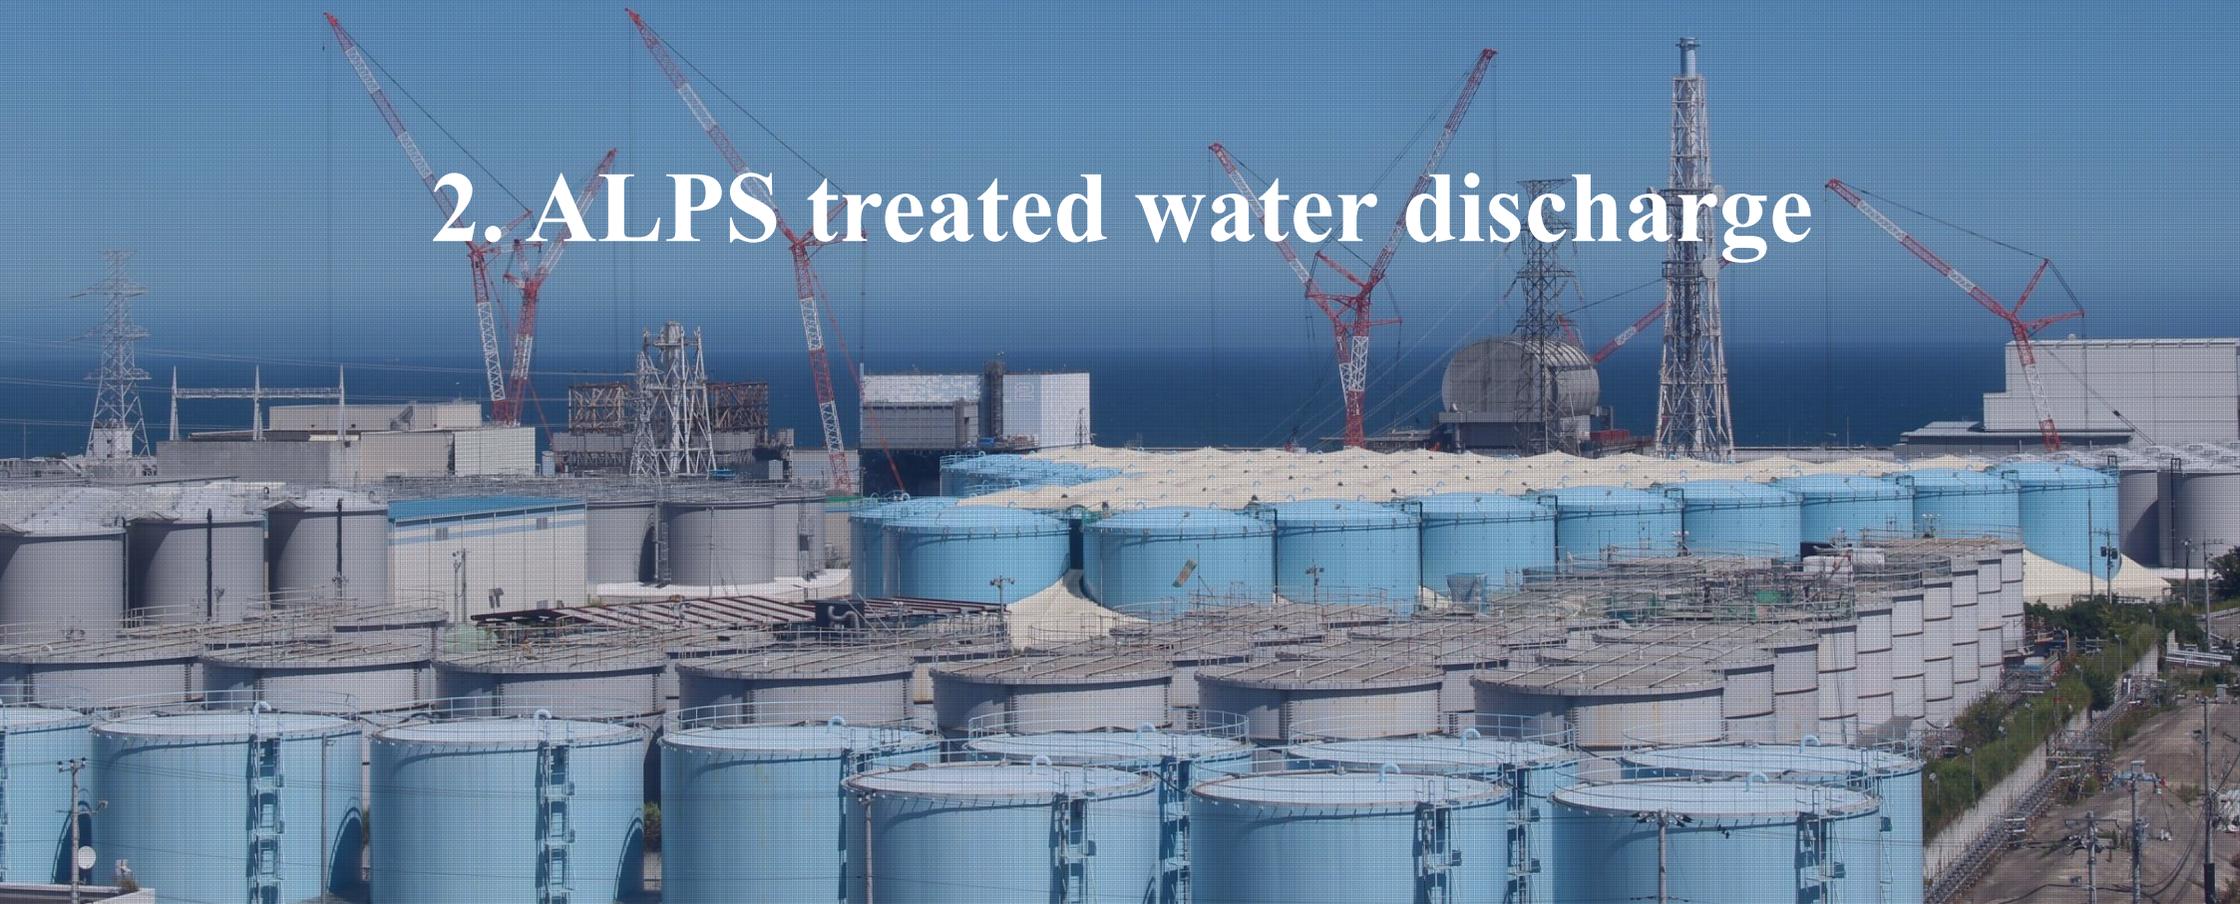
Design and operations for ALPS treated water discharge

Treatment facilities (ALPS)

Measurement/confirmation facilities

Transfer facilities

ALPS treated water, etc. tanks

Dilution facilities

Seawater for dilution

Discharge facilities

Undersea tunnel (approx. 1km)
