Main decommissioning work and steps

July 31, 2025
Secretariat of the Team for
Countermeasures for Decommissioning,
Contaminated Water and Treated Water

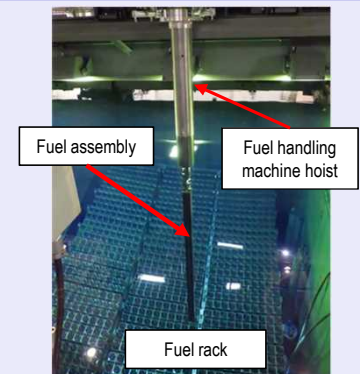
Fuel removal from Unit 5 SFP (July 23, 2025)

Fuel removal from Unit 5 will be conducted within a scope that does not impact on fuel removal from Units 2 and 1 and will be temporarily suspended after fuel removal from Unit 2 commences on FY2026.

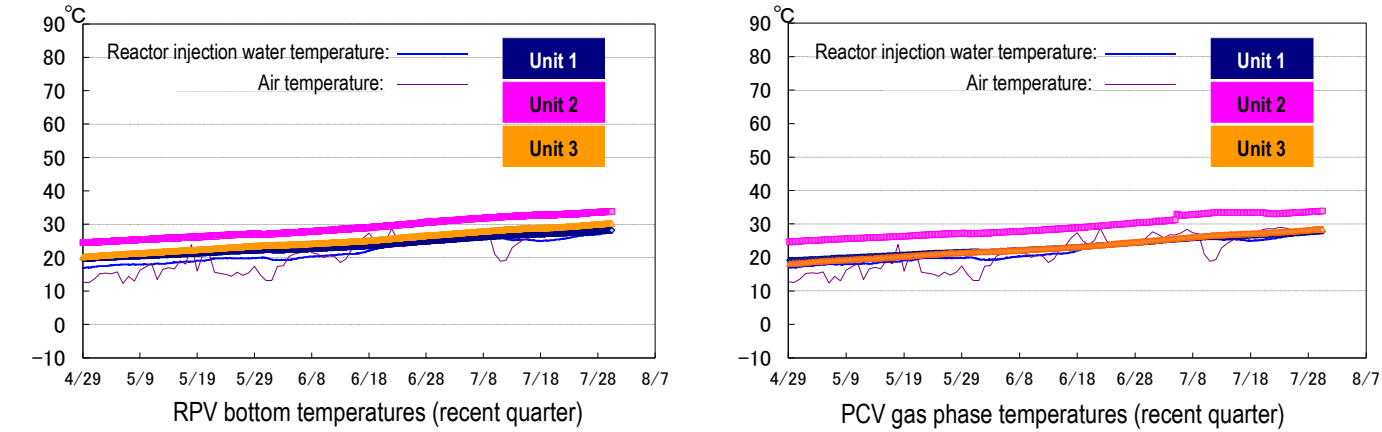
Through continuous reactor cooling by water injection, the temperatures of the Reactor Pressure Vessel (RPV) bottom and the Primary Containment Vessel (PCV) gas phase were maintained as shown below for recent, though they varied depending on the unit and location of the thermometer.

*1 The trend graphs show part of the temperature data measured at multiple points.
*2 A part of data could not be measured due to maintenance and inspection of the facility and other work.

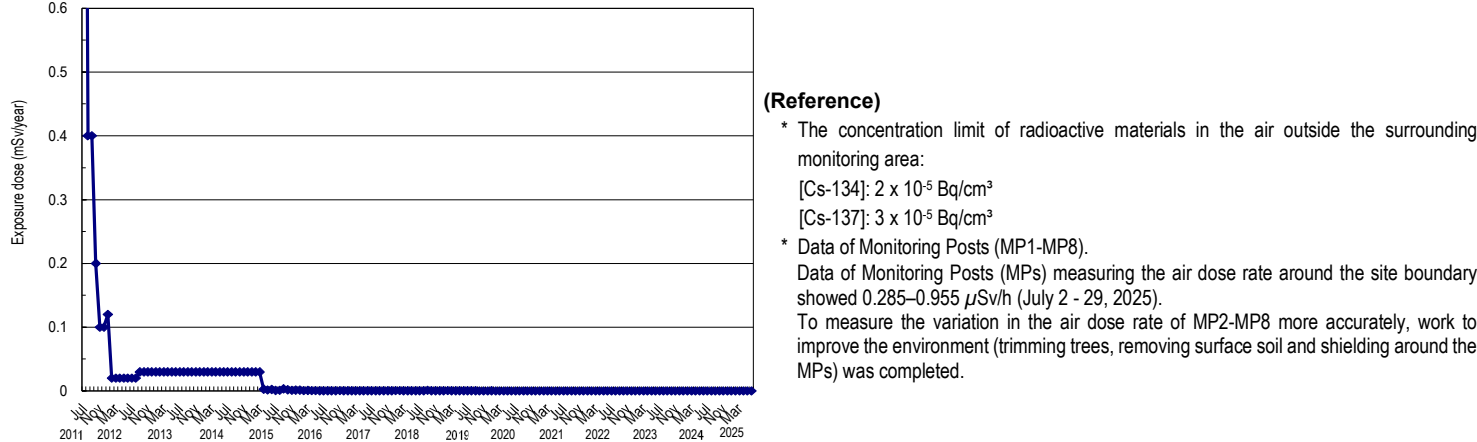
Annual radiation dose at site boundaries by radioactive materials (cesium) released from Reactor Building Units 1-4

As of June 2025, the concentration of radioactive materials newly released from Reactor Building Units 1-4 into the air and measured at the site boundary was evaluated at approx. 9.4×10^{-12} Bq/cm³ and 7.1×10^{-12} Bq/cm³ for Cs-134 and -137 respectively, while the radiation exposure dose due to the release of radioactive materials there was less than 0.00004 mSv/year.

(Reference)
* The concentration limit of radioactive materials in the air outside the surrounding monitoring area:
[Cs-134]: 2×10^{-5} Bq/cm³
[Cs-137]: 3×10^{-5} Bq/cm³
* Data of Monitoring Posts (MP1-MP8).
Data of Monitoring Posts (MPs) measuring the air dose rate around the site boundary showed 0.285-0.955 μ Sv/h (July 2 - 29, 2025).
To measure the variation in the air dose rate of MP2-MP8 more accurately, work to improve the environment (trimming trees, removing surface soil and shielding around the MPs) was completed.

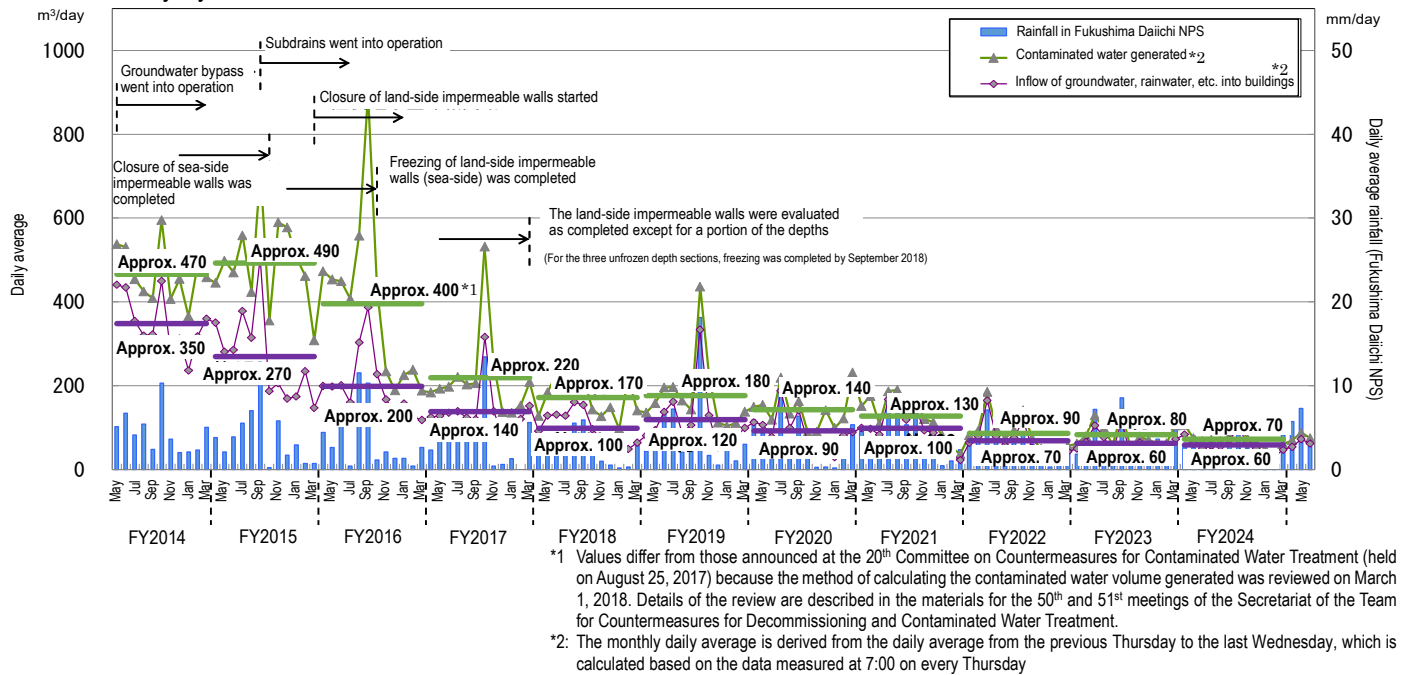
Figure 1: Changes in contaminated water generated and inflow of groundwater and rainwater into buildings

- Status of contaminated water generated
 - Multi-layered contaminated water management measures, including land-side impermeable walls and subdrains, have stabilized the groundwater at a low level and the increased contaminated water generated during rainfall is being suppressed by repairing damaged portions of building roofs facing onsite. Through these measures, the generation of contaminated water has been suppressed and reduced from approx. 540 m³/day (in May 2014) before implementing measures to approx. 70 m³/day (in FY2024). It was confirmed that the milestone of "suppressing the amount of contaminated water generated to 100 m³/day or less during average rainfall within FY2025," which was achieved in FY2023, has been maintained in FY2024.
 - Measures will proceed to further reduce the amount of contaminated water generated and suppress to approx. 50-70 m³/day by FY2028.

*1 Values differ from those announced at the 20th Committee on Countermeasures for Contaminated Water Treatment (held on August 25, 2017) because the method of calculating the contaminated water volume generated was reviewed on March 1, 2018. Details of the review are described in the materials for the 50th and 51st meetings of the Secretariat of the Team for Countermeasures for Decommissioning and Contaminated Water Treatment.
*2: The monthly daily average is derived from the daily average from the previous Thursday to the last Wednesday, which is calculated based on the data measured at 7:00 on every Thursday

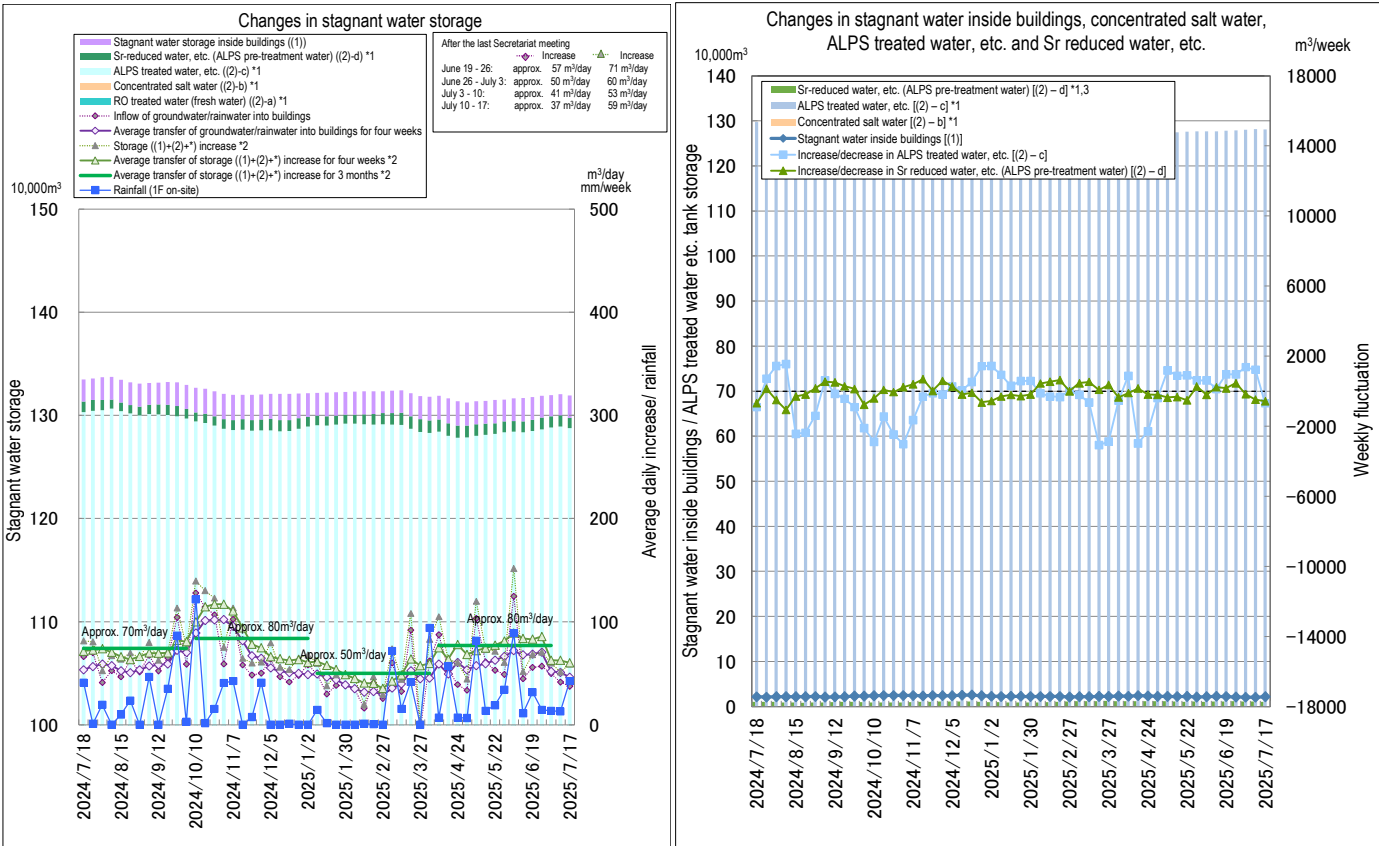
As of July 17, 2025

- The volume of ALPS treated water, etc. was approx. 1,283,298 m³ as of July 17, 2025.
- The total volume of ALPS treated water discharged into the sea since the discharge commenced on August 24, 2023, was approx. 93,997 m³ as of the completion of the first discharge in FY2025.

(1): Stagnant water storage inside buildings (Units 1-4, Process Main Building, High Temperature Incinerator Building, Waste Liquid Supply Tank, SPT (A), SPT (B), Units 1-3 CST, buffer tank)

(2): Units 1-4 tank storage ([(2)-a RO-treated water (fresh water)] + [(2)-b Concentrated salt water] + [(2)-c ALPS treated water, etc.] + [(2)-d Sr-reduced water, etc. (ALPS pre-treatment water)])
*: Water amount from tank bottom to water-level gauge 0% (DS)
*1: Water amount for which the water-level gauge indicates 0% or more
*2: Calculated in the method of contaminated water generated ([Inflow of groundwater/rainwater into buildings] + (other transfer) + (chemical injection into ALPS)), amount of ALPS treated water discharged was not taken into account.
*3: Amount of Sr-reduced water and others increased and decreased depending on the operation status of facilities due to clog of the cross-flow filter for the multi-nuclide removal system.

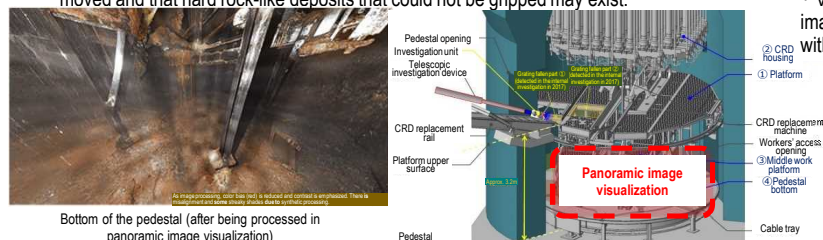
- In January 2018, the conditions below the platform inside the pedestal were investigated. Based on the analytical results of images obtained in the investigation, deposits, probably including fuel debris, were found at the bottom of the pedestal. Moreover, multiple parts exceeding the surrounding deposits were also detected. We presumed that there were multiple instances of fuel debris falling.

- In February 2019, an investigation touching the deposits at the bottom of the pedestal and on the platform was conducted and confirmed that the pebble-shaped deposits, etc. could be moved and that hard rock-like deposits that could not be gripped may exist.

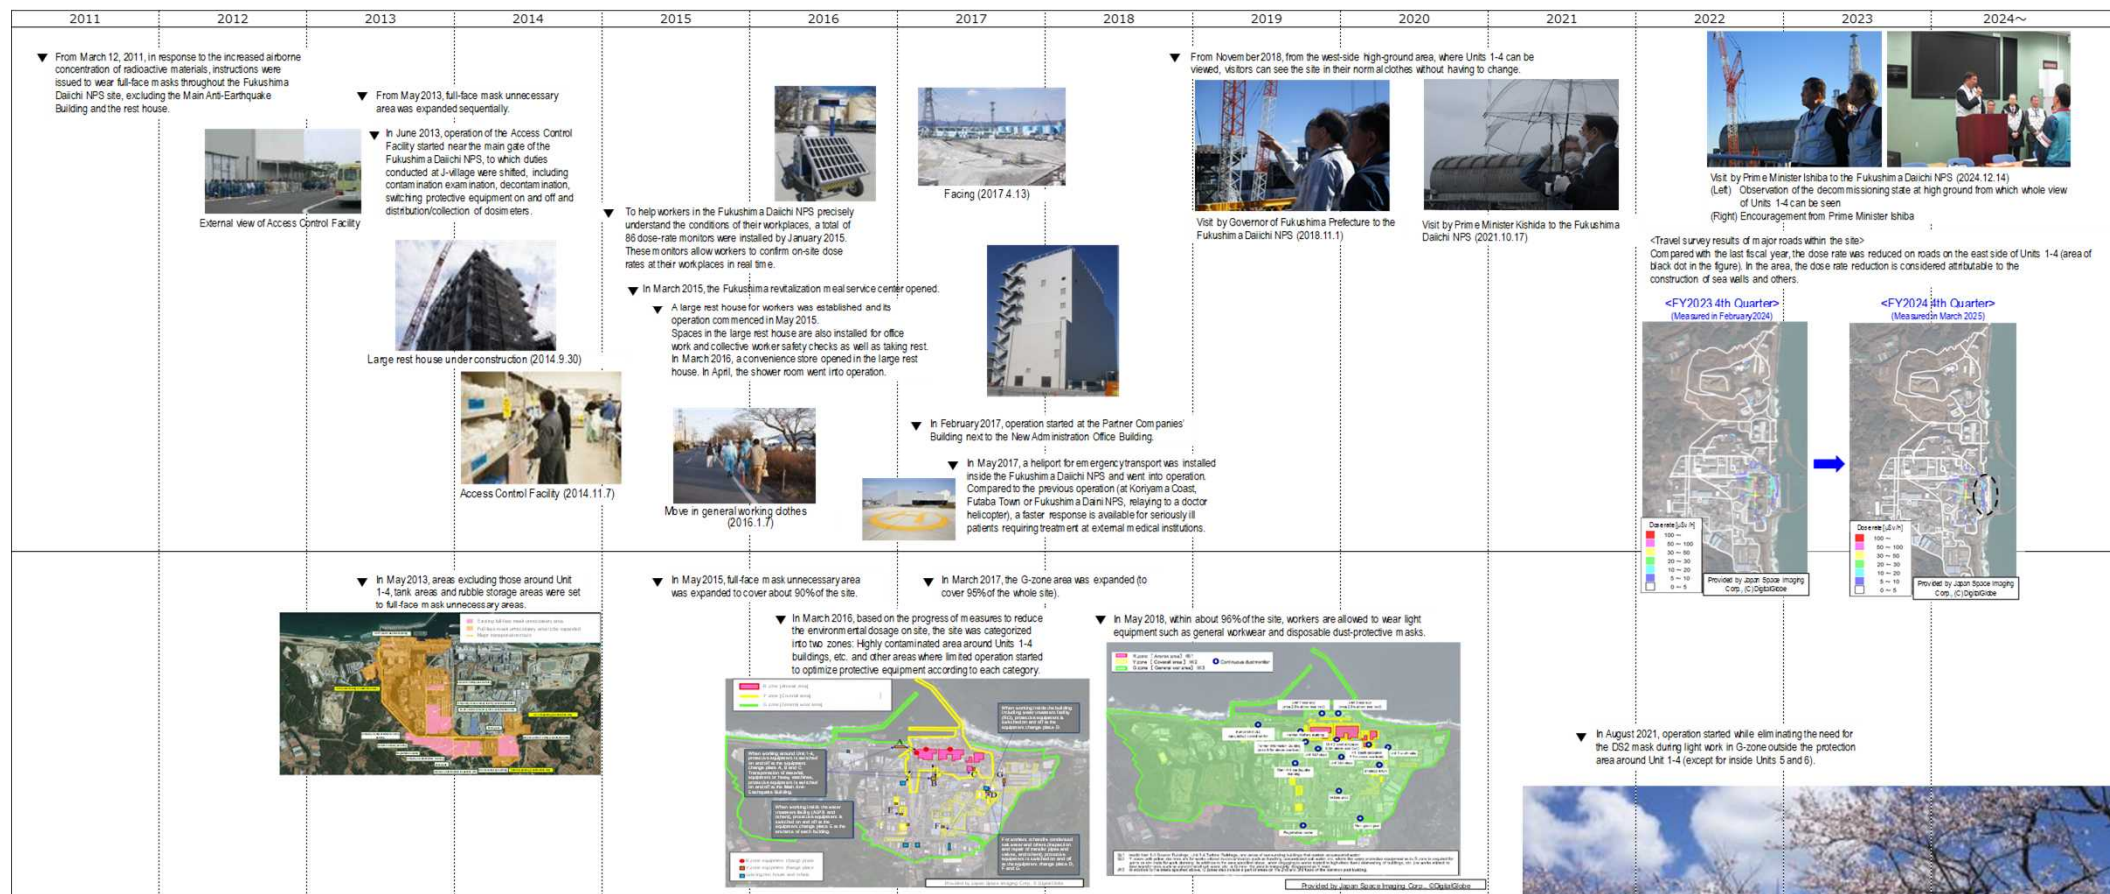
Regarding the site-wide reduction in the radiation dose and prevention of contamination spreading, the radiation dose on site was reduced by removal of rubble, topsoil and facing. Moreover, the operation was improved to use environmentally-improved areas as a Green Zone, within which workers are allowed to wear general work clothes and disposable dust-protective masks which are less of a physical burden.
