Main decommissioning work and steps

Reference
March 31, 2022
Secretariat of the Team for Countermeasures for
Decommissioning, Contaminated Water and Treated Water
1/6

Milestones of the Mid- and Long-Term Roadmap (major target processes)

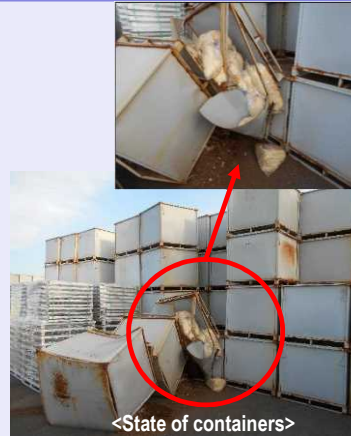
<State of containers>

The earthquake had influence on facilities (water-level decline in the Unit 1 Primary Containment Vessel (PCV), cooling of the spent fuel pool stopped, toppled-over containers, tanks moved out of position and others), but there was no leakage of radioactive materials into the environment, fatal accidents, or events possibly affecting future plant operation.

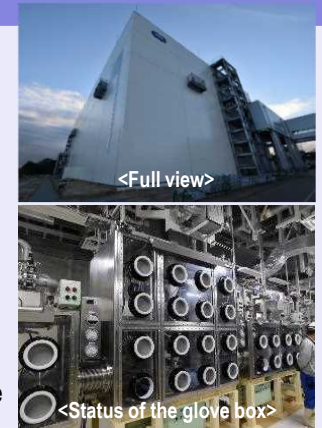
<Full view>

When the air-conditioning equipment was tested in January 2021, insufficient air volume was detected. However, the evaluation confirmed that the present air volume would be able to maintain the safety function such as maintaining negative pressure.

Toward construction completion and operation start at the end of June 2022, applications to change the implementation plan and final adjustment of the air volume for air-conditioning are underway.

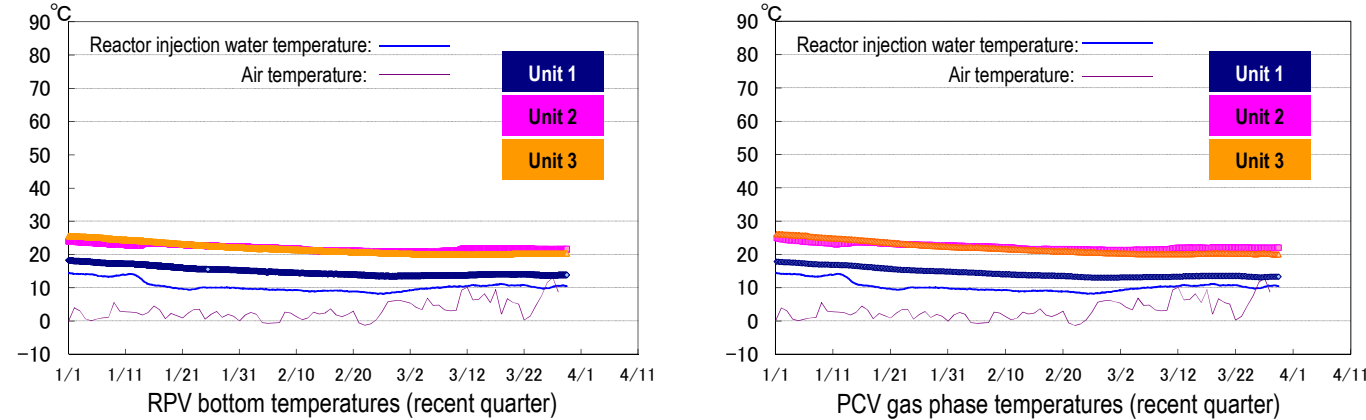
Through continuous reactor cooling by water injection, the temperatures of the Reactor Pressure Vessel (RPV) bottom and the Primary Containment Vessel (PCV) gas phase were maintained within the range of approx. 15 to 25°C for the past month, though it varied depending on the unit and location of the thermometer.

*1 The trend graphs show part of the temperature data measured at multiple points.
*2 A part of data could not be measured due to maintenance and inspection of the facility and other work.

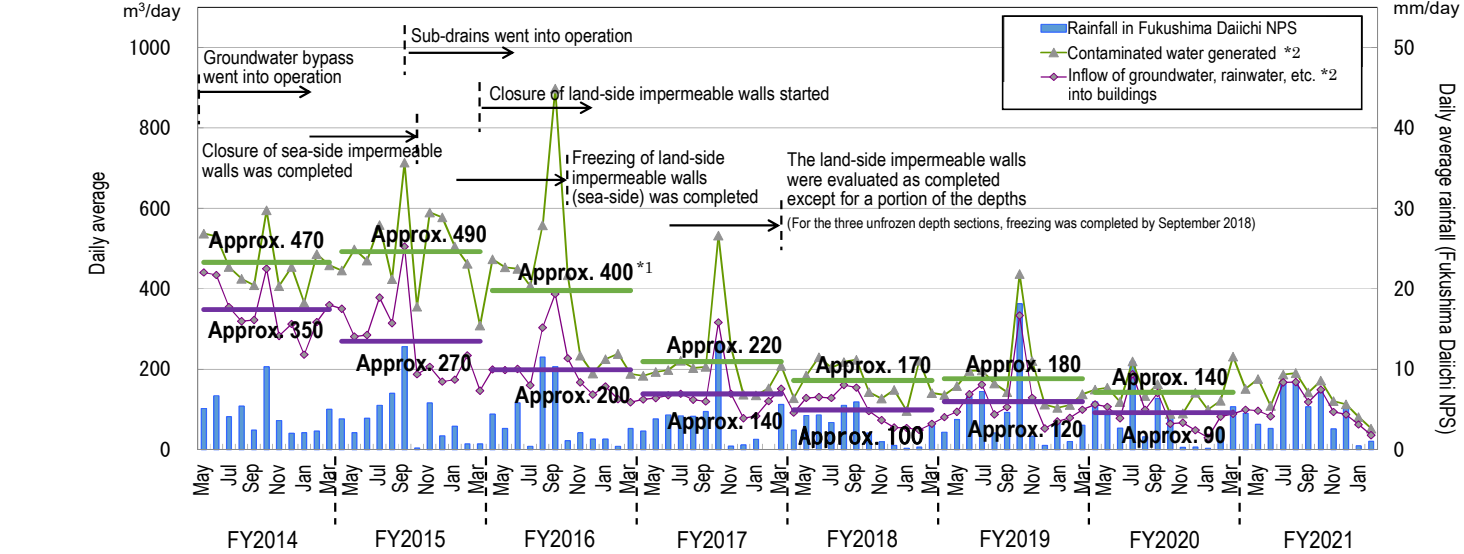
Figure 1: Changes in contaminated water generated and inflow of groundwater and rainwater into buildings

- Status of contaminated water generated
 - Multi-layered measures, including pumping up by sub-drains and land-side impermeable walls, which were implemented to control the continued generation of contaminated water, suppressed the groundwater inflow into buildings.
 - After implementing “redirecting” measures (groundwater bypass, sub-drains, land-side impermeable walls and others) and rainwater prevention measures, including repairing damaged portions of building roofs, the amount of contaminated water generated within FY2020 declined to approx. 140 m³/day.
 - Measures will continue to further reduce the amount of contaminated water generated.

*1 Values differ from those announced at the 20th Committee on Countermeasures for Contaminated Water Treatment (held on August 25, 2017) because the method of calculating the contaminated water volume generated was reviewed on March 1, 2018. Details of the review are described in the materials for the 50th and 51st meetings of the Secretariat of the Team for Countermeasures for Decommissioning and Contaminated Water Treatment.
*2: The monthly daily average is derived from the daily average from the previous Thursday to the last Wednesday, which is calculated based on the data measured at 7:00 on every Thursday.

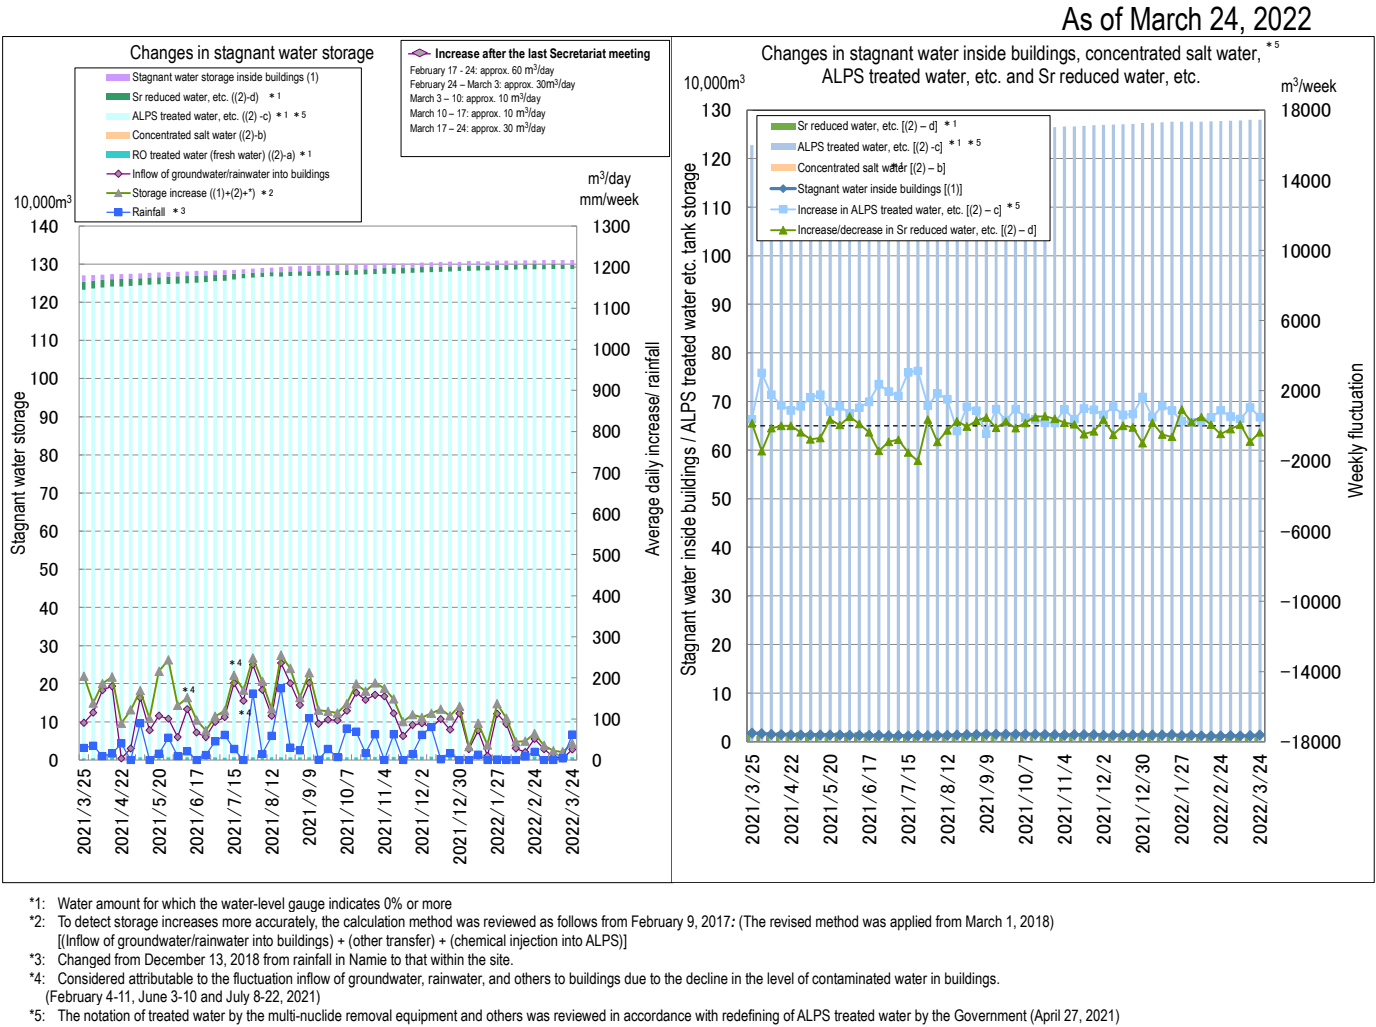
Figure 3: Status of stagnant water storage

*1: Water amount for which the water-level gauge indicates 0% or more
*2: To detect storage increases more accurately, the calculation method was reviewed as follows from February 9, 2017: (The revised method was applied from March 1, 2018)
[(Inflow of groundwater/rainwater into buildings) + (other transfer) + (chemical injection into ALPS)]
*3: Changed from December 13, 2018 from rainfall in Namie to that within the site.
*4: Considered attributable to the fluctuation inflow of groundwater, rainwater, and others to buildings due to the decline in the level of contaminated water in buildings.
(Febuary 4-11, June 3-10 and July 8-22, 2021)
*5: The notation of treated water by the multi-nuclide removal equipment and others was reviewed in accordance with redefining of ALPS treated water by the Government (April 27, 2021)

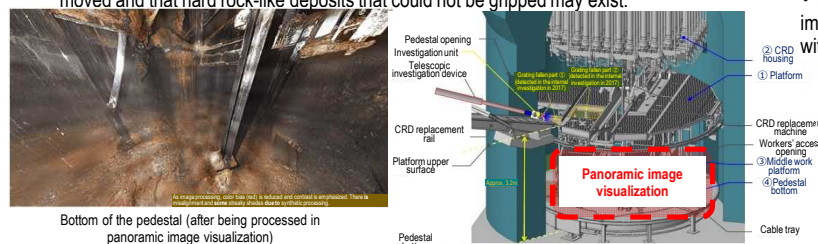
- In February 2019, an investigation touching the deposits at the bottom of the pedestal and on the platform was conducted and confirmed that the pebble-shaped deposits, etc. could be moved and that hard rock-like deposits that could not be gripped may exist.

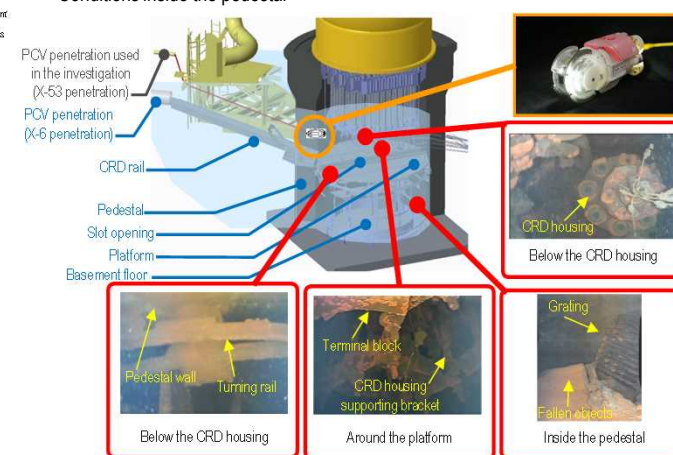
<Conditions inside the pedestal>

- In July 2017, the inside of the PCV was investigated using the underwater ROV (remotely operated underwater vehicle) to inspect the inside of the pedestal. Analysis of the imagery obtained in the investigation identified damage to multiple structures and the supposed core internals.

- Videos obtained in the investigation were reproduced in 3D. Based on the reproduced images, the relative positions of the structures, such as the rotating platform slipping off the rail with a portion buried in deposits, were visually understood.

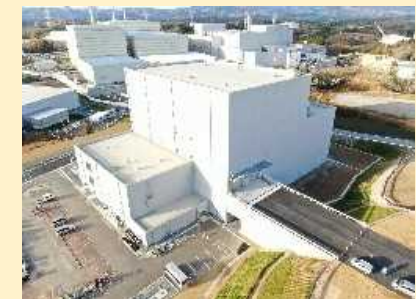
Whole view of the Additional Solid Waste Incinerator Building

To incinerate trimmed trees and combustible rubble (woods, packing materials, paper and others), work to install the Additional Solid Waste Facility is underway.

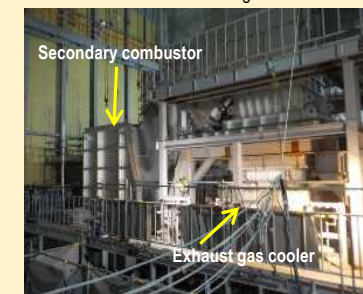
Secondary combustor

Exhaust gas cooler
