Main decommissioning work and steps

Contaminated water management – triple-pronged efforts -

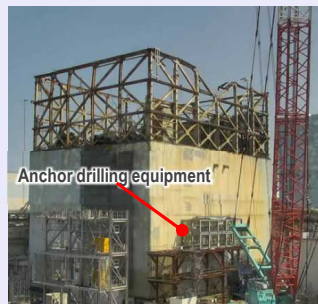
<On-site status (from northwest)>
(photo: April 12, 2022)

Unit 1 Progress of work to help fuel removal

Before installing a large cover, the investigation of external walls on the western, northern and eastern sides of the Reactor Building was completed. Subsequently, from April 13, drilling to install an anchor in the building started.

To reduce the exposure risk of workers, work proceeds carefully using a remotely-operated anchor drilling equipment and suctioning dust.

- A work yard was prepared around the Reactor Building and work to install a large cover started from August 2021.
 - Before installing the anchor of the large cover, the exterior walls of the Reactor Building were investigated. An investigation of representative parts on the west side of the building revealed that both cracking and concrete strength were within the assumed range and that the anchor would be installable as planned.

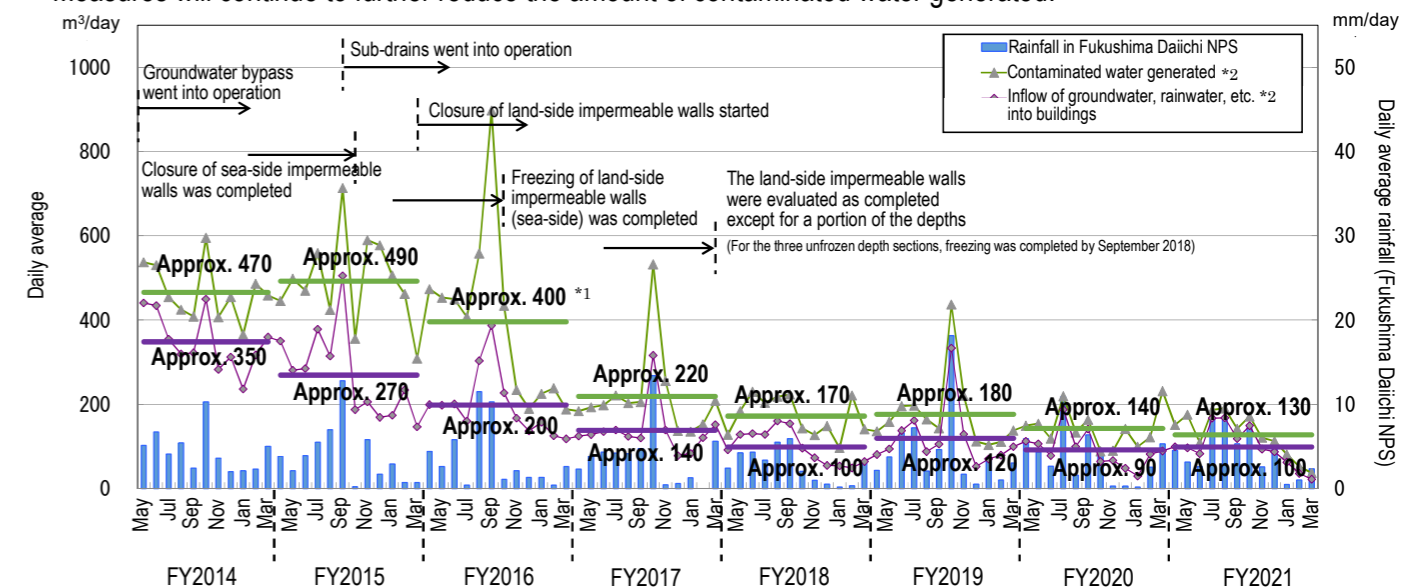
- Multi-layered measures, including pumping up by sub-drains and land-side impermeable walls, which were implemented to control the continued generation of contaminated water, suppressed the groundwater inflow into buildings.
- After implementing "redirecting" measures (groundwater bypass, sub-drains, land-side impermeable walls and others) and rainwater prevention measures, including repairing damaged portions of building roofs, the amount of contaminated water generated within FY2021 declined to approx. 130 m³/day.
- Measures will continue to further reduce the amount of contaminated water generated.

*1 Values differ from those announced at the 20th Committee on Countermeasures for Contaminated Water Treatment (held on August 25, 2017) because the method of calculating the contaminated water volume generated was reviewed on March 1, 2018. Details of the review are described in the materials for the 50th and 51st meetings of the Secretariat of the Team for Countermeasures for Decommissioning and Contaminated Water Treatment.

*2: The monthly daily average is derived from the daily average from the previous Thursday to the last Wednesday, which is calculated based on the data measured at 7:00 on every Thursday.

After implementing multi-layered contaminated water management measures, including repairing building roofs and facing around the buildings, the amount of contaminated water generated within FY2021 declined to approx. 130 m³/day and the groundwater inflow into the buildings is considered suppressed.

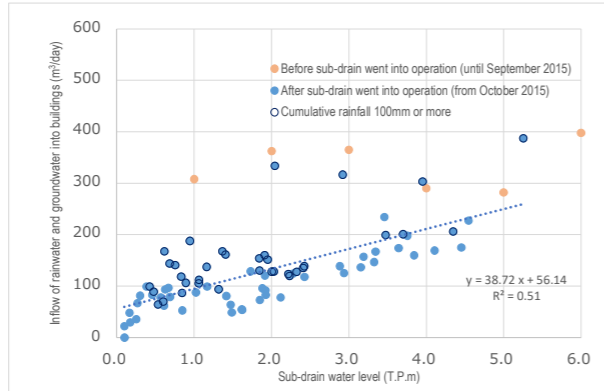
Figure 2: Correlation between inflow such as groundwater and rainwater into buildings and the water level of Units 1-4 sub-drains

- At the Water-Treatment Facility special for Sub-drain & Groundwater drains, release started from September 14, 2015 and up until April 18, 2022, 1,820 releases had been conducted.
- The water quality of all temporary storage tanks satisfied the operation target.

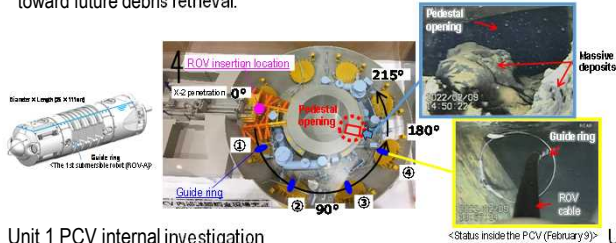
In February, the first remotely operated underwater vehicle (ROV-A) was inserted to install "guide rings" which will facilitate the investigation. As installation of guide rings has been completed, then a detailed investigation will be implemented. In this investigation, distribution of deposits outside the pedestal and their characteristics or others will also be investigated. The results of these investigations will be utilized in the examination of method and procedures toward future debris retrieval.

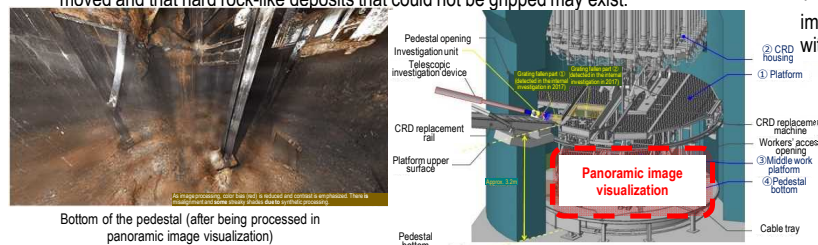
- In January 2017, a camera was inserted from the PCV penetration to inspect the conditions of the rail on which the robot traveled. The results of a series of investigations confirmed some gratings had fallen and deformed as well as a quantity of deposit inside the pedestal.

- In January 2018, the conditions below the platform inside the pedestal were investigated. Based on the analytical results of images obtained in the investigation, deposits, probably including fuel debris, were found at the bottom of the pedestal. Moreover, multiple parts exceeding the surrounding deposits were also detected. We presumed that there were multiple instances of fuel debris falling.

- In February 2019, an investigation touching the deposits at the bottom of the pedestal and on the platform was conducted and confirmed that the pebble-shaped deposits, etc. could be moved and that hard rock-like deposits that could not be gripped may exist.

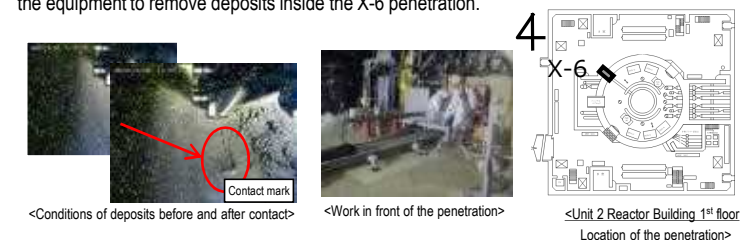
- In October 2020, as part of work to prepare for the PCV internal investigation and trial retrieval, a contact investigation to study deposits inside the penetration (X-6 penetration) was conducted, which involved inserting a guide pipe incorporating an investigative unit into the penetration. This confirmed that deposits inside the penetration had not deformed and come unstuck. The investigative information obtained will be utilized in the mockup test of the equipment to remove deposits inside the X-6 penetration.

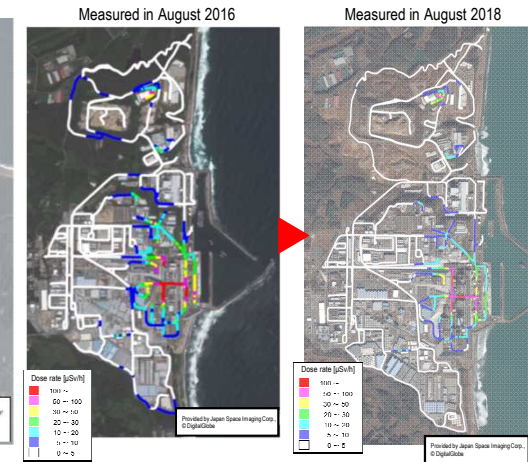
<Travel survey results of major roads within the site>
The dose rate has been declining every year.
