Main decommissioning work and steps

Progress status

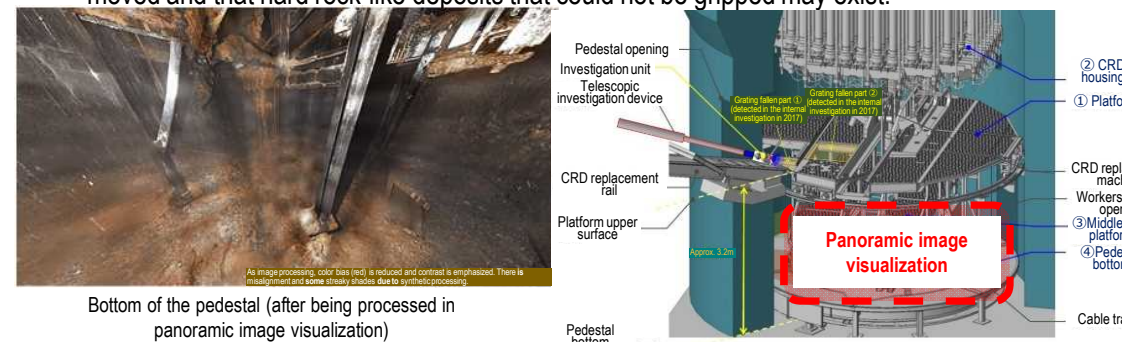
- In February 2019, an investigation touching the deposits at the bottom of the pedestal and on the platform was conducted and confirmed that the pebble-shaped deposits, etc. could be moved and that hard rock-like deposits that could not be gripped may exist.

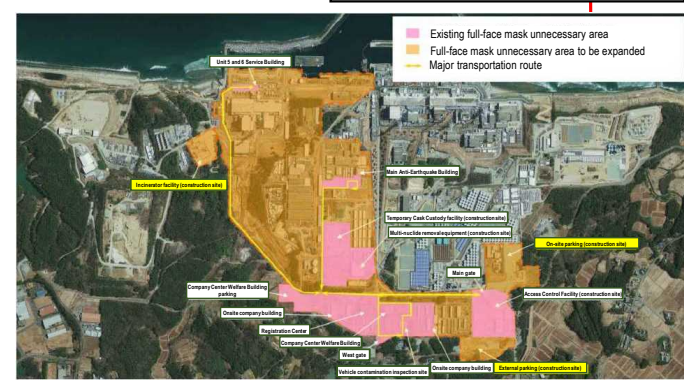
In May 2013, areas excluding those around Unit 1-4, tank areas and rubble storage areas were set to full-face mask unnecessary areas.
