Main decommissioning work and steps

Progress status

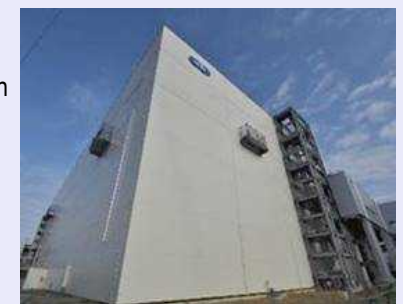
<Radioactive Material Analysis and Research Facility Laboratory-1 >

Construction completion of the Radioactive Material Analysis and Research Facility Laboratory-1

The Japan Atomic Energy Agency (JAEA) had been constructing the Radioactive Material Analysis and Research Facility Laboratory-1 within the site of the Fukushima Daiichi Nuclear Power Station, as part of research and development into waste treatment and handling. After finishing the comprehensive functional test and others, construction was completed on June 24.

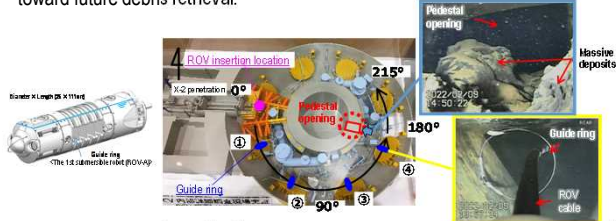
In February, the first remotely operated underwater vehicle (ROV-A) was inserted to install "guide rings" which will facilitate the investigation. As installation of guide rings has been completed, then a detailed investigation will be implemented. In this investigation, distribution of deposits outside the pedestal and their characteristics or others will also be investigated. The results of these investigations will be utilized in the examination of method and procedures toward future debris retrieval.

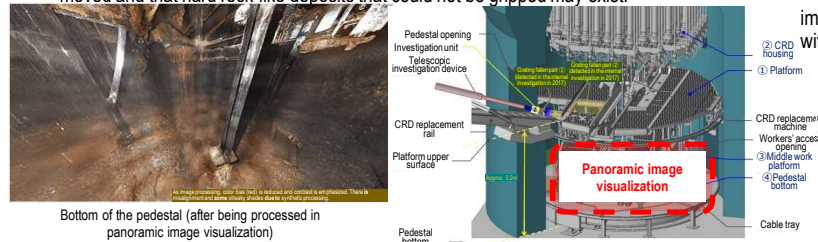
- In January 2017, a camera was inserted from the PCV penetration to inspect the conditions of the rail on which the robot traveled. The results of a series of investigations confirmed some gratings had fallen and deformed as well as a quantity of deposit inside the pedestal.

- In January 2018, the conditions below the platform inside the pedestal were investigated. Based on the analytical results of images obtained in the investigation, deposits, probably including fuel debris, were found at the bottom of the pedestal. Moreover, multiple parts exceeding the surrounding deposits were also detected. We presumed that there were multiple instances of fuel debris falling.

- In February 2019, an investigation touching the deposits at the bottom of the pedestal and on the platform was conducted and confirmed that the pebble-shaped deposits, etc. could be moved and that hard rock-like deposits that could not be gripped may exist.

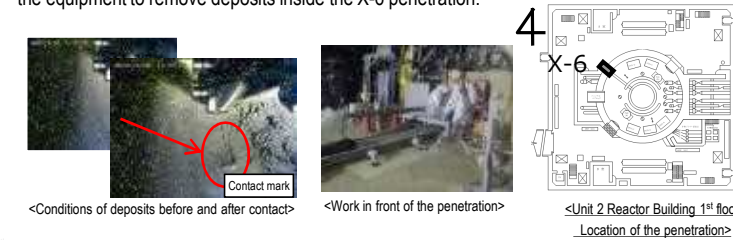
- In October 2020, as part of work to prepare for the PCV internal investigation and trial retrieval, a contact investigation to study deposits inside the penetration (X-6 penetration) was conducted, which involved inserting a guide pipe incorporating an investigative unit into the penetration. This confirmed that deposits inside the penetration had not deformed and come unstuck. The investigative information obtained will be utilized in the mockup test of the equipment to remove deposits inside the X-6 penetration.

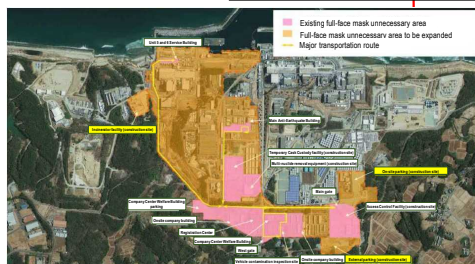
In August 2021, operation started while eliminating the need for the DS2 mask during light work in G-zone outside the protection area around Unit 1-4 (except for inside Units 5 and 6).

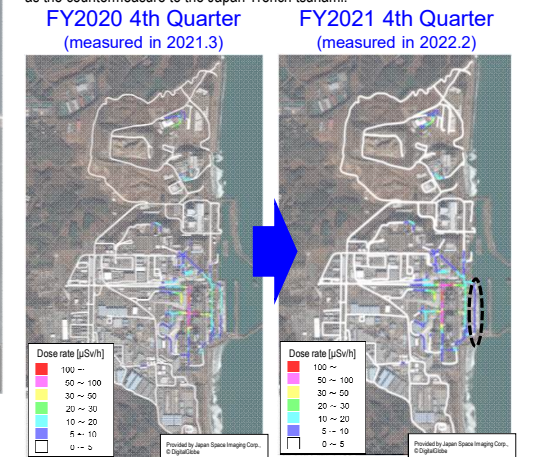
<Travel survey results of major roads within the site>
The dose rate has been declining every year. In particular, in the area on the east side of the Turbine Building shown a black dotted line, the dose rate declined by facing related to installation of the seawall as the countermeasure to the Japan Trench tsunami.
