Main decommissioning work and steps

Progress status

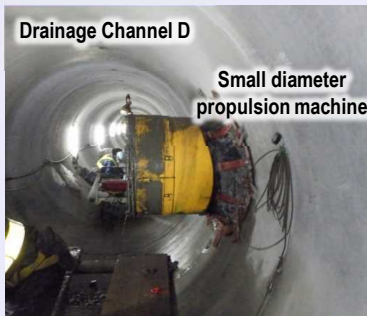
<Construction status of Drainage Channel D>
(Small diameter propulsion work)

To reduce the risks of heavy rain, Drainage Channel D will go into operation within August

To eliminate the risk of heavy rain from an early stage, work to extend Drainage Channel D is underway.

By operating Drainage Channel D, drainage in areas with a low dose on the west side of the site can be conveyed to the inside of the port during rainfall to prevent the existing drainage channel from flooding. Flowing down associated by flooding to around the Units 1-4 buildings can also be prevented.

Preparation such as installing the drainage gate proceeds and the drainage channel is expected to go into operation within August.

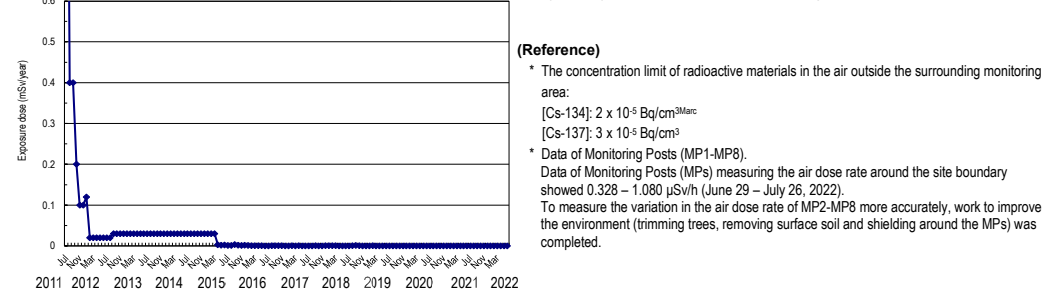
Annual radiation dose at site boundaries by radioactive materials (cesium) released from Reactor Building Units 1-4

As of June 2022, the concentration of radioactive materials newly released from Reactor Building Units 1-4 into the air and measured at the site boundary was evaluated at approx. 3.0×10^{-12} Bq/cm³ and 2.3×10^{-12} Bq/cm³ for Cs-134 and -137 respectively, while the radiation exposure dose due to the release of radioactive materials there was less than 0.00006 mSv/year.

Note 1: Different formulas and coefficients were used to evaluate the radiation dose in the facility operation plan and monthly report. The evaluation methods were integrated in September 2012. As the fuel removal from the spent fuel pool (SFP) commenced for Unit 4, the radiation exposure dose from Unit 4 was added to the items subject to evaluation since November 2013. The evaluation has been changed to a method considering the values of continuous dust monitors since FY2015, with data to be evaluated monthly and announced the following month.
Note 2: Radiation dose was calculated using the evaluation values of release amount from Units 1-4 and Units 5 and 6. The radiation dose of Unit 5 and 6 was evaluated based on expected release amount during operation until September 2019 but the evaluation method was reviewed and changed to calculate based on the actual measurement results of Units 5 and 6 from October.

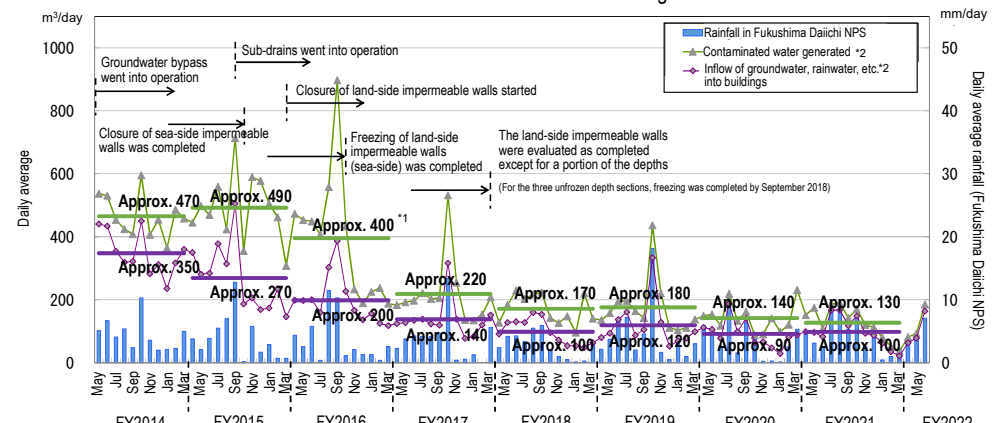
Figure 1: Changes in contaminated water generated and inflow of groundwater and rainwater into buildings

- Multi-layered measures, including pumping up by sub-drains and land-side impermeable walls, which were implemented to control the continued generation of contaminated water, suppressed the groundwater inflow into buildings.
- After implementing "redirecting" measures (groundwater bypass, sub-drains, land-side impermeable walls and others) and rainwater prevention measures, including repairing damaged portions of building roofs, the amount of contaminated water generated within FY2021 declined to approx. 130 m³/day.
- Measures will continue to further reduce the amount of contaminated water generated.

*1 Values differ from those announced at the 20th Committee on Countermeasures for Contaminated Water Treatment (held on August 25, 2017) because the method of calculating the contaminated water volume generated was reviewed on March 1, 2018. Details of the review are described in the materials for the 50th and 51st meetings of the Secretariat of the Team for Countermeasures for Decommissioning and Contaminated Water Treatment.
*2: The monthly daily average is derived from the daily average from the previous Thursday to the last Wednesday, which is calculated based on the data measured at 7:00 on every Thursday.

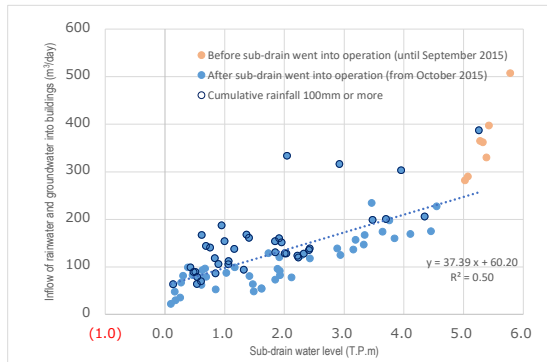
Figure 2: Correlation between inflow such as groundwater and rainwater into buildings and the water level of Units 1-4 sub-drains

- At the Water-Treatment Facility Special for Sub-drain & Groundwater drains, release started from September 14, 2015 and up until July 18, 2022, 1,914 release operations had been conducted.
- The water quality of all temporary storage tanks satisfied the operation target.

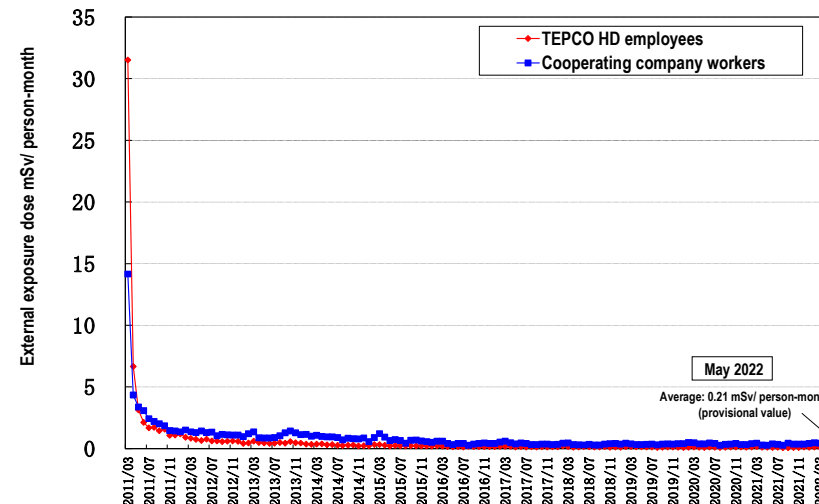
Figure 7: Changes in monthly average exposure dose of individual worker (monthly exposure dose since March 2011)

- The number of workers both from within and outside Fukushima Prefecture increased slightly. The local employment ratio (cooperating company workers and TEPCO HD employees) as of June 2022 remained constant at around 70%.
- The average exposure doses of workers were approx. 2.54 and 2.60 and 2.51 mSv/person-year during FY2019, 2020 and 2021, respectively. (The legal exposure dose limits are 100 mSv/person and 50 mSv/person-year over five years, the TEPCO HD management target is 20 mSv/person-year).
- For most workers, the exposure dose was sufficiently within the limit and allowed them to continue engaging in radiation work.

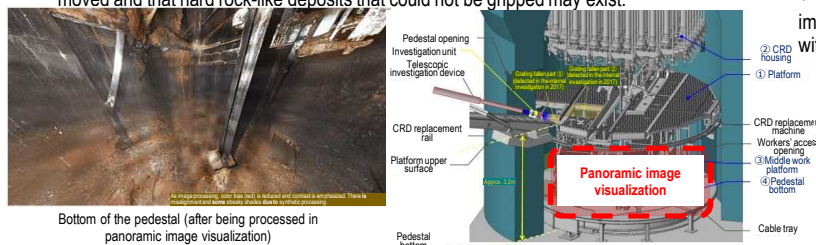
- In January 2017, a camera was inserted from the PCV penetration to inspect the conditions of the rail on which the robot traveled. The results of a series of investigations confirmed some gratings had fallen and deformed as well as a quantity of deposit inside the pedestal.

- In January 2018, the conditions below the platform inside the pedestal were investigated. Based on the analytical results of images obtained in the investigation, deposits, probably including fuel debris, were found at the bottom of the pedestal. Moreover, multiple parts exceeding the surrounding deposits were also detected. We presumed that there were multiple instances of fuel debris falling.

- In February 2019, an investigation touching the deposits at the bottom of the pedestal and on the platform was conducted and confirmed that the pebble-shaped deposits, etc. could be moved and that hard rock-like deposits that could not be gripped may exist.

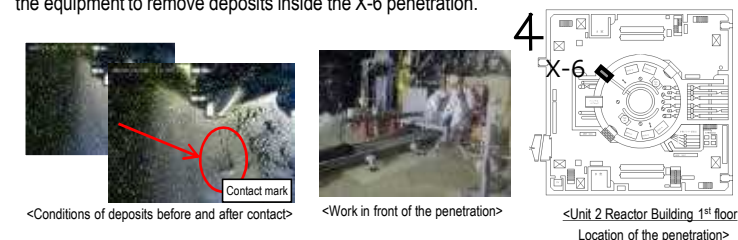
- In October 2020, as part of work to prepare for the PCV internal investigation and trial retrieval, a contact investigation to study deposits inside the penetration (X-6 penetration) was conducted, which involved inserting a guide pipe incorporating an investigative unit into the penetration. This confirmed that deposits inside the penetration had not deformed and come unstuck. The investigative information obtained will be utilized in the mockup test of the equipment to remove deposits inside the X-6 penetration.

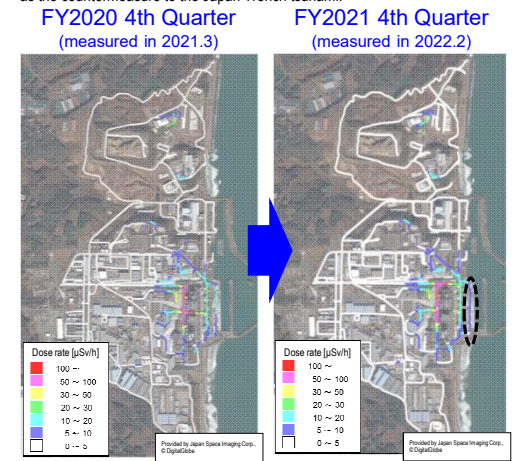
<Travel survey results of major roads within the site>
 The dose rate has been declining every year. In particular, in the area on the east side of the Turbine Building shown a black dotted line, the dose rate declined by facing related to installation of the seawall as the countermeasure to the Japan Trench tsunami.
