Main decommissioning work and steps

Progress status

Major initiatives – Locations on site

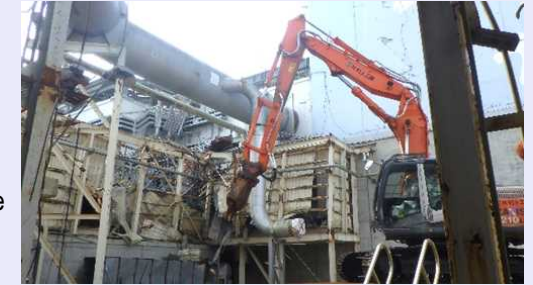
<Rubble removal work>

Progress of work around the Unit 1/2 Radioactive Waste Treatment Building

Rubble removal work around the Unit 1/2 Rw/B resumed from August 23, as the construction of the course for the rubble-removing heavy machine was completed in the range for preceding work.

Work to date to remove the SGTS pipes was reviewed and measures to improve reliability by modifying the cutter and others are being examined.

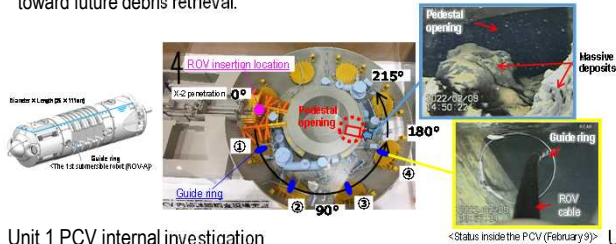
In February, the first remotely operated underwater vehicle (ROV-A) was inserted to install "guide rings" which will facilitate the investigation. As installation of guide rings has been completed, then a detailed investigation will be implemented. In this investigation, distribution of deposits outside the pedestal and their characteristics or others will also be investigated. The results of these investigations will be utilized in the examination of method and procedures toward future debris retrieval.

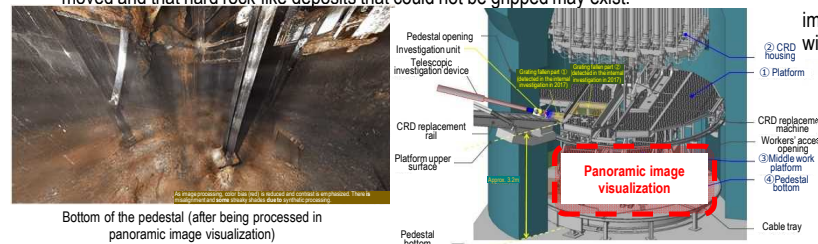
- In January 2017, a camera was inserted from the PCV penetration to inspect the conditions of the rail on which the robot traveled. The results of a series of investigations confirmed some gratings had fallen and deformed as well as a quantity of deposit inside the pedestal.

- In January 2018, the conditions below the platform inside the pedestal were investigated. Based on the analytical results of images obtained in the investigation, deposits, probably including fuel debris, were found at the bottom of the pedestal. Moreover, multiple parts exceeding the surrounding deposits were also detected. We presumed that there were multiple instances of fuel debris falling.

- In February 2019, an investigation touching the deposits at the bottom of the pedestal and on the platform was conducted and confirmed that the pebble-shaped deposits, etc. could be moved and that hard rock-like deposits that could not be gripped may exist.

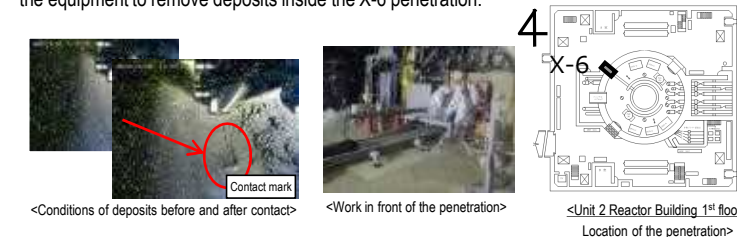
- In October 2020, as part of work to prepare for the PCV internal investigation and trial retrieval, a contact investigation to study deposits inside the penetration (X-6 penetration) was conducted, which involved inserting a guide pipe incorporating an investigative unit into the penetration. This confirmed that deposits inside the penetration had not deformed and come unstuck. The investigative information obtained will be utilized in the mockup test of the equipment to remove deposits inside the X-6 penetration.

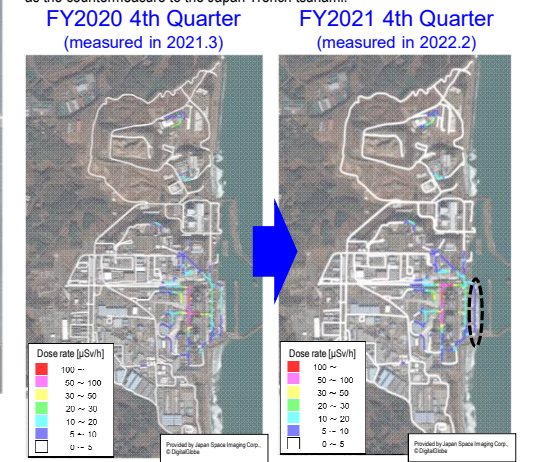
<Travel survey results of major roads within the site>
The dose rate has been declining every year. In particular, in the area on the east side of the Turbine Building shown a black dotted line, the dose rate declined by facing related to installation of the seawall as the countermeasure to the Japan Trench tsunami.
