Main decommissioning work and steps

Fuel removal from the spent fuel pool was completed in December 2014 at Unit 4 and on February 28, 2021 at Unit 3.
 Work continues sequentially toward the start of fuel removal from Units 1 and 2 and debris (Note 1) retrieval from Units 1-3.
 (Note 1) Fuel assemblies having melted through in the accident.

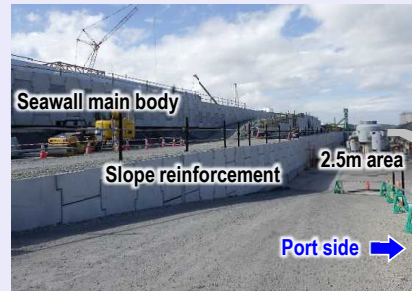
<Construction of the seawall main body>

Tsunami countermeasures, including installing the Japan Trench Tsunami Seawall are steadily progressing

Regarding the Japan Trench Tsunami Seawall, with completion in FY2023 in mind, installation of the seawall main body is now 30% complete.

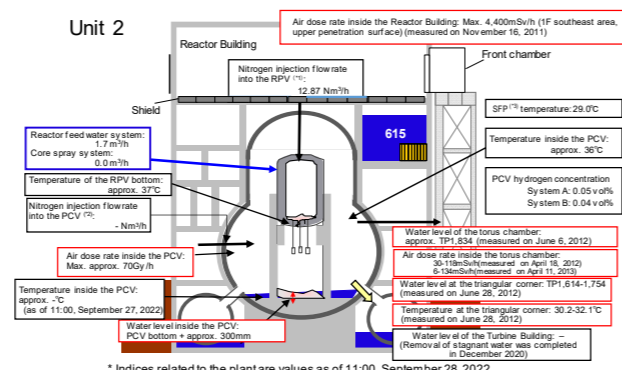
Temperatures inside the reactors

Through continuous reactor cooling by water injection, the temperatures of the Reactor Pressure Vessel (RPV) bottom and the Primary Containment Vessel (PCV) gas phase were maintained within the range of approx. 25 to 40°C for the past month, though it varied depending on the unit and location of the thermometer.

*1 The trend graphs show part of the temperature data measured at multiple points.
*2 A part of data could not be measured due to maintenance and inspection of the facility and other work.

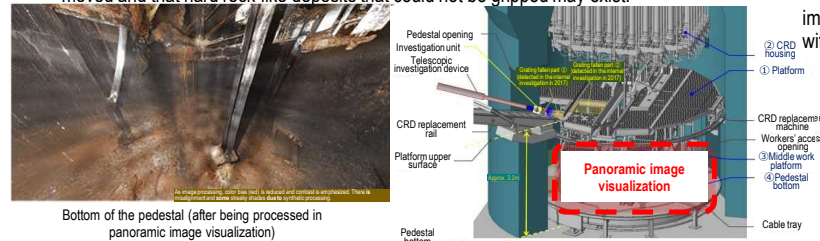
Unit 2 Investigation overview

- In January 2017, a camera was inserted from the PCV penetration to inspect the conditions of the rail on which the robot traveled. The results of a series of investigations confirmed some gratings had fallen and deformed as well as a quantity of deposit inside the pedestal.

- In January 2018, the conditions below the platform inside the pedestal were investigated. Based on the analytical results of images obtained in the investigation, deposits, probably including fuel debris, were found at the bottom of the pedestal. Moreover, multiple parts exceeding the surrounding deposits were also detected. We presumed that there were multiple instances of fuel debris falling.

- In February 2019, an investigation touching the deposits at the bottom of the pedestal and on the platform was conducted and confirmed that the pebble-shaped deposits, etc. could be moved and that hard rock-like deposits that could not be gripped may exist.

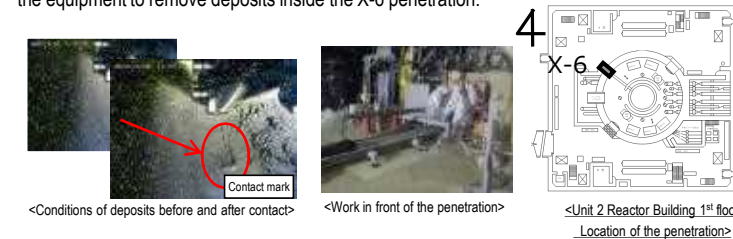
- In October 2020, as part of work to prepare for the PCV internal investigation and trial retrieval, a contact investigation to study deposits inside the penetration (X-6 penetration) was conducted, which involved inserting a guide pipe incorporating an investigative unit into the penetration. This confirmed that deposits inside the penetration had not deformed and come unstuck. The investigative information obtained will be utilized in the mockup test of the equipment to remove deposits inside the X-6 penetration.

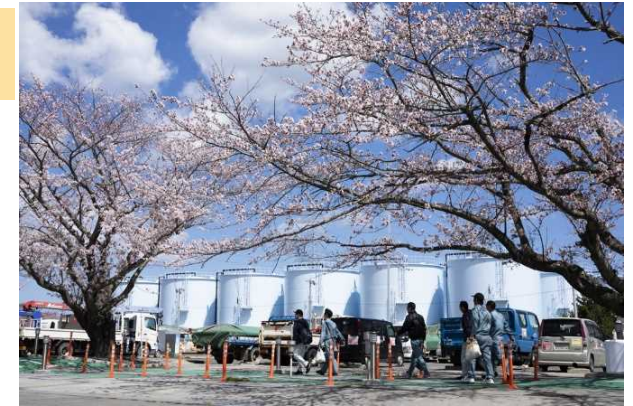
Regarding the site-wide reduction in the radiation dose and prevention of contamination spreading, the radiation dose on site was reduced by removal of rubble, topsoil and facing. Moreover, the operation was improved to use environmentally-improved areas as a Green Zone, within which workers are allowed to wear general work clothes and disposable dust-protective masks which are less of a physical burden.

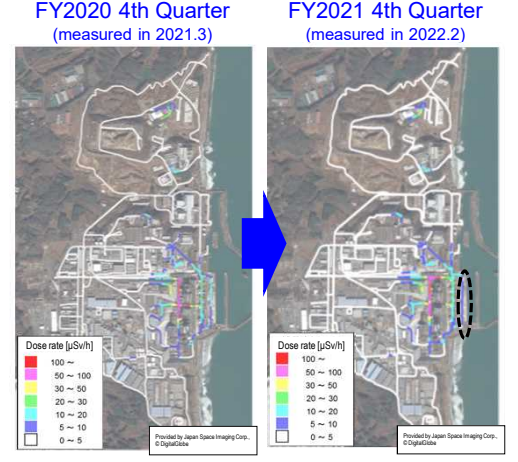
<Travel survey results of major roads within the site>
The dose rate has been declining every year. In particular, in the area on the east side of the Turbine Building shown a black dotted line, the dose rate declined by facing related to installation of the seawall as the countermeasure to the Japan Trench tsunami.
