Main decommissioning work and steps

Fuel removal from the spent fuel pool was completed in December 2014 at Unit 4 and on February 28, 2021 at Unit 3.
 Work continues sequentially toward the start of fuel removal from Units 1 and 2 and debris (Note 1) retrieval from Units 1-3.
 (Note 1) Fuel assemblies having melted through in the accident.

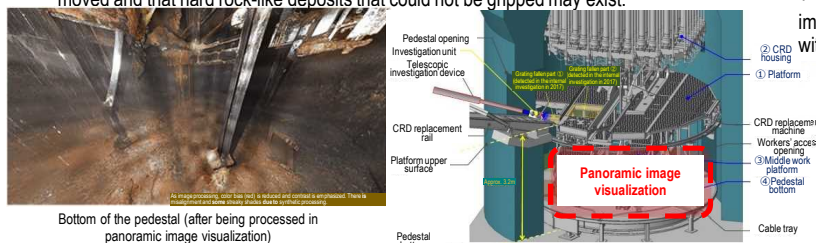
Unit 2 Investigation overview

- In January 2017, a camera was inserted from the PCV penetration to inspect the conditions of the rail on which the robot traveled. The results of a series of investigations confirmed some gratings had fallen and deformed as well as a quantity of deposit inside the pedestal.

- In January 2018, the conditions below the platform inside the pedestal were investigated. Based on the analytical results of images obtained in the investigation, deposits, probably including fuel debris, were found at the bottom of the pedestal. Moreover, multiple parts exceeding the surrounding deposits were also detected. We presumed that there were multiple instances of fuel debris falling.

- In February 2019, an investigation touching the deposits at the bottom of the pedestal and on the platform was conducted and confirmed that the pebble-shaped deposits, etc. could be moved and that hard rock-like deposits that could not be gripped may exist.

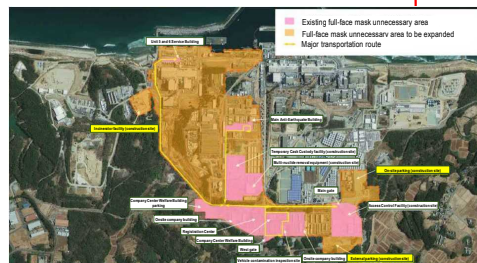
In August 2021, operation started while eliminating the need for the DS2 mask during light work in G-zone outside the protection area around Unit 1-4 (except for inside Units 5 and 6).

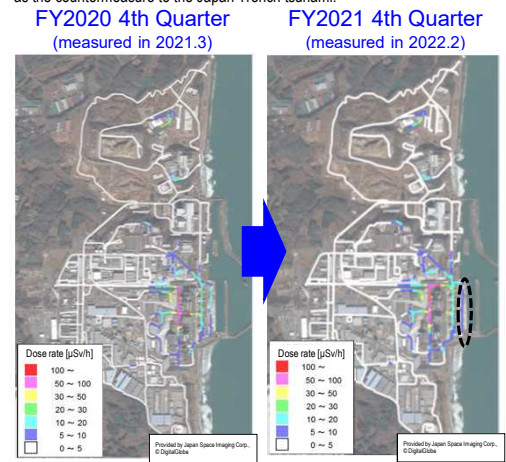
<Travel survey results of major roads within the site>
The dose rate has been declining every year. In particular, in the area on the east side of the Turbine Building shown a black dotted line, the dose rate declined by facing related to installation of the seawall as the countermeasure to the Japan Trench tsunami.
