## Main decommissioning work and steps

Fuel removal from the spent fuel pool was completed in December 2014 at Unit 4 and on February 28, 2021 at Unit 3.  
 Work continues sequentially toward the start of fuel removal from Units 1 and 2 and debris (Note 1) retrieval from Units 1-3.  
 (Note 1) Fuel assemblies having melted through in the accident.

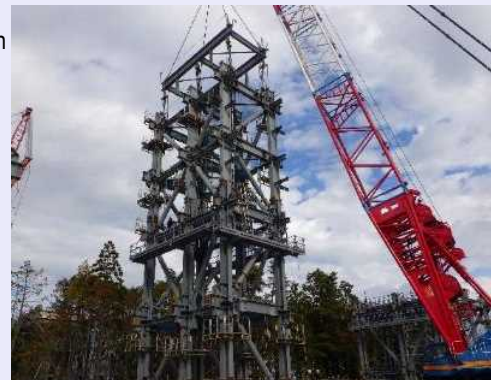
<Steel frame unit connection verification (November 5, 2022)>

Outside the building, the gantry is being installed and concrete placement of the 2nd (final) layer for the gantry foundation is underway from September 13. Outside the site, ground assembly of steel frames proceeds from August 31 and assembled steel frames will be carried in from mid-January for on-site assembly.

- Outside the building, construction of a gantry foundation has been underway since June 2022. After the construction is completed, steel structure erection will commence. Outside the site, before erecting the steel structure, ground assembly continues.

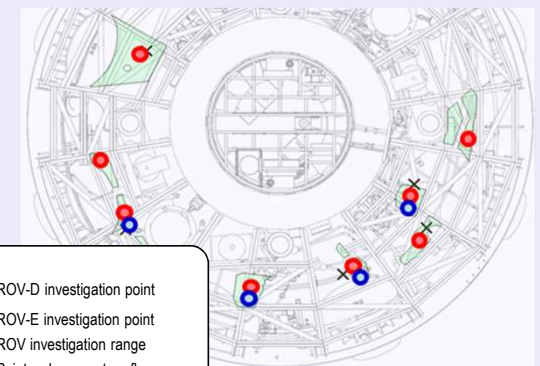
<Points of the PCV internal investigation by ROV-D and E>

First, the debris detection by ROV-D (nuclide analysis of gamma-ray) will be conducted at eight points and investigative results will be evaluated for about 2-4 weeks.

Moreover, preparation is underway to commence deposit sampling by ROV-E from January 2023.

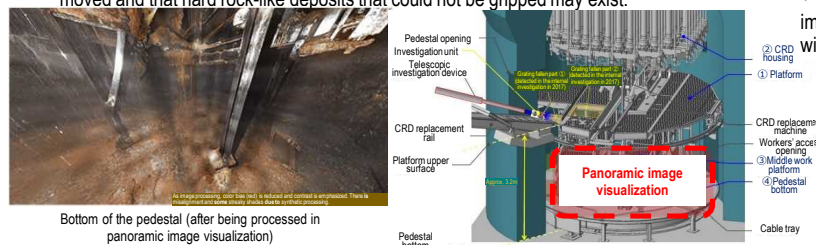
- In January 2017, a camera was inserted from the PCV penetration to inspect the conditions of the rail on which the robot traveled. The results of a series of investigations confirmed some gratings had fallen and deformed as well as a quantity of deposit inside the pedestal.

- In January 2018, the conditions below the platform inside the pedestal were investigated. Based on the analytical results of images obtained in the investigation, deposits, probably including fuel debris, were found at the bottom of the pedestal. Moreover, multiple parts exceeding the surrounding deposits were also detected. We presumed that there were multiple instances of fuel debris falling.

- In February 2019, an investigation touching the deposits at the bottom of the pedestal and on the platform was conducted and confirmed that the pebble-shaped deposits, etc. could be moved and that hard rock-like deposits that could not be gripped may exist.

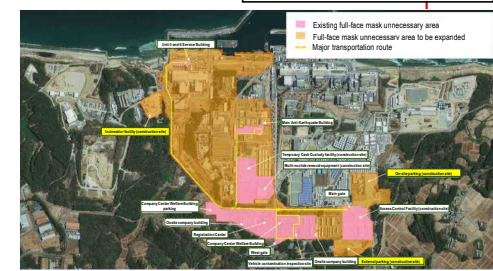
In May 2013, areas excluding those around Unit 1-4, tank areas and rubble storage areas were set to full-face mask unnecessary areas.
