Main decommissioning work and steps

Progress status

I. Confirmation of the reactor conditions

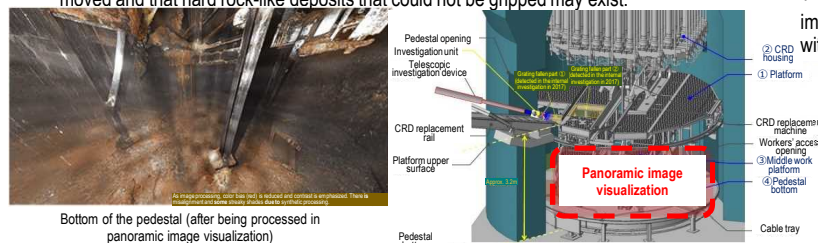
Unit 2 Investigation overview

- In January 2017, a camera was inserted from the PCV penetration to inspect the conditions of the rail on which the robot traveled. The results of a series of investigations confirmed some gratings had fallen and deformed as well as a quantity of deposit inside the pedestal.

- In January 2018, the conditions below the platform inside the pedestal were investigated. Based on the analytical results of images obtained in the investigation, deposits, probably including fuel debris, were found at the bottom of the pedestal. Moreover, multiple parts exceeding the surrounding deposits were also detected. We presumed that there were multiple instances of fuel debris falling.

- In February 2019, an investigation touching the deposits at the bottom of the pedestal and on the platform was conducted and confirmed that the pebble-shaped deposits, etc. could be moved and that hard rock-like deposits that could not be gripped may exist.

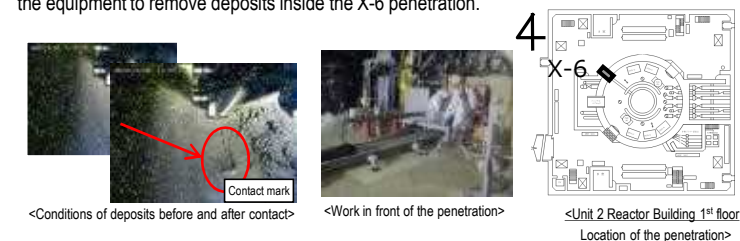
- In October 2020, as part of work to prepare for the PCV internal investigation and trial retrieval, a contact investigation to study deposits inside the penetration (X-6 penetration) was conducted, which involved inserting a guide pipe incorporating an investigative unit into the penetration. This confirmed that deposits inside the penetration had not deformed and come unstuck. The investigative information obtained will be utilized in the mockup test of the equipment to remove deposits inside the X-6 penetration.

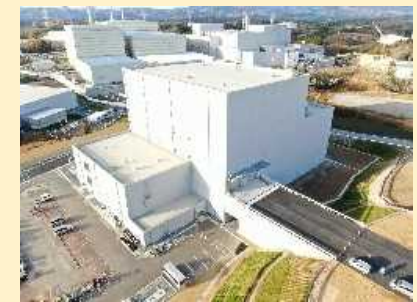
To incinerate trimmed trees and combustible rubble (woods, packing materials, paper and others), work to install the Additional Solid Waste Facility is underway.

Whole view of the Additional Solid Waste Incinerator Building

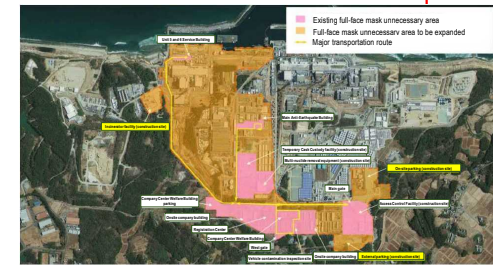
In May 2013, areas excluding those around Unit 1-4, tank areas and rubble storage areas were set to full-face mask unnecessary areas.

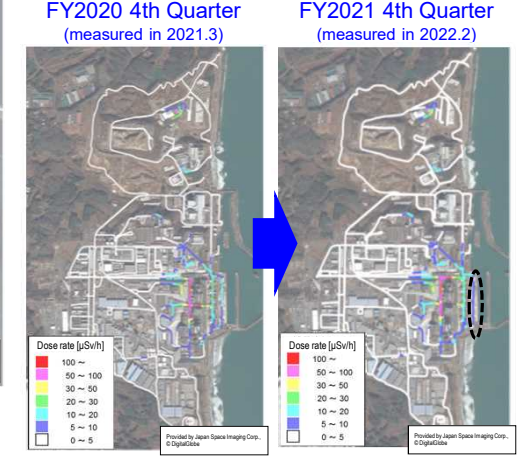
<Travel survey results of major roads within the site>
 The dose rate has been declining every year. In particular, in the area on the east side of the Turbine Building shown a black dotted line, the dose rate declined by facing related to installation of the seawall as the countermeasure to the Japan Trench tsunami.
