Main decommissioning work and steps

Fuel removal from the spent fuel pool was completed in December 2014 at Unit 4 and on February 28, 2021 at Unit 3.
Work continues sequentially toward the start of fuel removal from Units 1 and 2 and debris (Note 1) retrieval from Units 1-3.
(Note 1) Fuel assemblies having melted through in the accident.

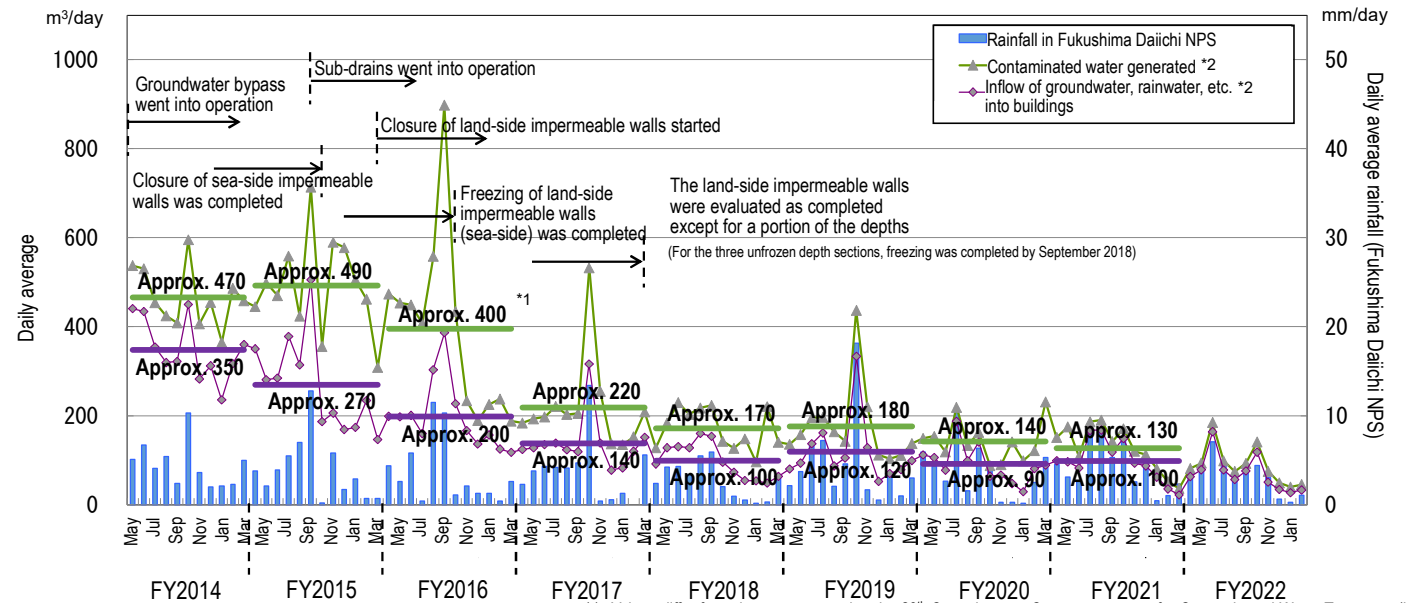
Figure 1: Changes in contaminated water generated and inflow of groundwater and rainwater into buildings

- Multi-layered measures, including pumping up by sub-drains and land-side impermeable walls, which were implemented to control the continued generation of contaminated water, suppressed the groundwater inflow into buildings.
- After implementing “redirecting” measures (groundwater bypass, sub-drains, land-side impermeable walls and others) and rainwater prevention measures, including repairing damaged portions of building roofs, the amount of contaminated water generated within FY2021 declined to approx. 130 m³/day.
- Measures will continue to further reduce the amount of contaminated water generated.

*1 Values differ from those announced at the 20th Committee on Countermeasures for Contaminated Water Treatment (held on August 25, 2017) because the method of calculating the contaminated water volume generated was reviewed on March 1, 2018. Details of the review are described in the materials for the 50th and 51st meetings of the Secretariat of the Team for Countermeasures for Decommissioning and Contaminated Water Treatment.
*2: The monthly daily average is derived from the daily average from the previous Thursday to the last Wednesday, which is calculated based on the data measured at 7:00 on every Thursday.

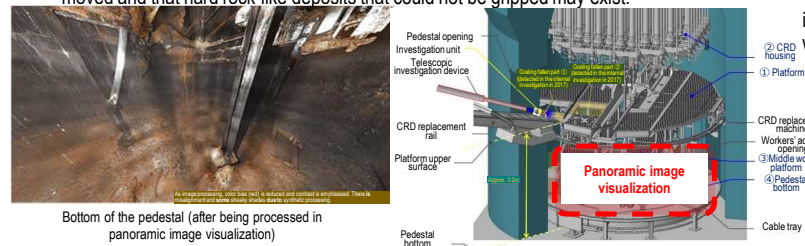
- In February 2019, an investigation touching the deposits at the bottom of the pedestal and on the platform was conducted and confirmed that the pebble-shaped deposits, etc. could be moved and that hard rock-like deposits that could not be gripped may exist.
