## Main decommissioning work and steps

Fuel removal from the spent fuel pool was completed in December 2014 at Unit 4 and on February 28, 2021 at Unit 3.  
Work continues sequentially toward the start of fuel removal from Units 1 and 2 and debris (Note 1) retrieval from Units 1-3.  
(Note 1) Fuel assemblies having melted through in the accident.

## Progress status

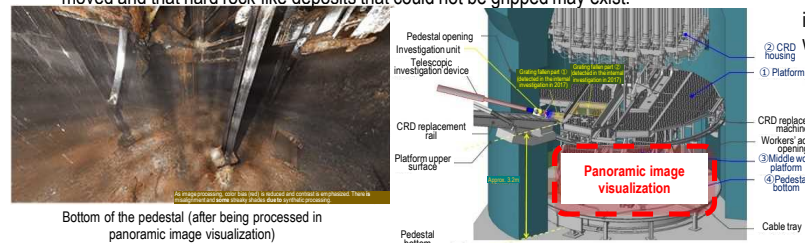
- In January 2017, a camera was inserted from the PCV penetration to inspect the conditions of the rail on which the robot traveled. The results of a series of investigations confirmed some gratings had fallen and deformed as well as a quantity of deposit inside the pedestal.

- In January 2018, the conditions below the platform inside the pedestal were investigated. Based on the analytical results of images obtained in the investigation, deposits, probably including fuel debris, were found at the bottom of the pedestal. Moreover, multiple parts exceeding the surrounding deposits were also detected. We presumed that there were multiple instances of fuel debris falling.

- In February 2019, an investigation touching the deposits at the bottom of the pedestal and on the platform was conducted and confirmed that the pebble-shaped deposits, etc. could be moved and that hard rock-like deposits that could not be gripped may exist.

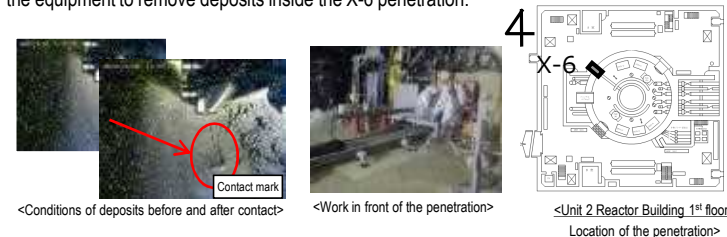
- In October 2020, as part of work to prepare for the PCV internal investigation and trial retrieval, a contact investigation to study deposits inside the penetration (X-6 penetration) was conducted, which involved inserting a guide pipe incorporating an investigative unit into the penetration. This confirmed that deposits inside the penetration had not deformed and come unstuck. The investigative information obtained will be utilized in the mockup test of the equipment to remove deposits inside the X-6 penetration.
