Main decommissioning work and steps

Progress status

I. Confirmation of the reactor conditions

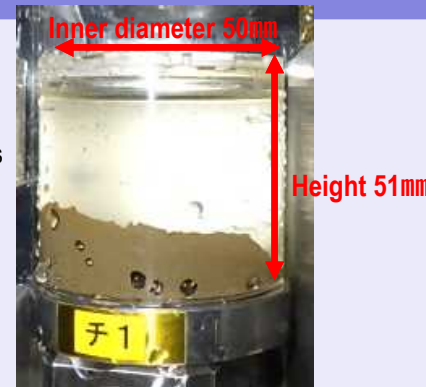
< Deposit sampling container >

Regarding the deposit samples acquired by the ROV-E investigation in the Unit 1 Primary Containment Vessel (PCV) internal investigation, deposits and supernatant in sampled PCV inclusive water will be separated and the deposits will then be transported to an external analysis institute for detailed analysis.

The external analysis institute will conduct an analysis, aiming to acquire information related to accident development by determining the types and amounts of elements and nuclides contained in samples and examining the particle generation process.
