Main decommissioning work and steps

Progress status

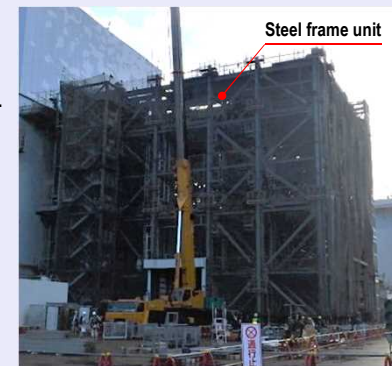
< Work on the south side of Unit 2 Reactor Building >
(August 10, 2023)

Outside the building, on the south side of the Reactor Building, assembly of the gantry part (27 units) was completed on July 13 among steel frames of the gantry for fuel removal. To install the floor on the operating floor level, concrete placement started from August 23. Regarding the remaining steel frames (18 units) of the front room, ground assembly is underway in the yard outside the site.

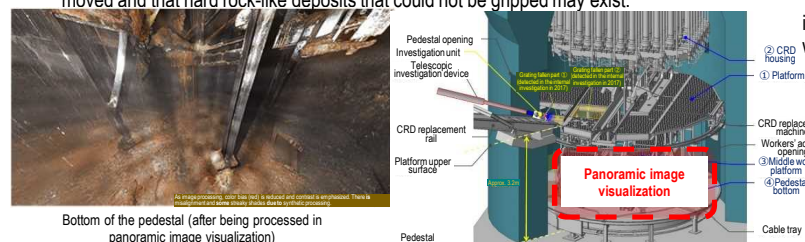
- In January 2018, the conditions below the platform inside the pedestal were investigated. Based on the analytical results of images obtained in the investigation, deposits, probably including fuel debris, were found at the bottom of the pedestal. Moreover, multiple parts exceeding the surrounding deposits were also detected. We presumed that there were multiple instances of fuel debris falling.

- In February 2019, an investigation touching the deposits at the bottom of the pedestal and on the platform was conducted and confirmed that the pebble-shaped deposits, etc. could be moved and that hard rock-like deposits that could not be gripped may exist.
