Main decommissioning work and steps

Progress status

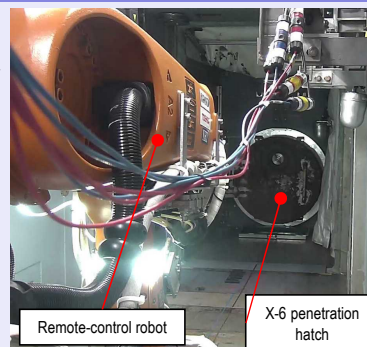
< Work to remove bolts >

On site, to open the PCV X-6 penetration hatch of PCV, work to remove 24 hatch bolts is underway. As of September 27, 21 bolts had been removed.

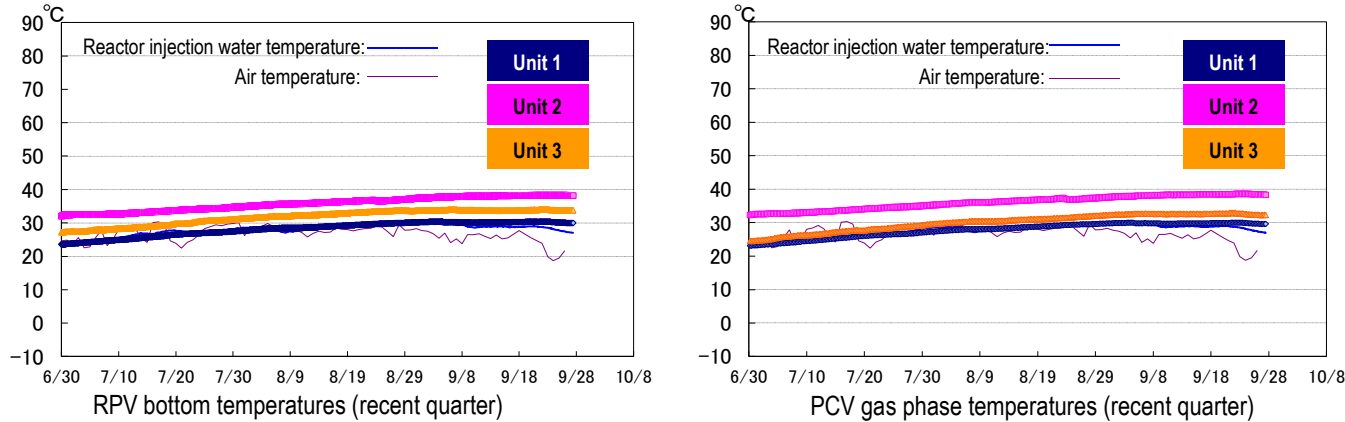
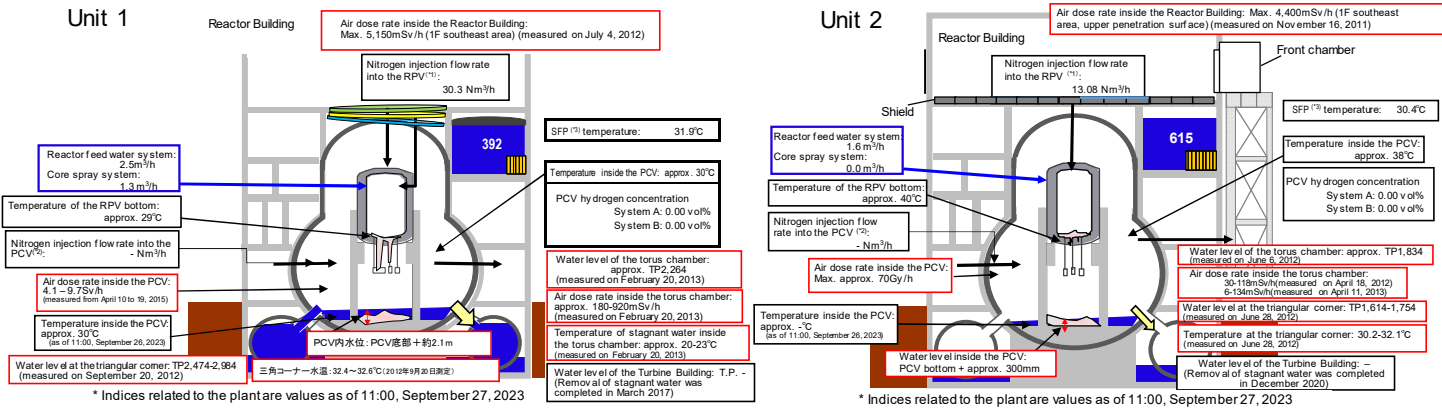
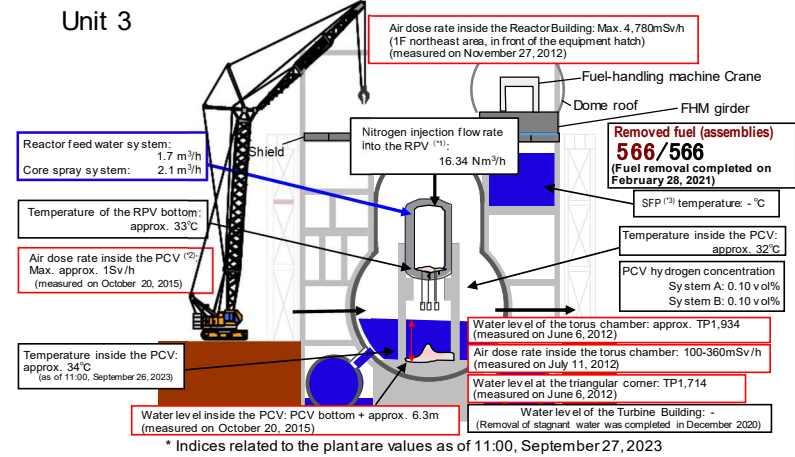
Temperatures inside the reactors

Through continuous reactor cooling by water injection, the temperatures of the Reactor Pressure Vessel (RPV) bottom and the Primary Containment Vessel (PCV) gas phase were maintained as shown below for the past month, though it varied depending on the unit and location of the thermometer.

*1 The trend graphs show part of the temperature data measured at multiple points.
*2 A part of data could not be measured due to maintenance and inspection of the facility and other work.

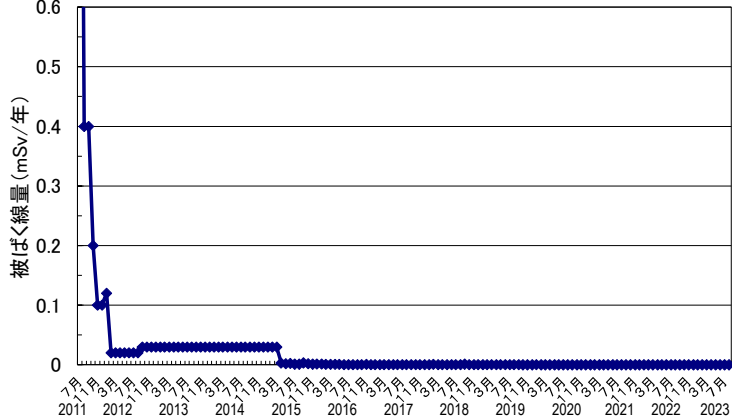
Annual radiation dose at site boundaries by radioactive materials (cesium) released from Reactor Building Units 1-4

As of August 2023, the concentration of radioactive materials newly released from Reactor Building Units 1-4 into the air and measured at the site boundary was evaluated at approx. 4.1×10^{-12} Bq/cm³ and 2.8×10^{-12} Bq/cm³ for Cs-134 and -137 respectively, while the radiation exposure dose due to the release of radioactive materials there was less than 0.00008 mSv/year.

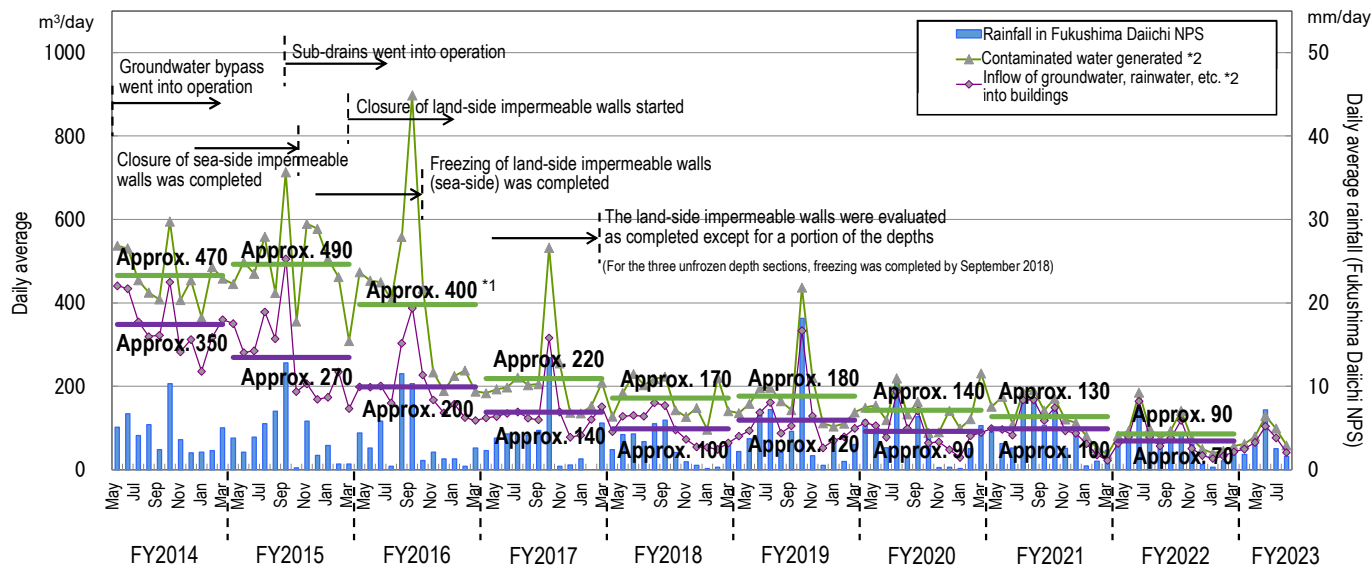
Figure 1: Changes in contaminated water generated and inflow of groundwater and rainwater into buildings

- Multi-layered measures, including pumping up by sub-drains and land-side impermeable walls, which were implemented to control the continued generation of contaminated water, suppressed the groundwater inflow into buildings.
- After implementing “redirecting” measures (groundwater bypass, sub-drains, land-side impermeable walls and others) and rainwater prevention measures, including repairing damaged portions of building roofs and due to less rainfall than in previous normal years without concentrated heavy rain of 100 mm/day or more, the amount of contaminated water generated within FY2022 declined to approx. 90 m³/day.
- Measures will continue to further reduce the amount of contaminated water generated.

*1 Values differ from those announced at the 20th Committee on Countermeasures for Contaminated Water Treatment (held on August 25, 2017) because the method of calculating the contaminated water volume generated was reviewed on March 1, 2018. Details of the review are described in the materials for the 50th and 51st meetings of the Secretariat of the Team for Countermeasures for Decommissioning and Contaminated Water Treatment.
*2: The monthly daily average is derived from the daily average from the previous Thursday to the last Wednesday, which is calculated based on the data measured at 7:00 on every Thursday.

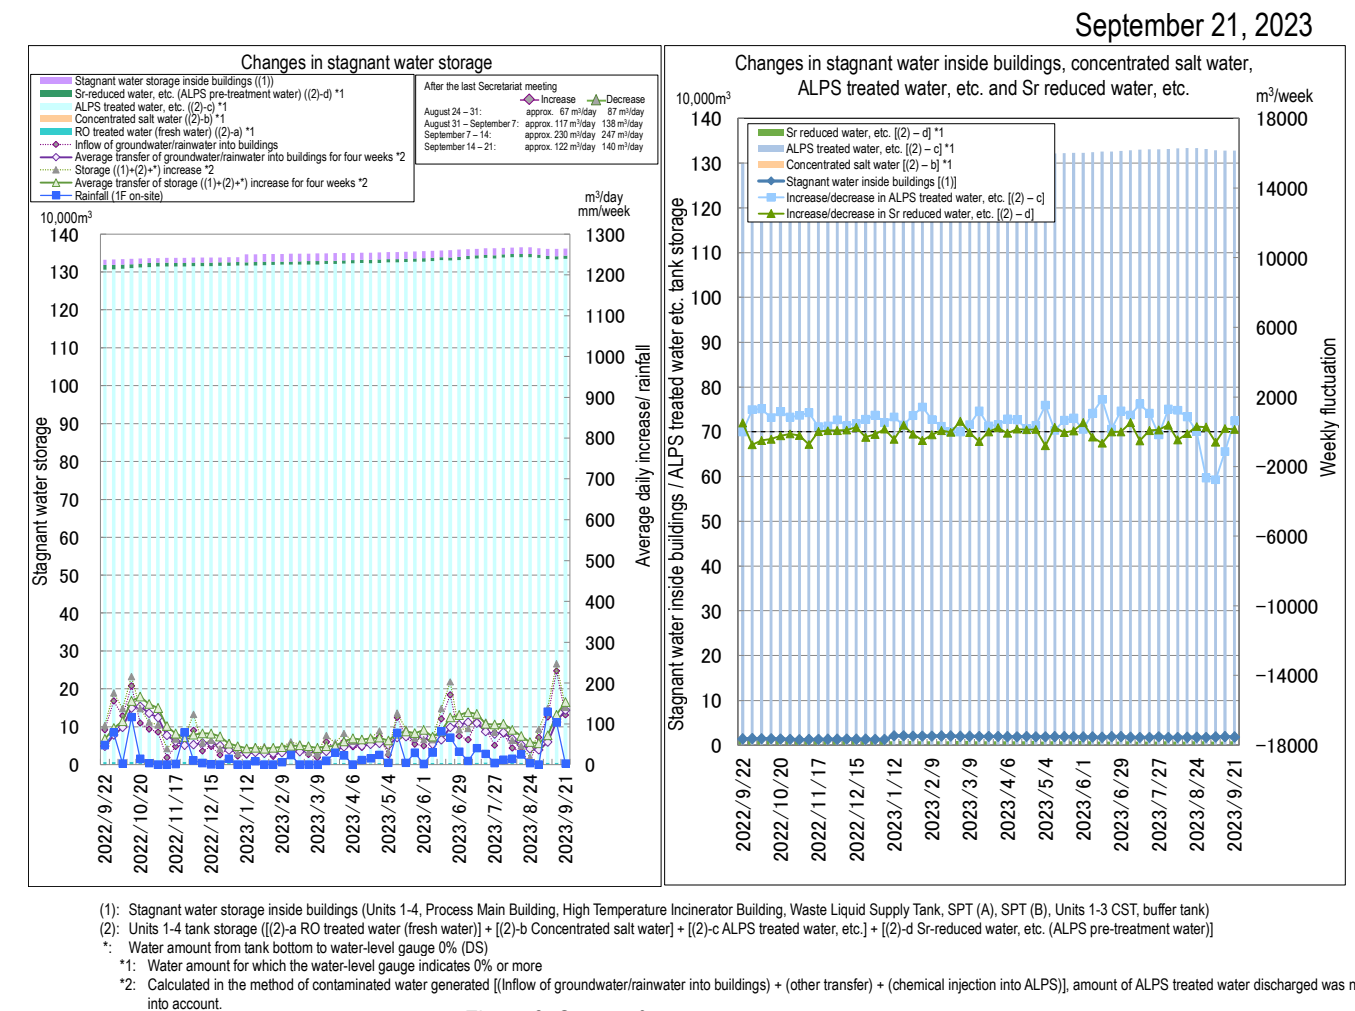
Figure 3: Status of stagnant water storage

- Amount of ALPS treated water, etc. was approx. 1,330,574 m³ as of September 21, 2023.
- Amount of ALPS treated water, discharged into the sea was approx. 7,788 m³ as of September 21, 2023.

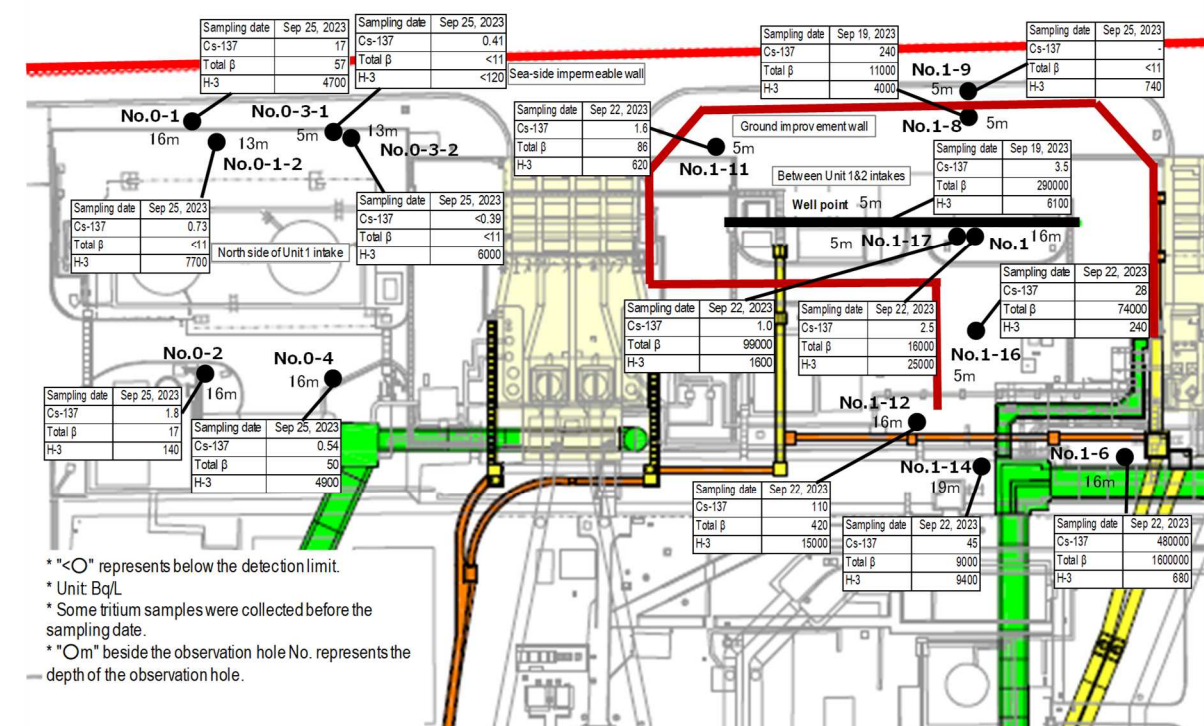
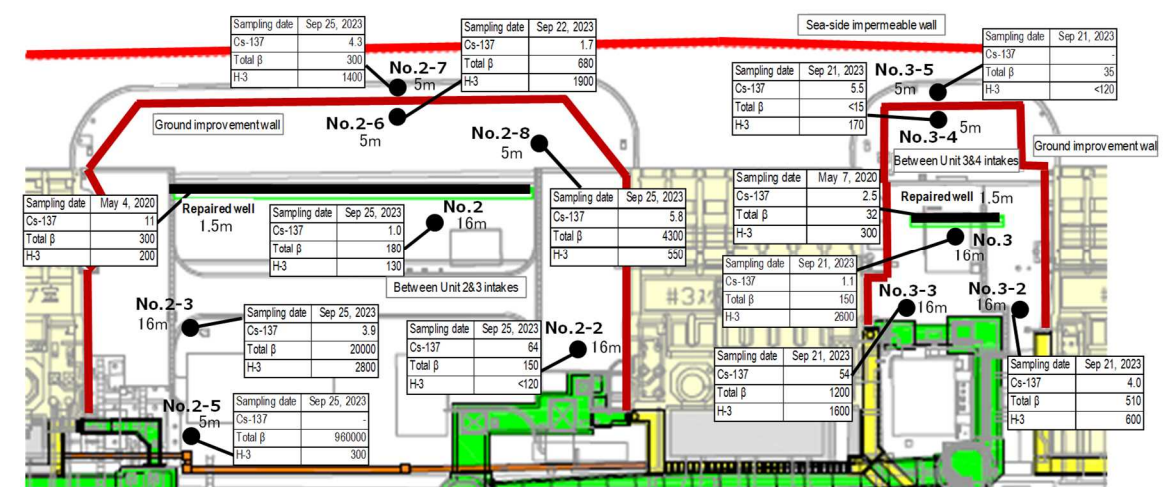
Figure 4: Groundwater concentration on the Turbine Building east side

<Unit 1 intake north side, between Unit 1 and 2 intakes>

<Between Unit 2 and 3 intakes, between Unit 3 and 4 intakes>

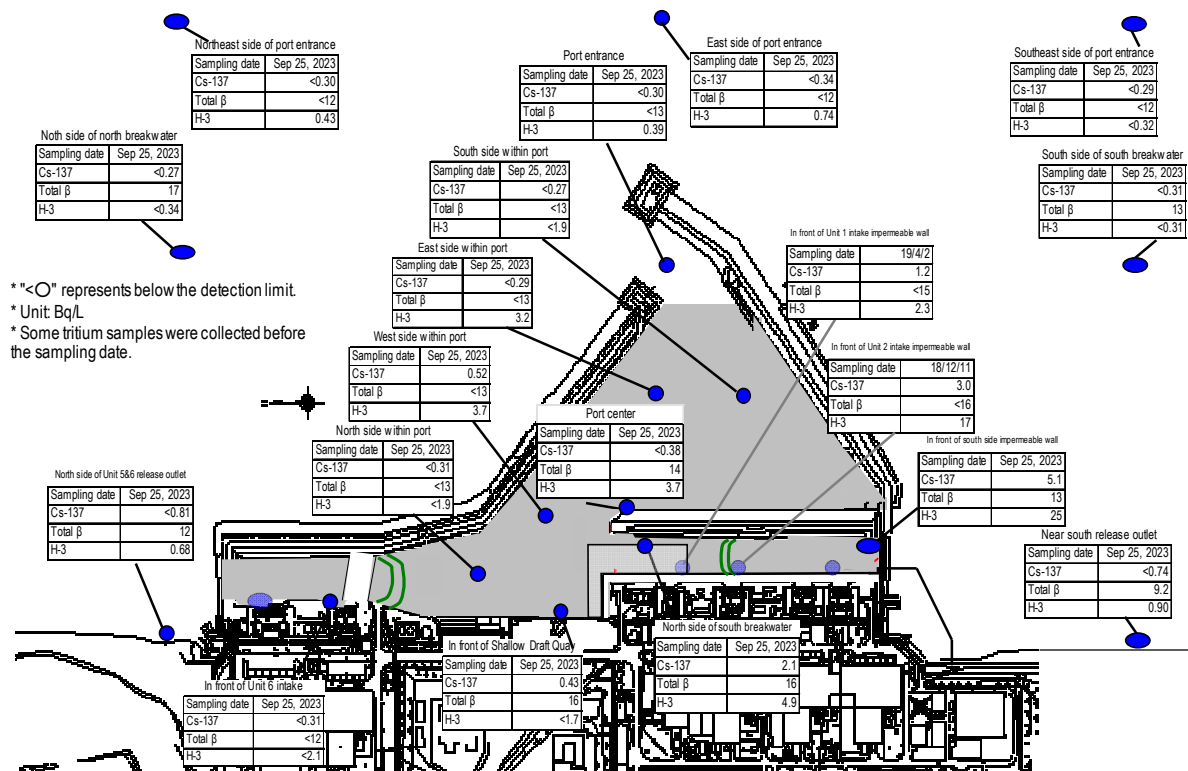
Figure 5: Seawater concentration around the port

- In the port area, the concentration of radioactive materials in seawater has remained below the legal discharge limit and has been declining long term, despite temporary increases in Cs-137 and Sr-90 observed during rainfall. They have remained below the level of those in the Units 1-4 intake open channel area and been declining following the completed installation and connection of steel pipe sheet piles for the sea-side impermeable walls.

- In the area outside the port, regarding the concentration of radioactive materials in seawater, those of Cs-137 and Sr-90 declined and remained low after steel pipe sheet piles for the sea-side impermeable walls were installed and connected. Regarding the concentration of Cs-137, a temporary increase was sometimes observed on the north side of the Unit 5 and 6 outlets and near the south outlet due to the influence of weather, marine meteorology and other factors. Regarding the concentration of Sr-90, variation was observed in FY2021 in the area outside the port (north and south outlets). Monitoring of the tendency continues, including the potential influence of the weather, marine meteorology and others.

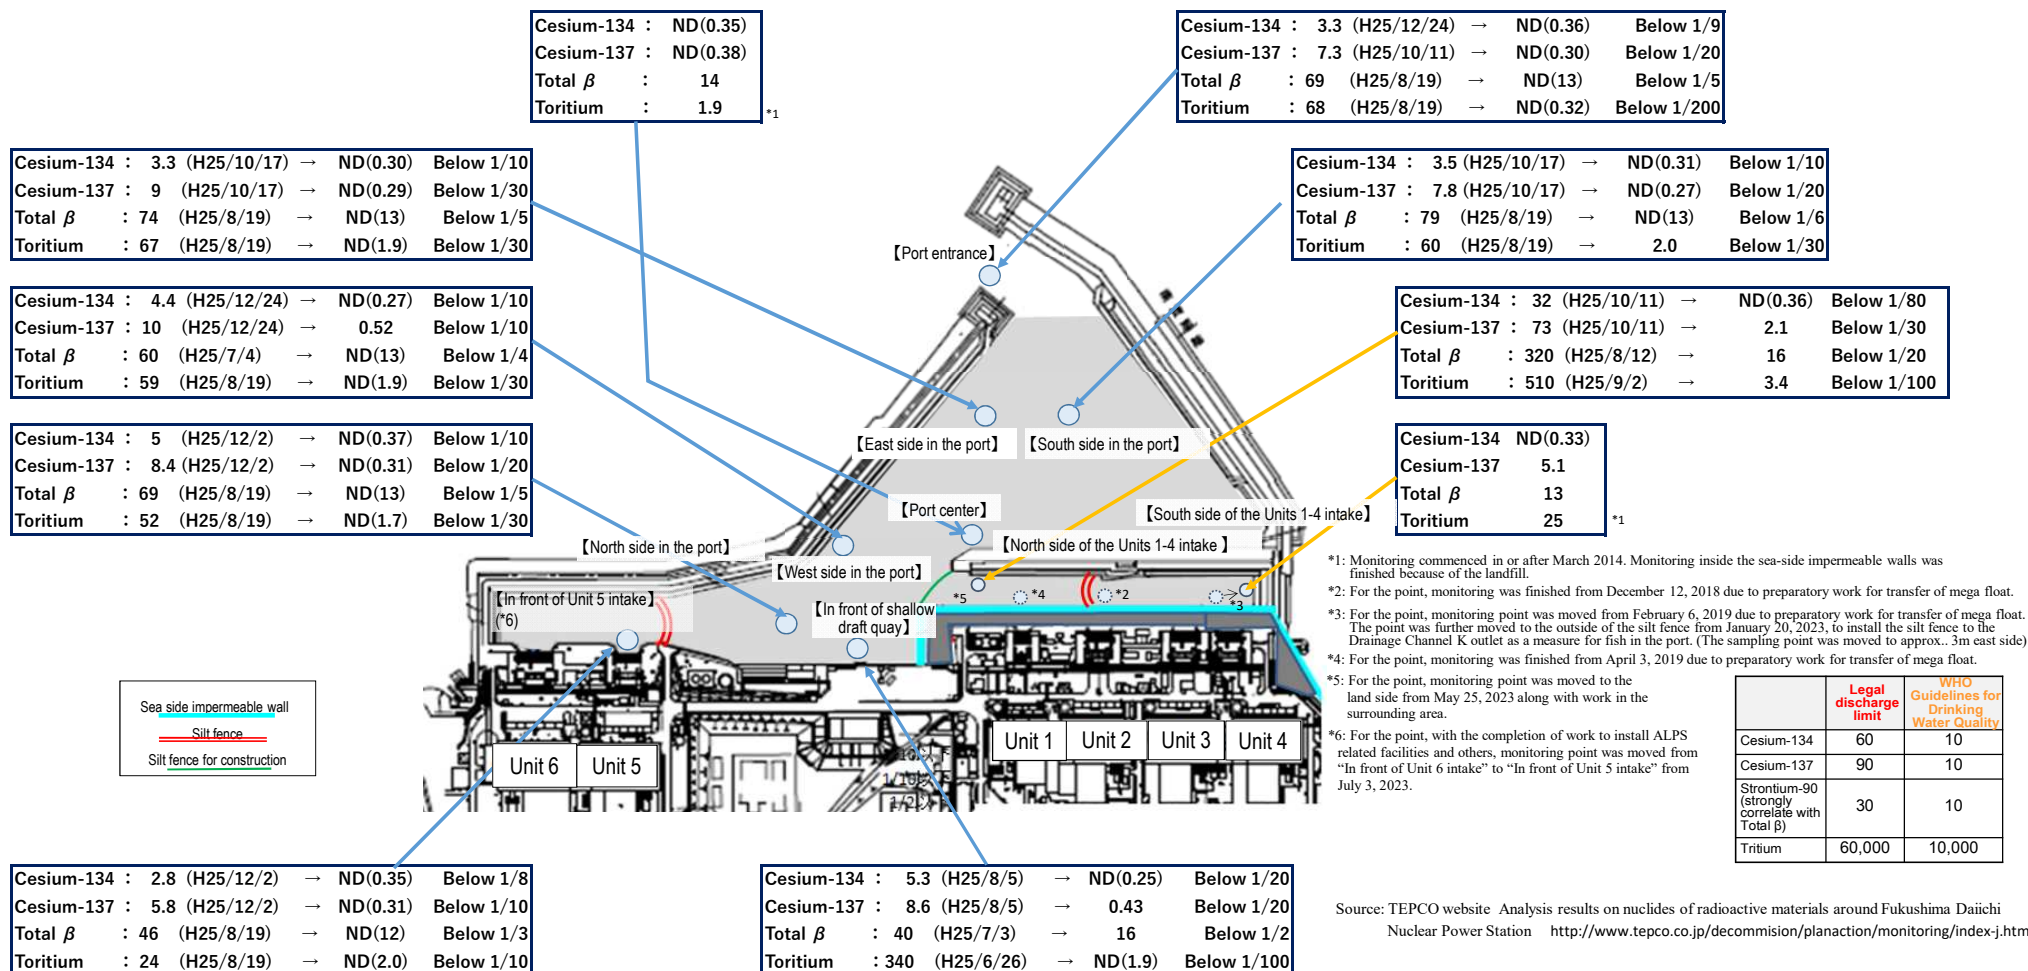
Status of seawater monitoring around outside of the port (comparison between the highest values in 2013 and the latest values)

Unit (Bq/L); ND represents a value below the detection limit; values in () represent the detection limit; ND (2013) represents ND throughout 2013 (The latest values sampled during August 21 - September 25)

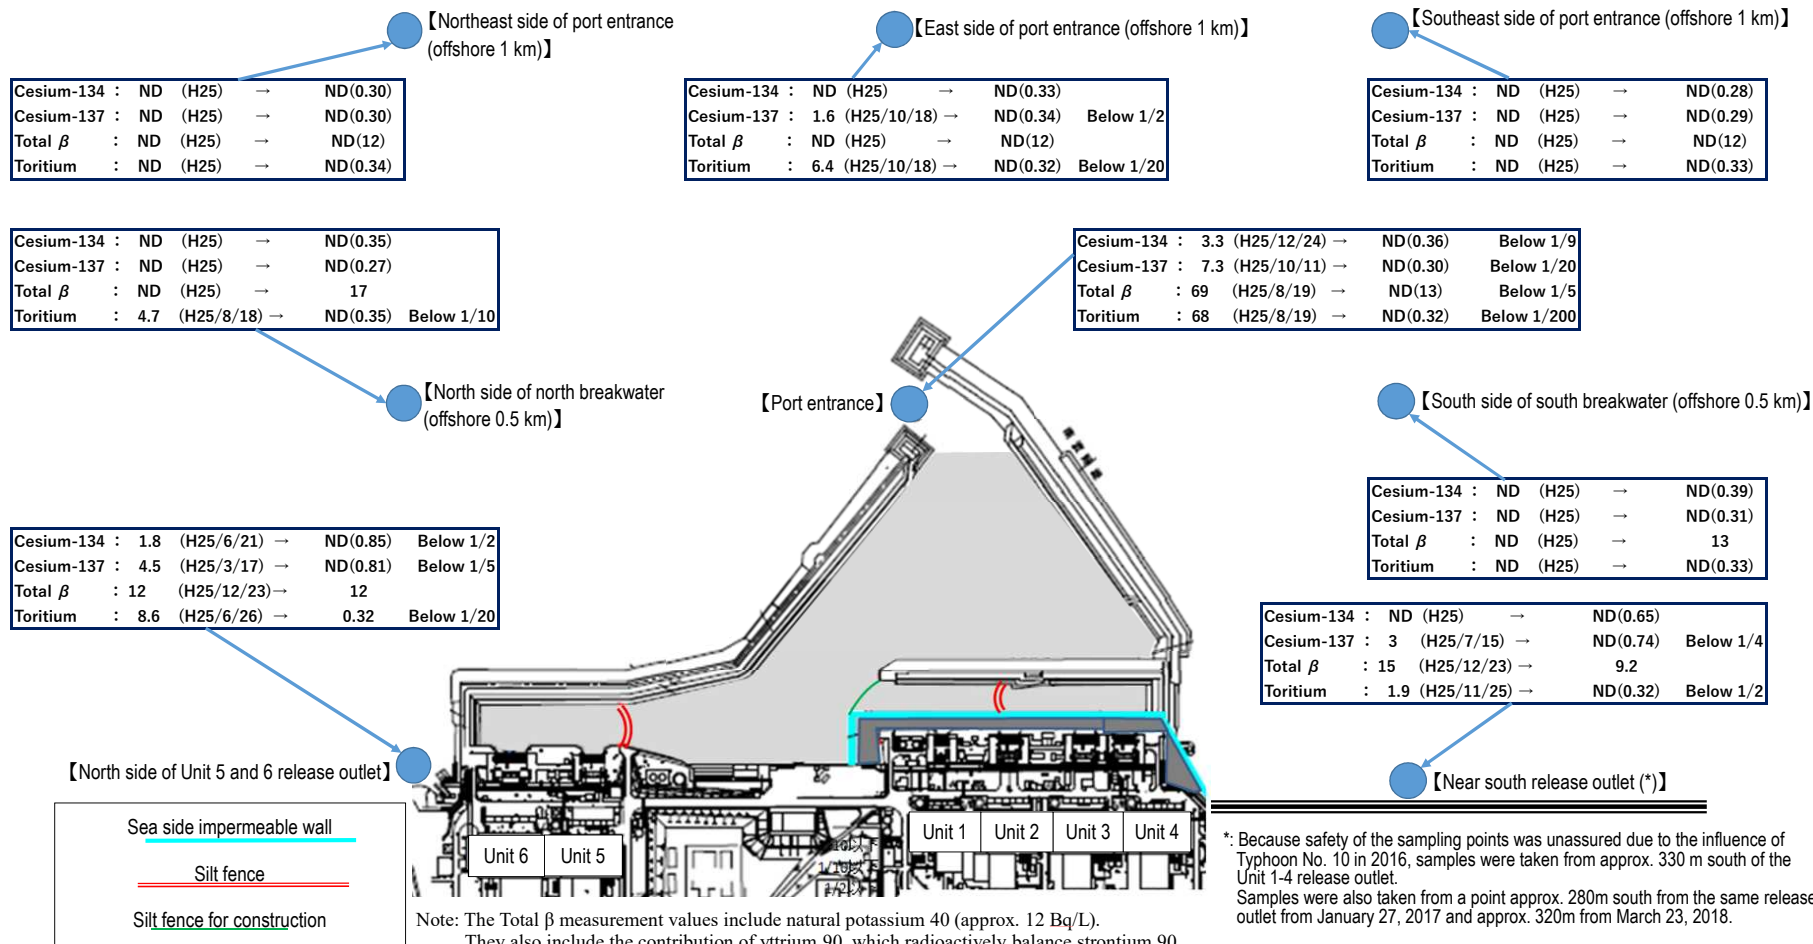
Legal discharge limit	WHO Guidelines for Drinking Water Quality
Cesium-134	60	10
Cesium-137	90	10
Strontium-90 (strongly correlate with Total β)	30	10
Tritium	60,000	10,000

*: Because safety of the sampling points was unassured due to the influence of Typhoon No. 10 in 2016, samples were taken from approx. 330 m south of the Unit 1-4 release outlet. Samples were also taken from a point approx. 280m south from the same release outlet from January 27, 2017 and approx. 320m from March 23, 2018.

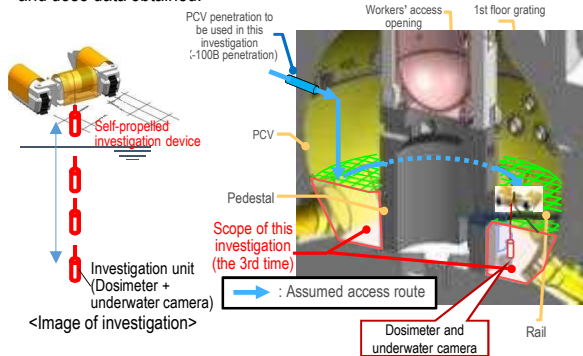
- In April 2015, a device having entered the inside of the PCV via a narrow opening (bore: $\phi 100$ mm) collected information such as images and airborne dose inside the PCV 1st floor.
- In March 2017, an investigation using a self-propelled investigation device was conducted to inspect the spreading of debris to the basement floor outside the pedestal, with images taken of the PCV bottom status for the first time. The conditions inside the PCV will continue to be examined, based on the imagery and dose data obtained.

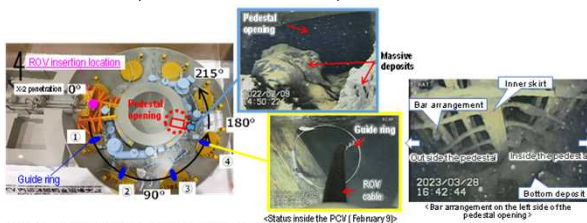
In February 2022, the guide ring* was installed to facilitate the investigation. From March 28, 2023, the investigation inside the pedestal by ROV-A2 started and confirmed that a portion of the bar arrangement was exposed. Regarding the soundness of the pedestal, based on the past earthquake resistant evaluation by the International Research Institute for Nuclear Decommissioning (IRID), it was evaluated that even though a portion of the pedestal was lost, there would be no serious risk. However, as the present information is very limited, the investigation will continue to acquire as much information as possible for continued evaluation.

Investigations inside the PCV	1st (2012.10)	<ul style="list-style-type: none">- Acquiring images- Measuring the air temperature and dose rate- Measuring the water level and temperature- Sampling stagnant water- Installing permanent monitoring instrumentation
	2nd (2015.4)	<ul style="list-style-type: none">- Confirming the status of the PCV 1st floor- Acquiring images- Measuring the air temperature and dose rate- Replacing permanent monitoring instrumentation
	3rd (2017.3)	<ul style="list-style-type: none">- Confirming the status of the PCV 1st basement floor- Acquiring images- Measuring the dose rate- Sampling deposit- Replacing permanent monitoring instrumentation
	4th (From 2022.2)	<ul style="list-style-type: none">- Acquiring information inside PCV (inside/outside of the pedestal)- Acquiring images- Measuring deposit thickness and sampling deposit- Detecting deposit debris, 3D mapping
Leakage points from PCV	<ul style="list-style-type: none">- PCV vent pipe vacuum break line bellows (identified in 2014.5)- Sand cushion drain line (identified in 2013.11)

- The Unit 1 PCV internal investigation revealed damage to the pedestal base concrete. However, the inner skirt embedded in the pedestal remained sufficiently strong by itself, even at an assumed earthquake of around Ss900. The remaining pedestal and inner skirt were thus deemed capable of supporting the upper pedestal structure.

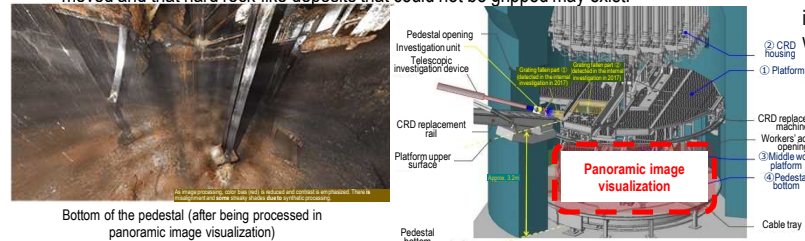
- In January 2017, a camera was inserted from the PCV penetration to inspect the conditions of the rail on which the robot traveled. The results of a series of investigations confirmed some gratings had fallen and deformed as well as a quantity of deposit inside the pedestal.

- In January 2018, the conditions below the platform inside the pedestal were investigated. Based on the analytical results of images obtained in the investigation, deposits, probably including fuel debris, were found at the bottom of the pedestal. Moreover, multiple parts exceeding the surrounding deposits were also detected. We presumed that there were multiple instances of fuel debris falling.

- In February 2019, an investigation touching the deposits at the bottom of the pedestal and on the platform was conducted and confirmed that the pebble-shaped deposits, etc. could be moved and that hard rock-like deposits that could not be gripped may exist.

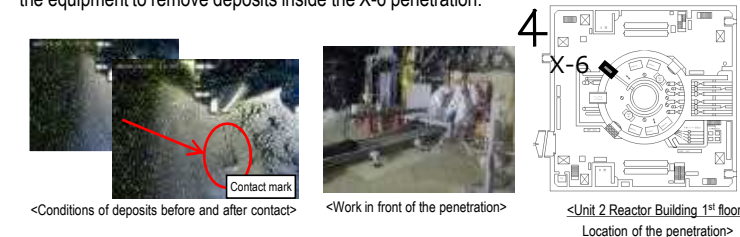
Unit 2 PCV internal investigation

- In October 2020, as part of work to prepare for the PCV internal investigation and trial retrieval, a contact investigation to study deposits inside the penetration (X-6 penetration) was conducted, which involved inserting a guide pipe incorporating an investigative unit into the penetration. This confirmed that deposits inside the penetration had not deformed and come unstuck. The investigative information obtained will be utilized in the mockup test of the equipment to remove deposits inside the X-6 penetration.

Investigations inside the PCV	1st (2012.1)	- Acquiring images - Measuring the air temperature
	2nd (2012.3)	- Confirming water surface - Measuring the water temperature - Measuring the dose rate
	3rd (2013.2 - 2014.6)	- Acquiring images - Sampling stagnant water - Measuring water level - Installing permanent monitoring instrumentation
	4th (2017.1-2)	- Acquiring images - Measuring the dose rate - Measuring the air temperature
	5th (2018.1)	- Acquiring images - Measuring the dose rate - Measuring the air temperature
	6th (2019.2)	- Acquiring images - Measuring the dose rate - Measuring the air temperature - Determining characteristics of a portion of deposit
Leakage points from PCV	- No leakage from the torus chamber rooftop - No leakage from any internal/external surfaces of S/C	
<u>Evaluation of the location of fuel debris inside the reactor by measurement using muons</u> The existence of high-density materials, which were considered to constitute fuel debris, was confirmed at the bottom of RPV and in the lower part and outer periphery of the reactor core. It was assumed that a significant portion of fuel debris existed at the bottom of RPV. (2016.3-7)

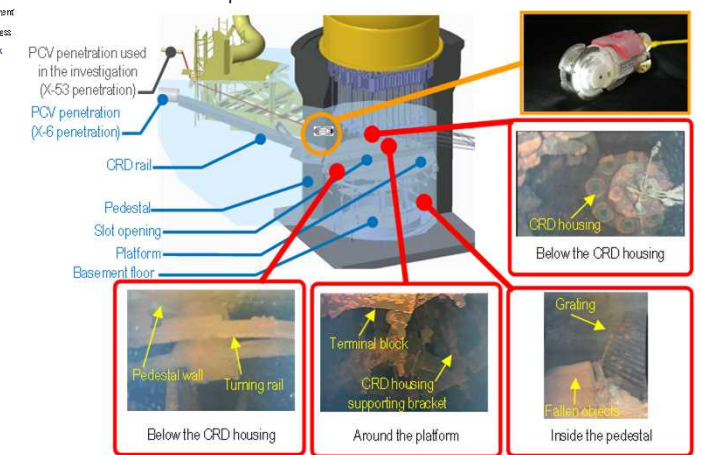
<Conditions inside the pedestal>

- In July 2017, the inside of the PCV was investigated using the underwater ROV (remotely operated underwater vehicle) to inspect the inside of the pedestal. Analysis of the imagery obtained in the investigation identified damage to multiple structures and the supposed core internals.

- Videos obtained in the investigation were reproduced in 3D. Based on the reproduced images, the relative positions of the structures, such as the rotating platform slipping off the rail with a portion buried in deposits, were visually understood.
