Main decommissioning work and steps

Progress status

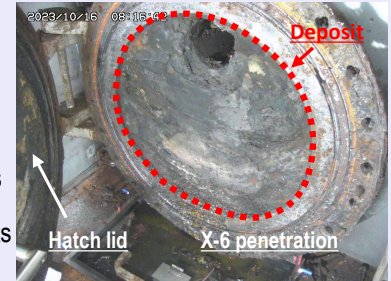
< Status after opening the X-6 penetration hatch >

Cutting and removal of all bolts and nuts, which secured the X-6 penetration hatch, was completed on October 12. Subsequently, the hatch was opened on October 16 and deposits covering around the inlet were detected.

At present, preparation for removing deposits inside X-6 penetration is underway.

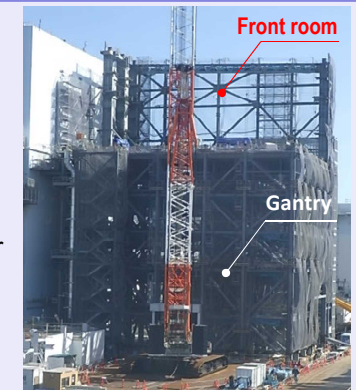
< Work on the south side of Unit 2 Reactor Building >
(October 6, 2023)

Outside the building, on the south side of the Reactor Building, installation of the concrete gantry floor was completed and work to install the front room has been underway. As of October 24, installation of 39 (among 45) units of the gantry for Unit 2 fuel removal was completed.

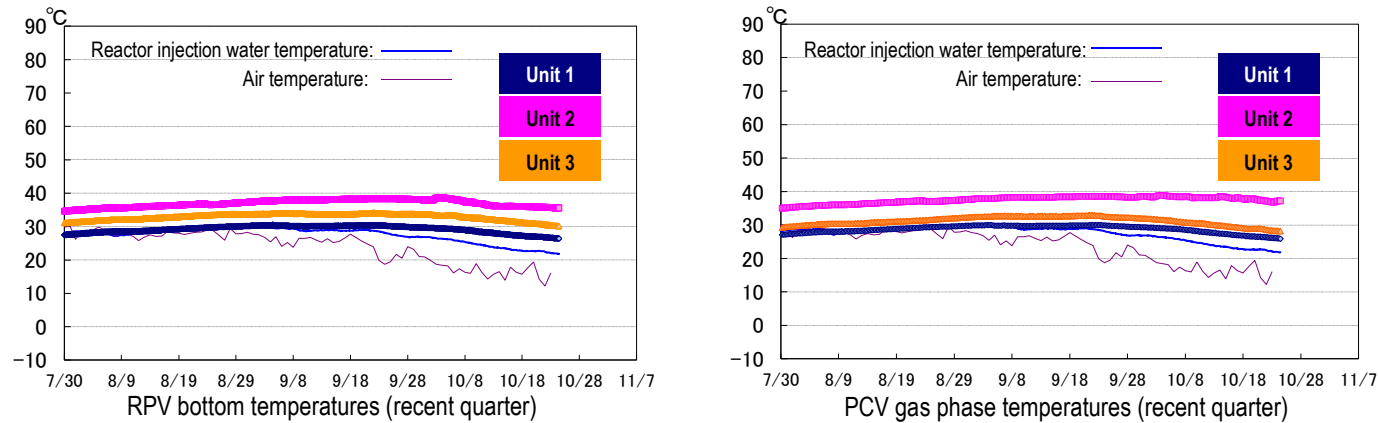
Through continuous reactor cooling by water injection, the temperatures of the Reactor Pressure Vessel (RPV) bottom and the Primary Containment Vessel (PCV) gas phase were maintained as shown below for recent, though it varied depending on the unit and location of the thermometer.

*1 The trend graphs show part of the temperature data measured at multiple points.

*2 A part of data could not be measured due to maintenance and inspection of the facility and other work.

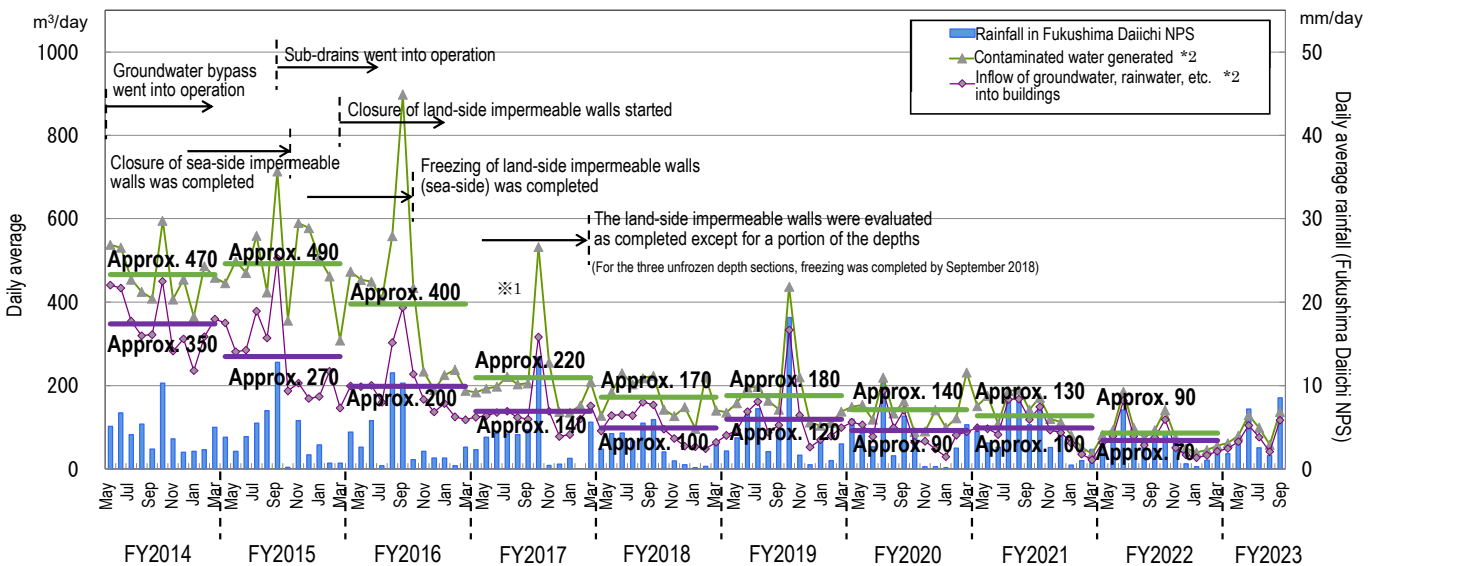
Figure 1: Changes in contaminated water generated and inflow of groundwater and rainwater into buildings

- Multi-layered measures, including pumping up by sub-drains and land-side impermeable walls, which were implemented to control the continued generation of contaminated water, suppressed the groundwater inflow into buildings.
- After implementing “redirecting” measures (groundwater bypass, sub-drains, land-side impermeable walls and others) and rainwater prevention measures, including repairing damaged portions of building roofs and due to less rainfall than in previous normal years without concentrated heavy rain of 100 mm/day or more, the amount of contaminated water generated within FY2022 declined to approx. 90 m³/day.
- Measures will continue to further reduce the amount of contaminated water generated.

*1 Values differ from those announced at the 20th Committee on Countermeasures for Contaminated Water Treatment (held on August 25, 2017) because the method of calculating the contaminated water volume generated was reviewed on March 1, 2018. Details of the review are described in the materials for the 50th and 51st meetings of the Secretariat of the Team for Countermeasures for Decommissioning and Contaminated Water Treatment.

*2: The monthly daily average is derived from the daily average from the previous Thursday to the last Wednesday, which is calculated based on the data measured at 7:00 on every Thursday.

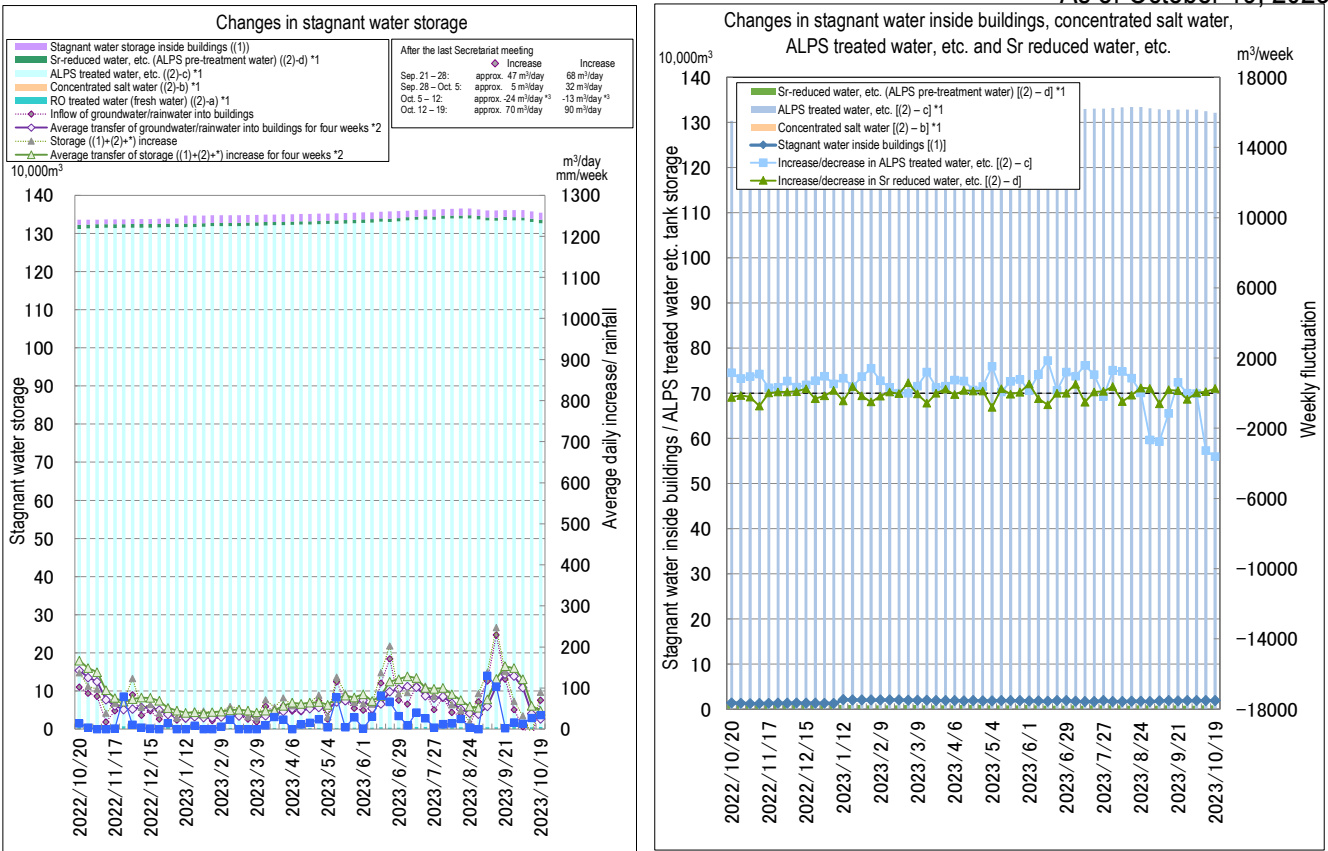
- Storage status of contaminated water and amount of ALPS treated water, etc. stored in tanks
- Amount of ALPS treated water, etc. was approx. 1,323,658 m³ as of October 19, 2023.

- Amount of ALPS treated water, discharged into the sea was approx. 15,599 m³ as of October 24, 2023. As of October 19, 2023

(1): Stagnant water storage inside buildings (Units 1-4, Process Main Building, High Temperature Incinerator Building, Waste Liquid Supply Tank, SPT (A), SPT (B), Units 1-3 CST, buffer tank)

(2): Units 1-4 tank storage ((2)-a RO treated water (fresh water)) + ((2)-b Concentrated salt water) + ((2)-c ALPS treated water, etc.) + ((2)-d Sr-reduced water, etc. (ALPS pre-treatment water))
*: Water amount from tank bottom to water-level gauge 0% (DS)
*1: Water amount for which the water-level gauge indicates 0% or more
*2: Calculated in the method of contaminated water generated ((inflow of groundwater/rainwater into buildings) + (other transfer) + (chemical injection into ALPS)), amount of ALPS treated water discharged was not taken into account.

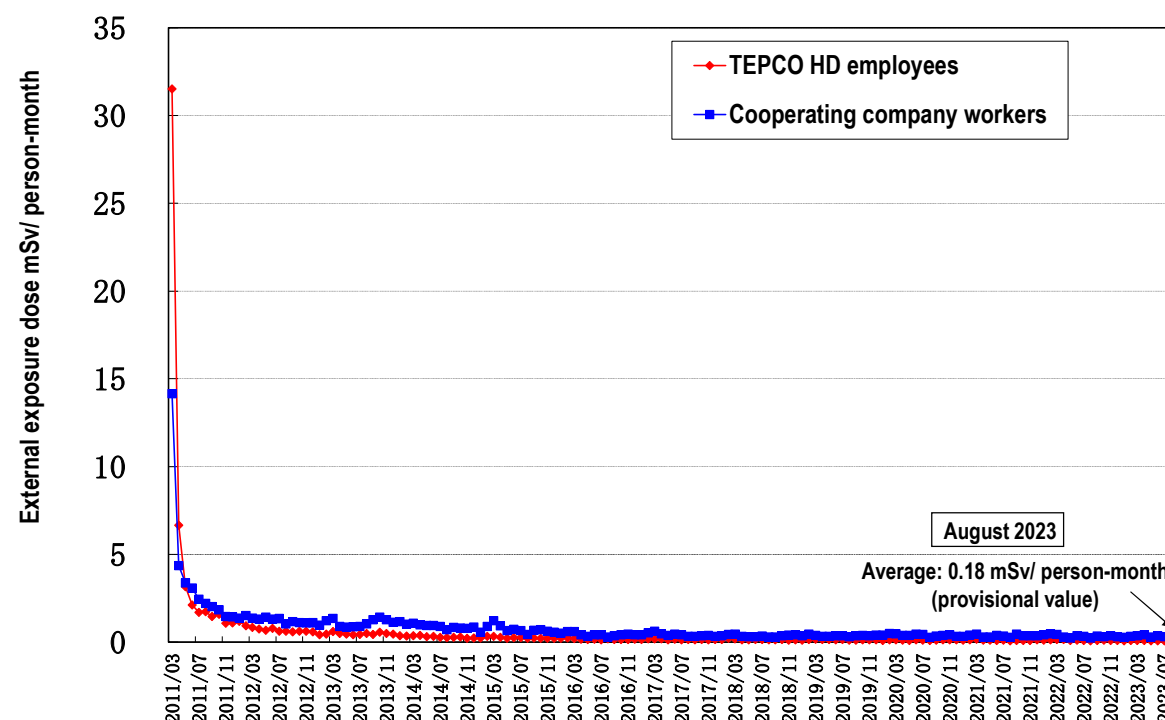
Figure 7: Changes in monthly average exposure dose of individual worker (monthly exposure dose since March 2011)

- The average exposure doses of workers were approx. 2.60, 2.51 and 2.16 mSv/person-year during FY2020, 2021 and 2022, respectively (The legal exposure dose limits are 100 and 50 mSv/person-year respectively over five years, the TEPCO HD management target is 20 mSv/person-year).
- For most workers, the exposure dose remained sufficiently within the limit and allowed them to continue engaging in radiation work.

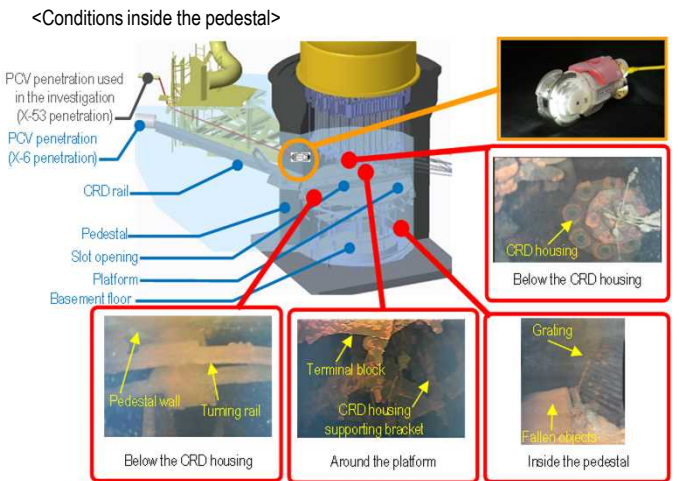
Unit 3 PCV internal investigation

- In October 2014, the conditions of X-53 penetration, which may be under water and which is scheduled for use to investigate the inside of the PCV, was investigated via remote-controlled ultrasonic test equipment. The results showed that the penetration was not under water.

- In October 2015, to confirm the conditions inside the PCV, an investigative device was inserted into the PCV from X-53 penetration to obtain images, data on dosage and temperature and sample stagnant water. No damage to the structure and walls inside the PCV was identified and the water level was almost identical to estimated values. In addition, the dose inside the PCV was confirmed to be lower than in other Units.

- In July 2017, the inside of the PCV was investigated using the underwater ROV (remotely operated underwater vehicle) to inspect the inside of the pedestal. Analysis of the imagery obtained in the investigation identified damage to multiple structures and the supposed core internals.

- Videos obtained in the investigation were reproduced in 3D. Based on the reproduced images, the relative positions of the structures, such as the rotating platform slipping off the rail with a portion buried in deposits, were visually understood.
