## Main decommissioning work and steps

Fuel removal from the spent fuel pool was completed in December 2014 at Unit 4 and on February 28, 2021 at Unit 3.  
Work continues sequentially toward the start of fuel removal from Units 1 and 2 and debris (Note 1) retrieval from Units 1-3.

# TEPCO Holdings Fukushima Daiichi Nuclear Power Station Site Layout

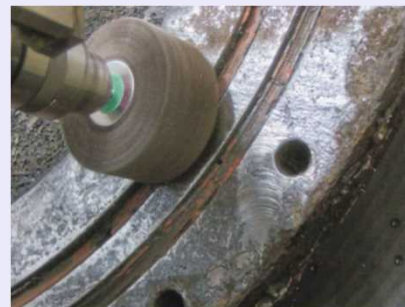
< Cleaning of X-6 penetration flange surface >

Regarding X-6 penetration, cleaning of the X-6 penetration flange surface was completed before removing deposit. Toward future deposit removal inside X-6 penetration, installation of the equipment and other related work is underway.

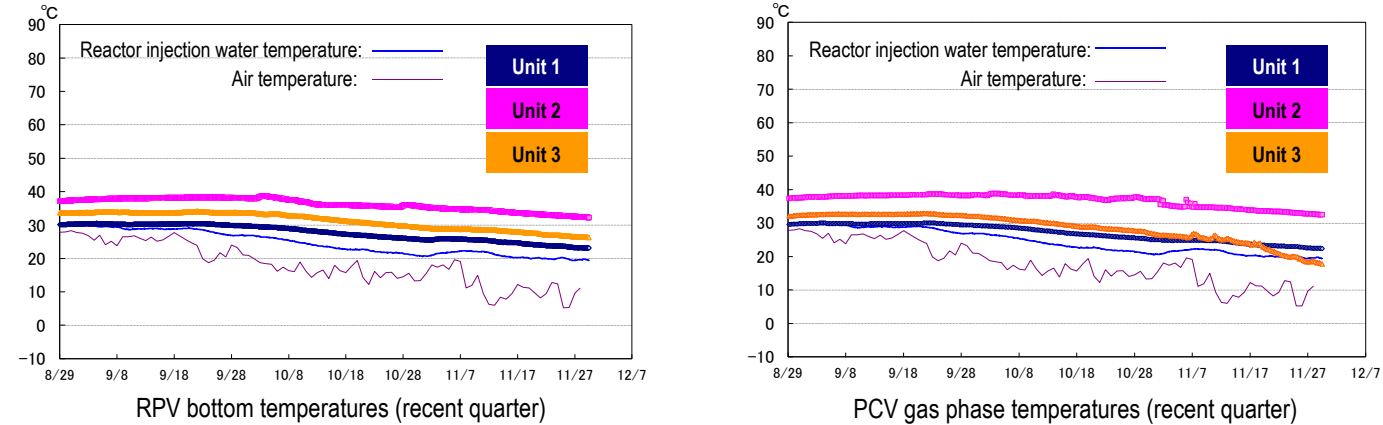
Through continuous reactor cooling by water injection, the temperatures of the Reactor Pressure Vessel (RPV) bottom and the Primary Containment Vessel (PCV) gas phase were maintained as shown below for recent, though it varied depending on the unit and location of the thermometer.

\*1 The trend graphs show part of the temperature data measured at multiple points.  
\*2 A part of data could not be measured due to maintenance and inspection of the facility and other work.

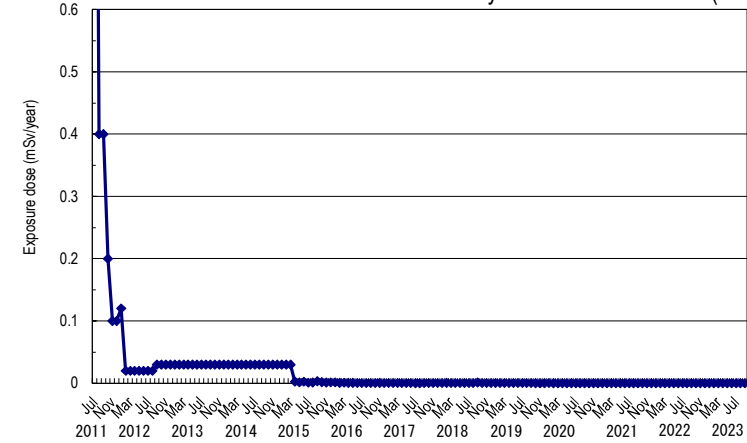
### Annual radiation dose at site boundaries by radioactive materials (cesium) released from Reactor Building Units 1-4

As of October 2023, the concentration of radioactive materials newly released from Reactor Building Units 1-4 into the air and measured at the site boundary was evaluated at approx.  $2.3 \times 10^{-12}$  Bq/cm<sup>3</sup> and  $1.7 \times 10^{-12}$  Bq/cm<sup>3</sup> for Cs-134 and -137 respectively, while the radiation exposure dose due to the release of radioactive materials there was less than 0.00004 mSv/year.

\* The concentration limit of radioactive materials in the air outside the surrounding monitoring area:  
[Cs-134]:  $2 \times 10^{-5}$  Bq/cm<sup>3</sup>  
[Cs-137]:  $3 \times 10^{-5}$  Bq/cm<sup>3</sup>  
\* Data of Monitoring Posts (MP1-MP8).  
Data of Monitoring Posts (MPs) measuring the air dose rate around the site boundary showed 0.306–1.029 μSv/h (October 25–November 28, 2023).  
To measure the variation in the air dose rate of MP2-MP8 more accurately, work to improve the environment (trimming trees, removing surface soil and shielding around the MPs) was completed.

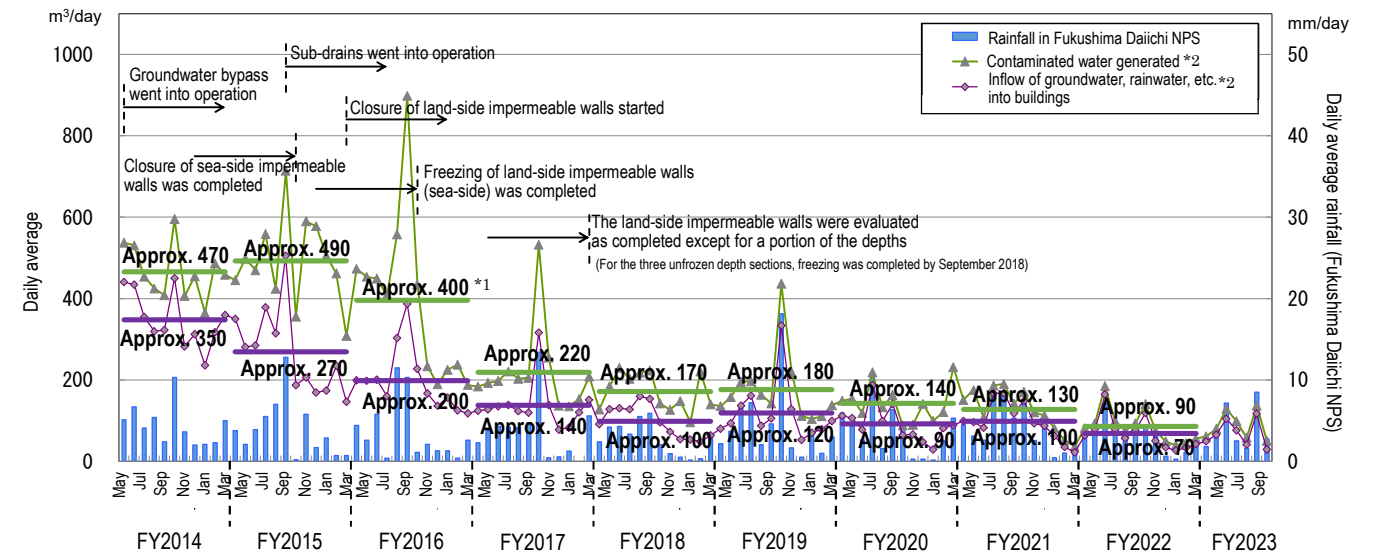
Figure 1: Changes in contaminated water generated and inflow of groundwater and rainwater into buildings

- Multi-layered measures, including pumping up by sub-drains and land-side impermeable walls, which were implemented to control the continued generation of contaminated water, suppressed the groundwater inflow into buildings.
- After implementing “redirecting” measures (groundwater bypass, sub-drains, land-side impermeable walls and others) and rainwater prevention measures, including repairing damaged portions of building roofs and due to less rainfall than in previous normal years without concentrated heavy rain of 100 mm/day or more, the amount of contaminated water generated within FY2022 declined to approx. 90 m<sup>3</sup>/day.
- Measures will continue to further reduce the amount of contaminated water generated.

\*1 Values differ from those announced at the 20th Committee on Countermeasures for Contaminated Water Treatment (held on August 25, 2017) because the method of calculating the contaminated water volume generated was reviewed on March 1, 2018. Details of the review are described in the materials for the 50th and 51st meetings of the Secretariat of the Team for Countermeasures for Decommissioning and Contaminated Water Treatment.

\*2: The monthly daily average is derived from the daily average from the previous Thursday to the last Wednesday, which is calculated based on the data measured at 7:00 on every Thursday.

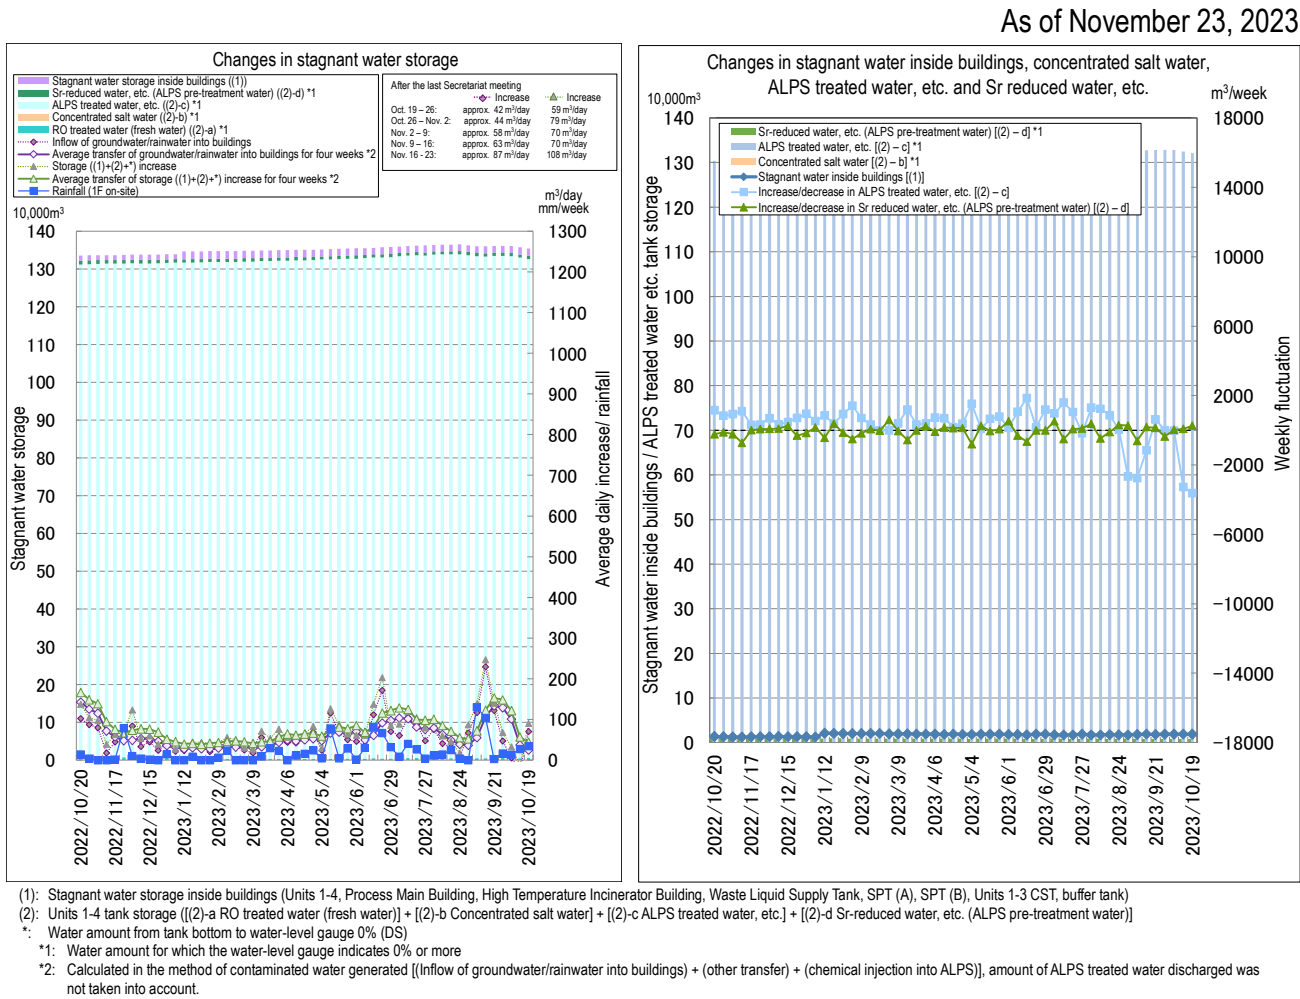
Figure 3: Status of stagnant water storage

- Storage status of contaminated water and amount of ALPS treated water, etc. stored in tanks
- The amount of ALPS treated water, etc. was approx. 1,315,233 m³ as of November 23, 2023.

- The amount of ALPS treated water discharged into the sea was approx. 23,353 m³ as of November 21, 2023.

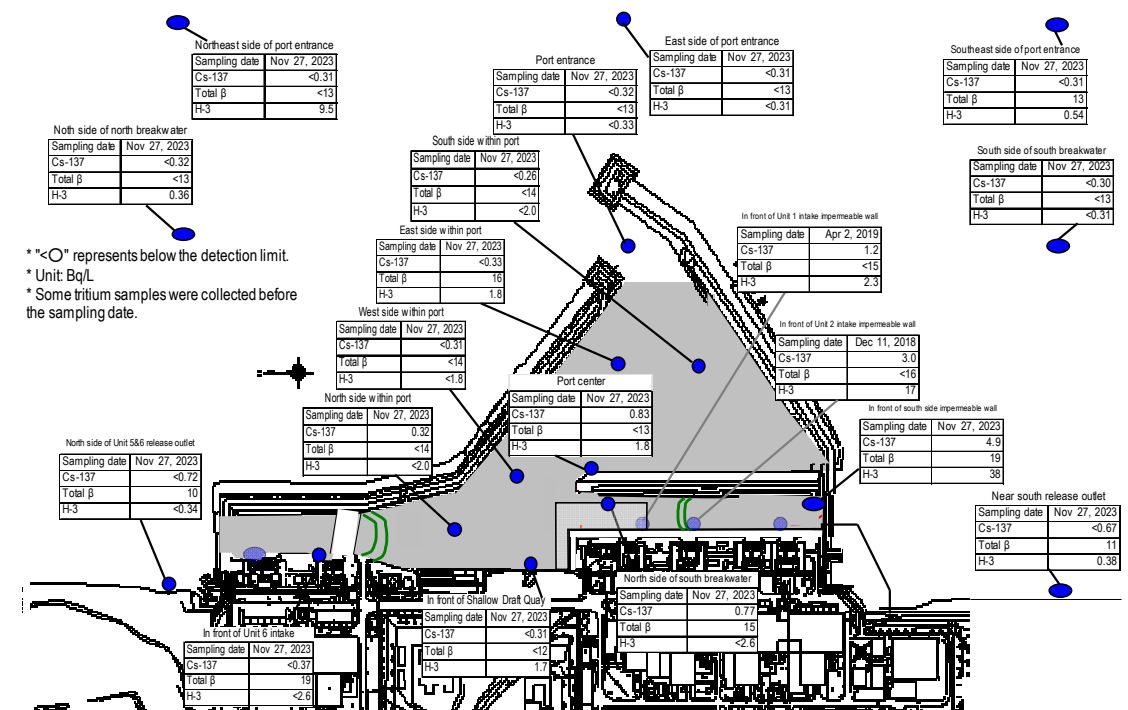
Figure 5: Seawater concentration around the port

- In the open channel area of seawater intake for Units 1 to 4, the concentration of radioactive materials in seawater has remained below the legal discharge limit and been declining long term, despite the temporary increases in Cs-137 and Sr-90 observed during rainfall. They have also been declining following the completed installation and the connection of steel pipe sheet piles for the sea-side impermeable walls. The concentration of Cs-137 remained slightly higher in front of the south-side impermeable walls and slightly lower on the north side of the east breakwater since March 20, 2019, when the silt fence was transferred to the center of the open channel due to mega float-related construction.

- In the port area, the concentration of radioactive materials in seawater has remained below the legal discharge limit and has been declining long term, despite temporary increases in Cs-137 and Sr-90 observed during rainfall. They have remained below the level of those in the Units 1-4 intake open channel area and been declining following the completed installation and connection of steel pipe sheet piles for the sea-side impermeable walls.

- In the area outside the port, regarding the concentration of radioactive materials in seawater, those of Cs-137 and Sr-90 declined and remained low after steel pipe sheet piles for the sea-side impermeable walls were installed and connected. Regarding the concentration of Cs-137, a temporary increase was sometimes observed on the north side of the Unit 5 and 6 outlets and near the south outlet due to the influence of weather, marine meteorology and other factors. Regarding the concentration of Sr-90, variation was observed in FY2021 in the area outside the port (north and south outlets). Monitoring of the tendency continues, including the potential influence of the weather, marine meteorology and others. During the period of discharge of ALPS treated water, concentration of tritium increased at the sampling point near the discharge outlet, but the increase was considered as within the assumed range based on the results of the oceanic dispersion simulation.

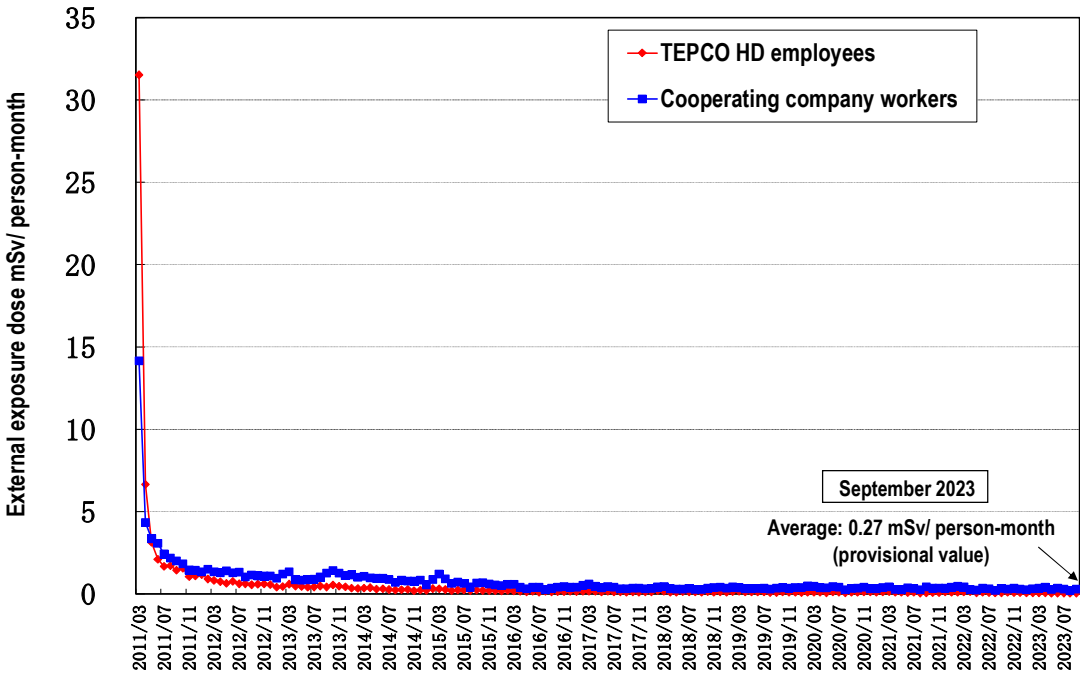
Figure 7: Changes in monthly average exposure dose of individual worker (monthly exposure dose since March 2011)

- The average exposure doses of workers were approx. 2.60, 2.51 and 2.16 mSv/person-year during FY2020, 2021 and 2022, respectively (The legal exposure dose limits are 100 mSv/person and 50 mSv/person-year over five years, the TEPCO HD management target is 20 mSv/person-year).

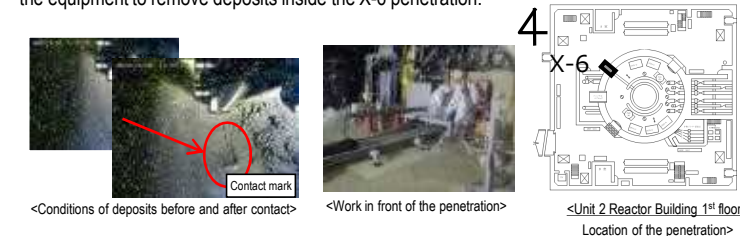
- In October 2020, as part of work to prepare for the PCV internal investigation and trial retrieval, a contact investigation to study deposits inside the penetration (X-6 penetration) was conducted, which involved inserting a guide pipe incorporating an investigative unit into the penetration. This confirmed that deposits inside the penetration had not deformed and come unstuck. The investigative information obtained will be utilized in the mockup test of the equipment to remove deposits inside the X-6 penetration.
