## Main decommissioning work and steps

## Progress status

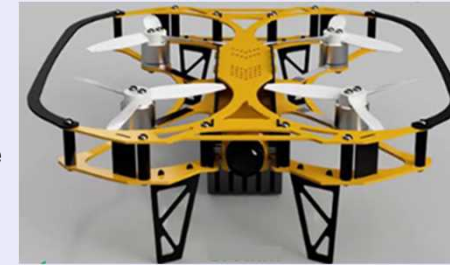
< Small drone >

This survey, to be conducted within the dark and confined space inside the PCV, will use a small drone and snake-type robot.

The investigation will be conducted not only outside the pedestal but also around the bottom of the Reactor Pressure Vessel (RPV) inside the pedestal. The investigative results will be utilized to examine fuel debris retrieval methods and for future PCV and RPV internal investigations.

Size: approx. 19×18×5 [cm]  
Weight: 185 [g] (including battery)

Size: approx. 300×18×17 [cm]  
Weight: approx. 25 [kg]

< Snake-type robot >

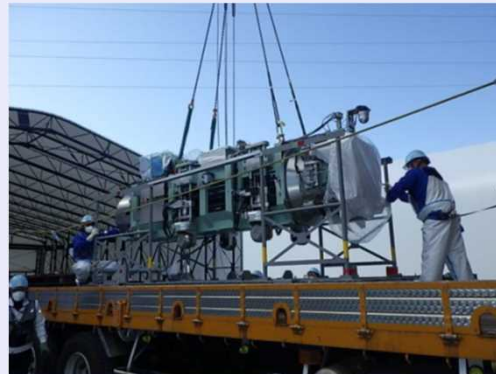
< Transportation of deposit removal equipment >

On site, before removing deposits inside the X-6 penetration, from which the robot arm would be inserted into the PCV, installation of the deposit removal equipment was completed on December 14. Subsequently, installation of the spray equipment to X-53 penetration is underway.

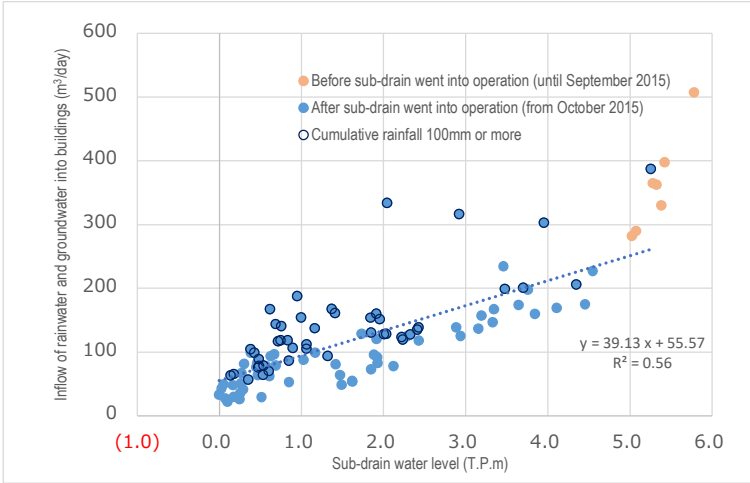
Figure 2: Correlation between inflow such as groundwater and rainwater into buildings and the water level of Units 1-4 sub-drains

- As the set water level of the sub-drains declined slightly (T.P. -0.55 ⇒ -0.65 m) and others in FY2021, the groundwater level on the sea side of the Unit 1-4 buildings remained low (except during heavy rainfall) compared to the T.P. 2.5 m area.

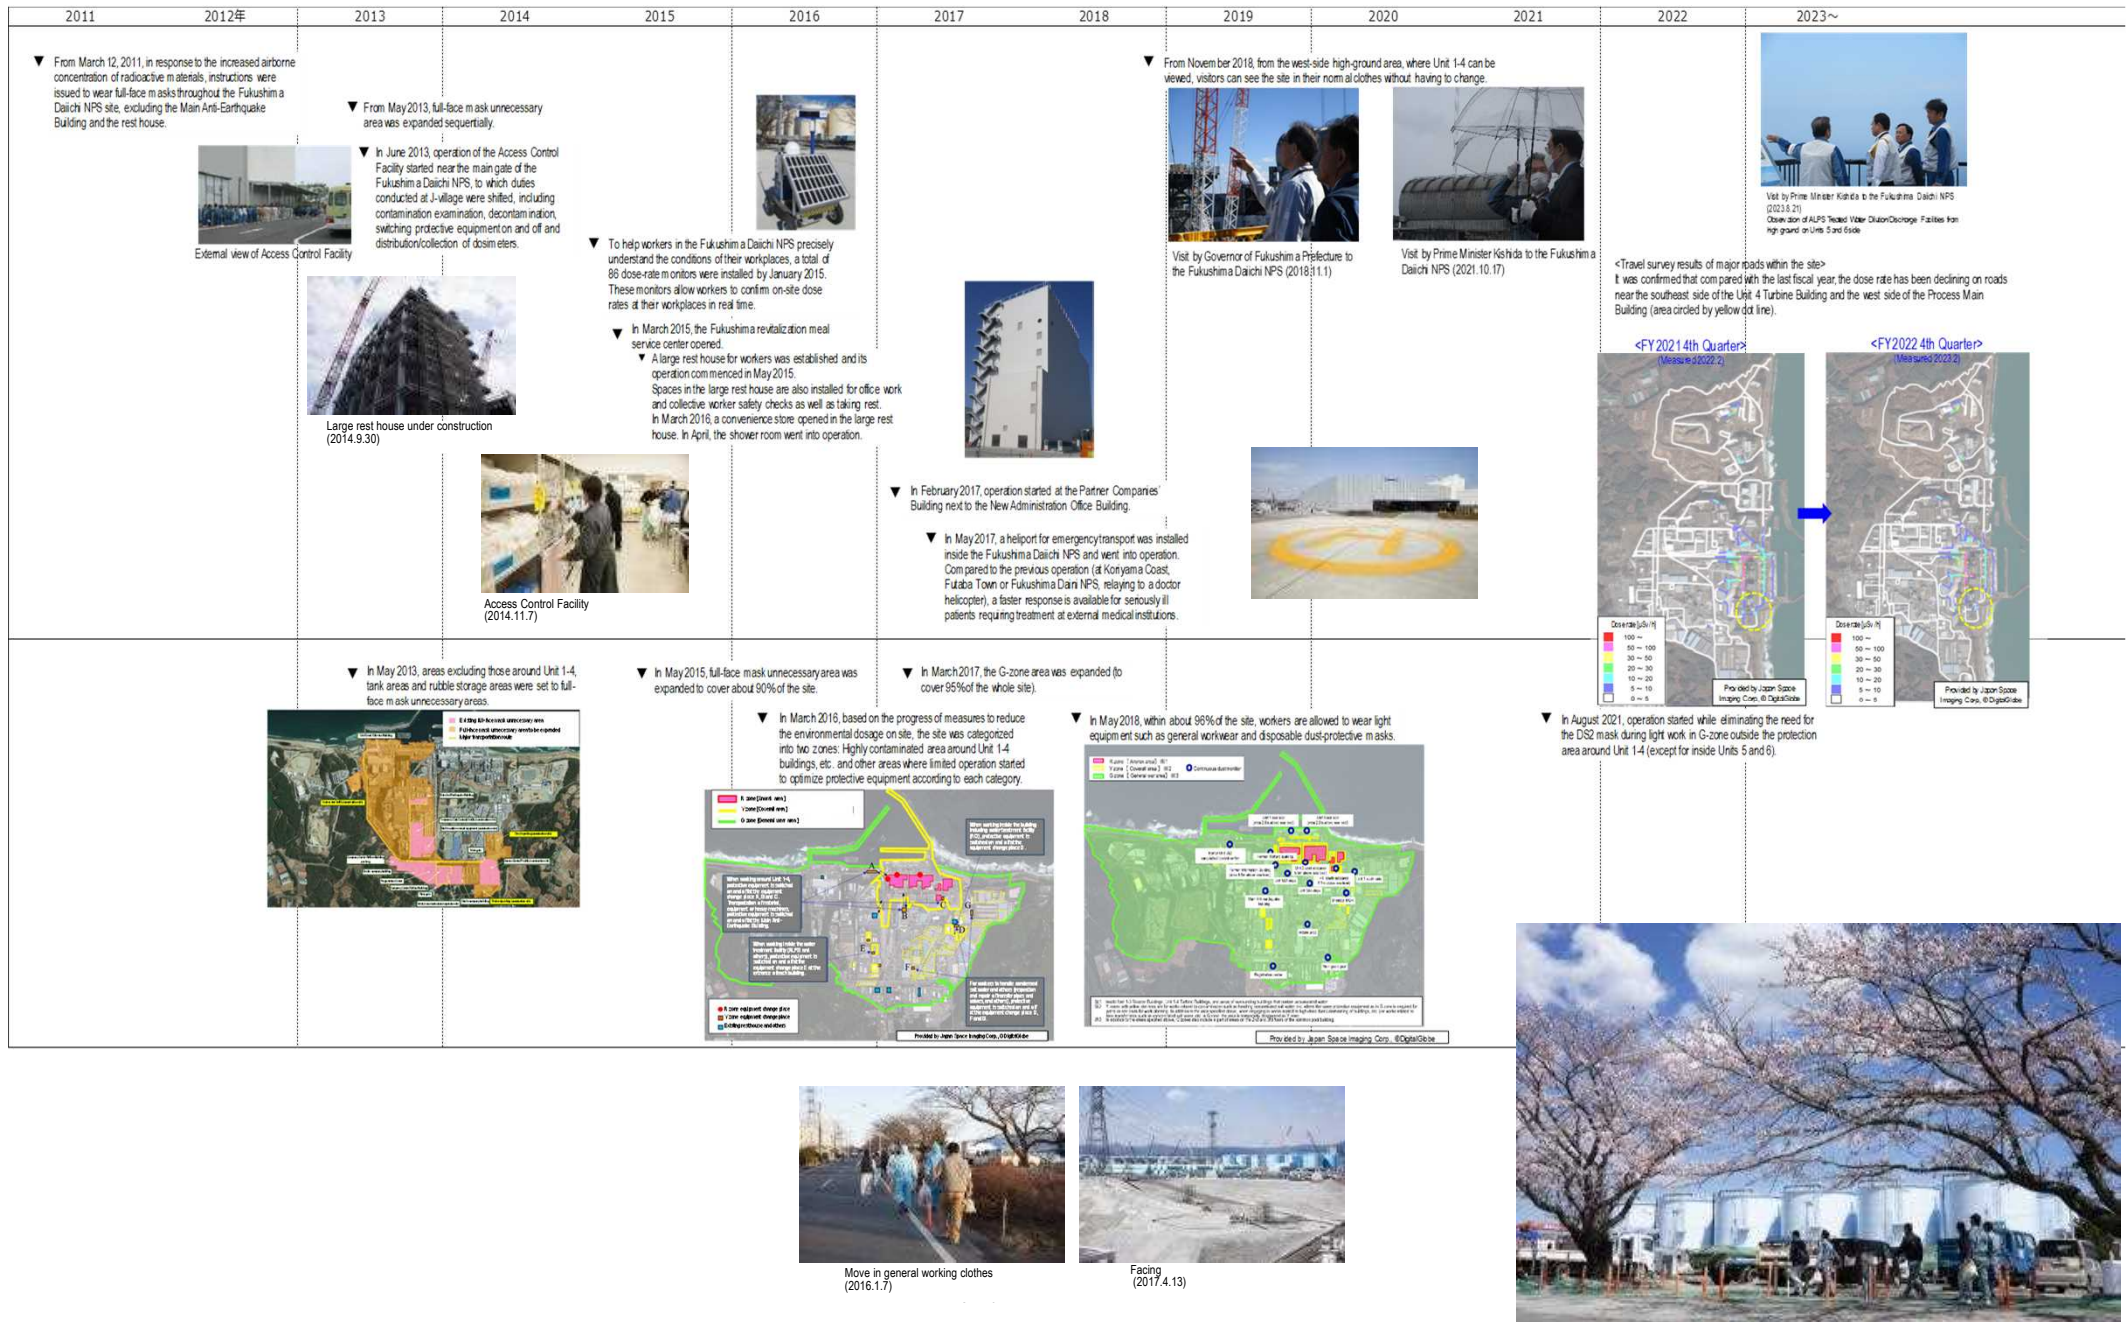
Regarding the site-wide reduction in the radiation dose and prevention of contamination spreading, the radiation dose on site was reduced by removal of rubble, topsoil and facing. Moreover, the operation was improved to use environmentally-improved areas as a Green Zone, within which workers are allowed to wear general work clothes and disposable dust-protective masks which are less of a physical burden.
