Main decommissioning work and steps

Progress status

Reference 3/6
March 28, 2024
Secretariat of the Team for
Countermeasures for Decommissioning,
Contaminated Water and Treated Water

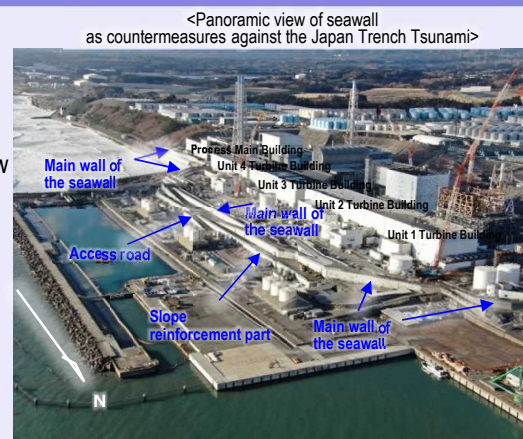
Completion of the seawall as countermeasures against the Japan Trench Tsunami

Installation of the seawall as countermeasures against the Japan Trench Tsunami, which commenced from June 21, 2021, was completed on March 15, 2024 (main wall: total length, approx. 1km and height, 13.5-16m above sea level).

The seawall will suppress flooding caused by the Japan Trench Tsunami, the imminent occurrence of which is evaluated and prevent any increase in contaminated water associated with inflow into buildings. Moreover, it will also help mitigate damage to key decommissioning facilities.

Countermeasures to tsunami	Seawall	▽ Installation of outer-rise tsunami seawall complete								Construction start of Chishima Trench Tsunami Seawall Completion of installation	On-site start		Japan Trench Tsunami Seawall Completion of main wall construction		
	Mega float							Start of marine construction Temporary grounding of mega float		Internal filling complete (reduction of tsunami risks)					 Unit 4 south side

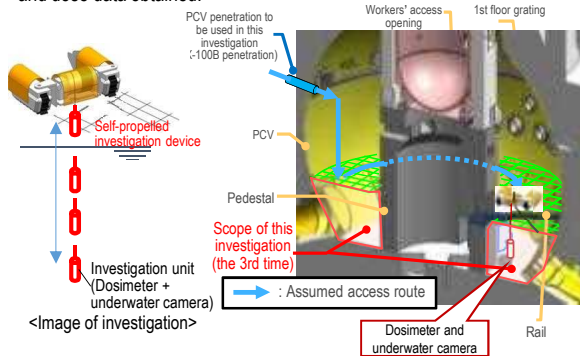
- In April 2015, a device having entered the inside of the PCV via a narrow opening (bore:φ100 mm) collected information such as images and airborne dose inside the PCV 1st floor.
- In March 2017, an investigation using a self-propelled investigation device was conducted to inspect the spreading of debris to the basement floor outside the pedestal, with images taken of the PCV bottom status for the first time. The conditions inside the PCV will continue to be examined, based on the imagery and dose data obtained.

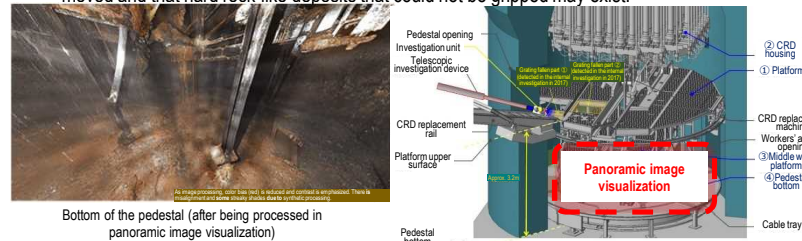
- In January 2017, a camera was inserted from the PCV penetration to inspect the conditions of the rail on which the robot traveled. The results of a series of investigations confirmed some gratings had fallen and deformed as well as a quantity of deposit inside the pedestal.

- In January 2018, the conditions below the platform inside the pedestal were investigated. Based on the analytical results of images obtained in the investigation, deposits, probably including fuel debris, were found at the bottom of the pedestal. Moreover, multiple parts exceeding the surrounding deposits were also detected. We presumed that there were multiple instances of fuel debris falling.

- In February 2019, an investigation touching the deposits at the bottom of the pedestal and on the platform was conducted and confirmed that the pebble-shaped deposits, etc. could be moved and that hard rock-like deposits that could not be gripped may exist.
