Main decommissioning work and steps

Progress status

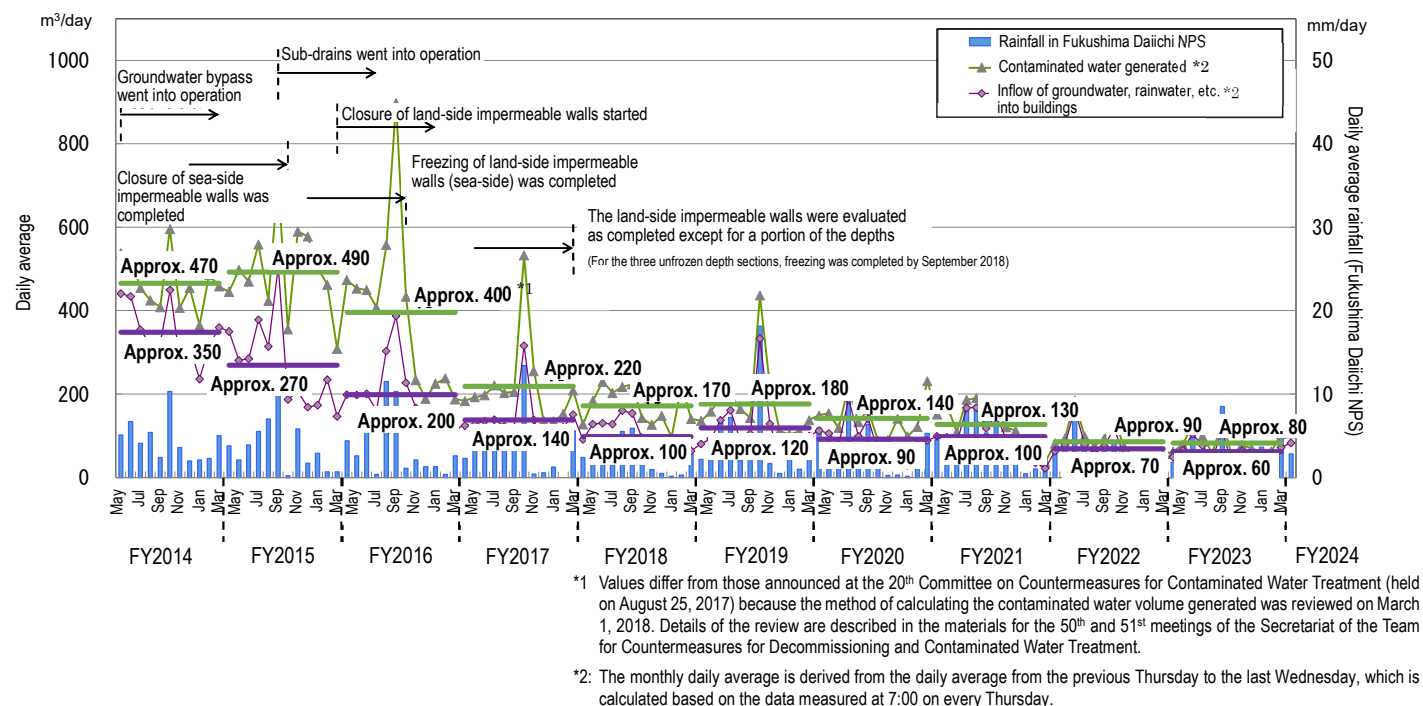
Figure 1: Changes in contaminated water generated and inflow of groundwater and rainwater into buildings

- Status of contaminated water generated
 - Multi-layered contaminated water management measures, including land-side impermeable walls and sub-drains, have stabilized the groundwater at a low level and the increased contaminated water generated during rainfall is being suppressed by repairing damaged portions of building roofs facing onsite. Through these measures, the generation of contaminated water has being suppressed and reduced from approx. 540 m³/day (in May 2014) before implementing measures to approx. 80 m³/day (in FY2023), achieving the milestone to “suppress the amount of contaminated water generated to 100 m³/day or less during average rainfall within FY2025.”
 - Measures will proceed to further reduce the amount of contaminated water generated and suppress to approx. 50-70 m³/day by FY2028.
