Main decommissioning work and steps

Progress status

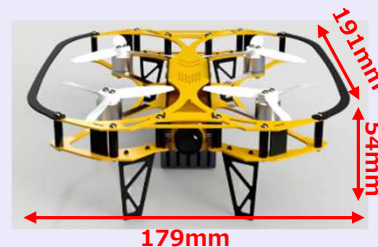
< Small drone used in the investigation in Unit 1 >

Regarding the X-53 penetration, an access route into the Unit 3 PCV, an investigation using a smaller micro drone than that used in the Unit 1 investigation is planned due to the small diameter of the penetration. Simultaneously, construction of a new access route is being examined to insert the same drone as with Unit 1.

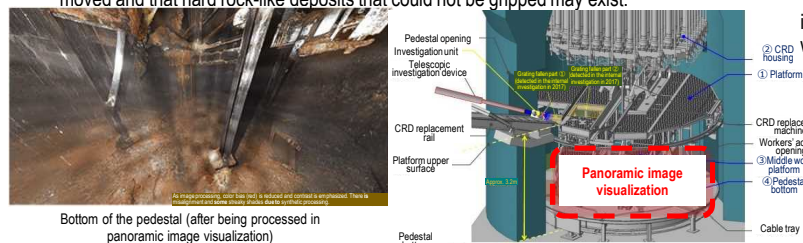
- In January 2017, a camera was inserted from the PCV penetration to inspect the conditions of the rail on which the robot traveled. The results of a series of investigations confirmed some gratings had fallen and deformed as well as a quantity of deposit inside the pedestal.

- In January 2018, the conditions below the platform inside the pedestal were investigated. Based on the analytical results of images obtained in the investigation, deposits, probably including fuel debris, were found at the bottom of the pedestal. Moreover, multiple parts exceeding the surrounding deposits were also detected. We presumed that there were multiple instances of fuel debris falling.

- In February 2019, an investigation touching the deposits at the bottom of the pedestal and on the platform was conducted and confirmed that the pebble-shaped deposits, etc. could be moved and that hard rock-like deposits that could not be gripped may exist.

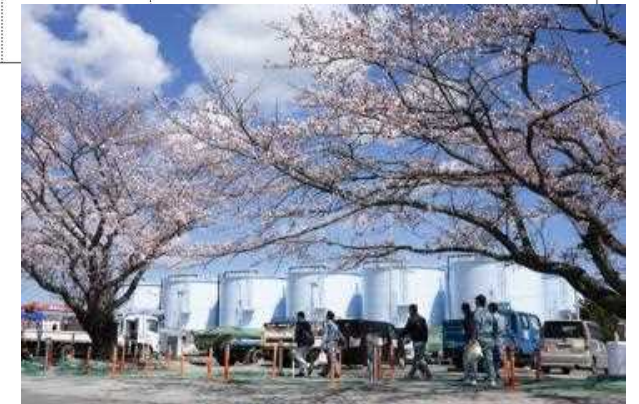
Facing
(2017.4.13)

Regarding the site-wide reduction in the radiation dose and prevention of contamination spreading, the radiation dose on site was reduced by removal of rubble, topsoil and facing. Moreover, the operation was improved to use environmentally-improved areas as a Green Zone, within which workers are allowed to wear general work clothes and disposable dust-protective masks which are less of a physical burden.
