Main decommissioning work and steps

Progress status

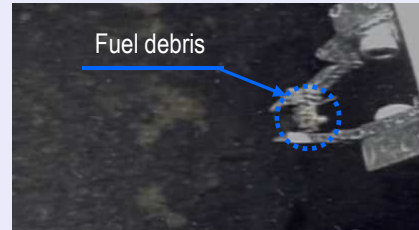
< Gripping fuel debris >

Unit 2 Progress of trial fuel debris retrieval

Trial retrieval of fuel debris has recommenced since October 28 and the fuel debris was gripped on October 30.

Going forward, radiation of the gripped fuel debris will be measured after returning the fuel debris into the enclosure.
