Outline of Decommissioning, Contaminated Water and Treated Water Management Secretariat of the Team for Countermeasures for Decommissioning, Contaminated Water and Treated Water Management

Progress Status and Future Challenges of the Mid-and-Long-Term Roadmap toward Decommissioning of TEPCO Holdings Fukushima Daiichi Nuclear Power Station (Outline)

Appendix 2 November 28, 2024

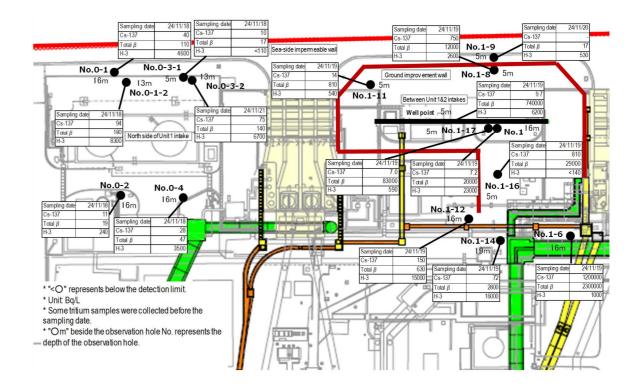
<Unit 1 intake north side, between Unit 1 and 2 intakes>

- In the open channel area of the seawater intake for Units 1 to 4, the concentration of radioactive materials in seawater has remained below the legal discharge limit and been declining long term, despite the temporary increases in Cs-137 and Sr-90 observed during rainfall. They have also been declining following the completed installation and the connection of steel pipe sheet piles for the sea-side impermeable walls. The concentration of Cs-137 remained slightly higher in front of the south-side impermeable walls and slightly lower on the north side of the east breakwater since March 20, 2019, when the silt fence was transferred to the center of the open channel due to mega float-related construction.

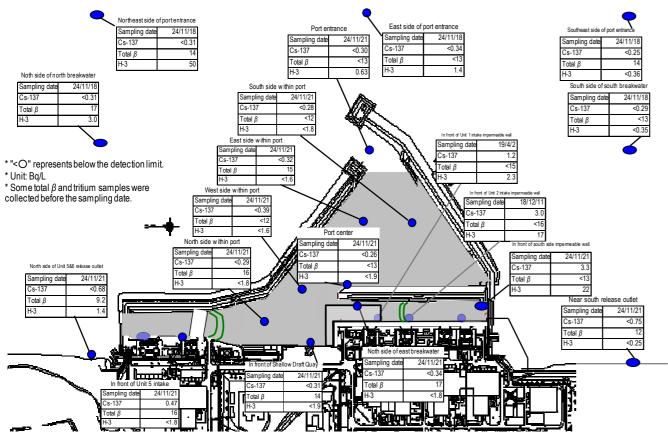
Figure 5: Seawater concentration around the port

- In the area outside the port, regarding the concentration of radioactive materials in seawater, those of Cs-137 and Sr-90 declined and remained low after steel pipe sheet piles for the sea-side impermeable walls were installed and connected. Regarding the concentration of Cs-137, a temporary increase was sometimes observed on the north side of the Unit 5 and 6 outlets and near the south outlet due to the influence of weather, marine meteorology and other factors. Regarding the concentration of Sr-90, variation was observed in FY2021 in the area outside the port (north and south outlets). Monitoring of the tendency continues, including the potential influence of weather, marine meteorology and others. During the period for which ALPS treated water was discharged, the tritium concentration increased at the sampling point near the discharge outlet, but this was considered within the assumed range based on the oceanic dispersion simulation results.

- In the port area, the concentration of radioactive materials in seawater has remained below the legal discharge limit and been declining long term, despite temporary increases in Cs-137 and Sr-90 observed during rainfall. They have remained below the level of those in the Units 1-4 intake open channel area and been declining following the completed installation and connection of steel pipe sheet piles for the sea-side impermeable walls.

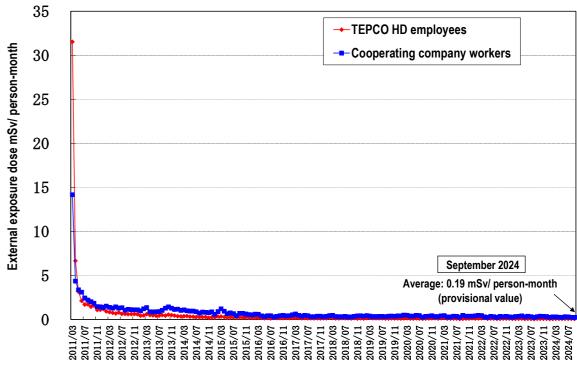
Figure 7: Changes in monthly average exposure dose of individual worker (monthly exposure dose since March 2011)

- The average exposure doses of workers were approx. 2.51, 2.16 and 2.18 mSv/person-year during FY2021, 2022 and 2023, respectively (The legal exposure dose limits are 100 and 50 mSv/person-year respectively over five years, the TEPCO HD management target is 20 mSv/person-year).

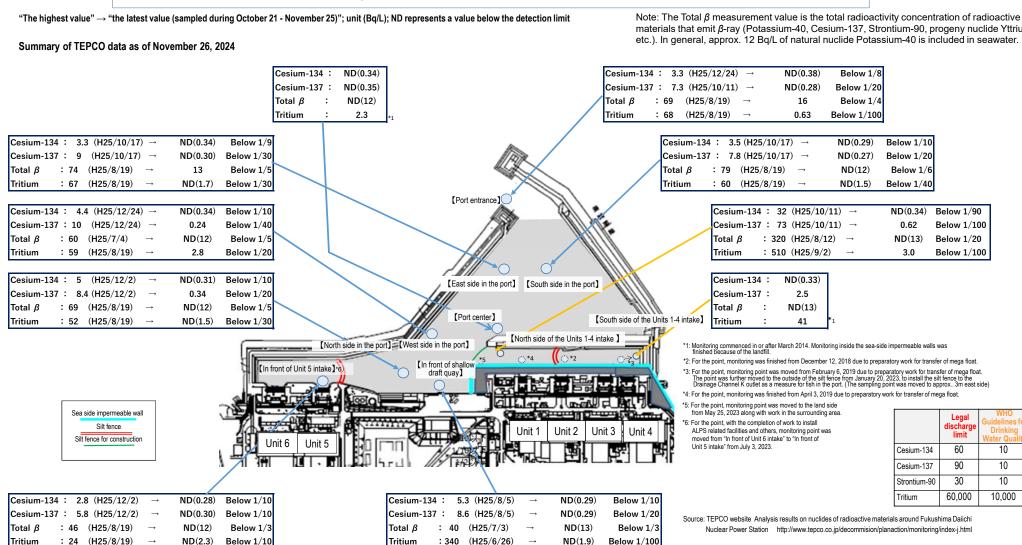
Status of seawater monitoring within the port (comparison between the highest values in 2013 and the latest values)

materials that emit β-ray (Potassium-40, Cesium-137, Strontium-90, progeny nuclide Yttrium-90, etc.). In general, approx. 12 Bq/L of natural nuclide Potassium-40 is included in seawater.

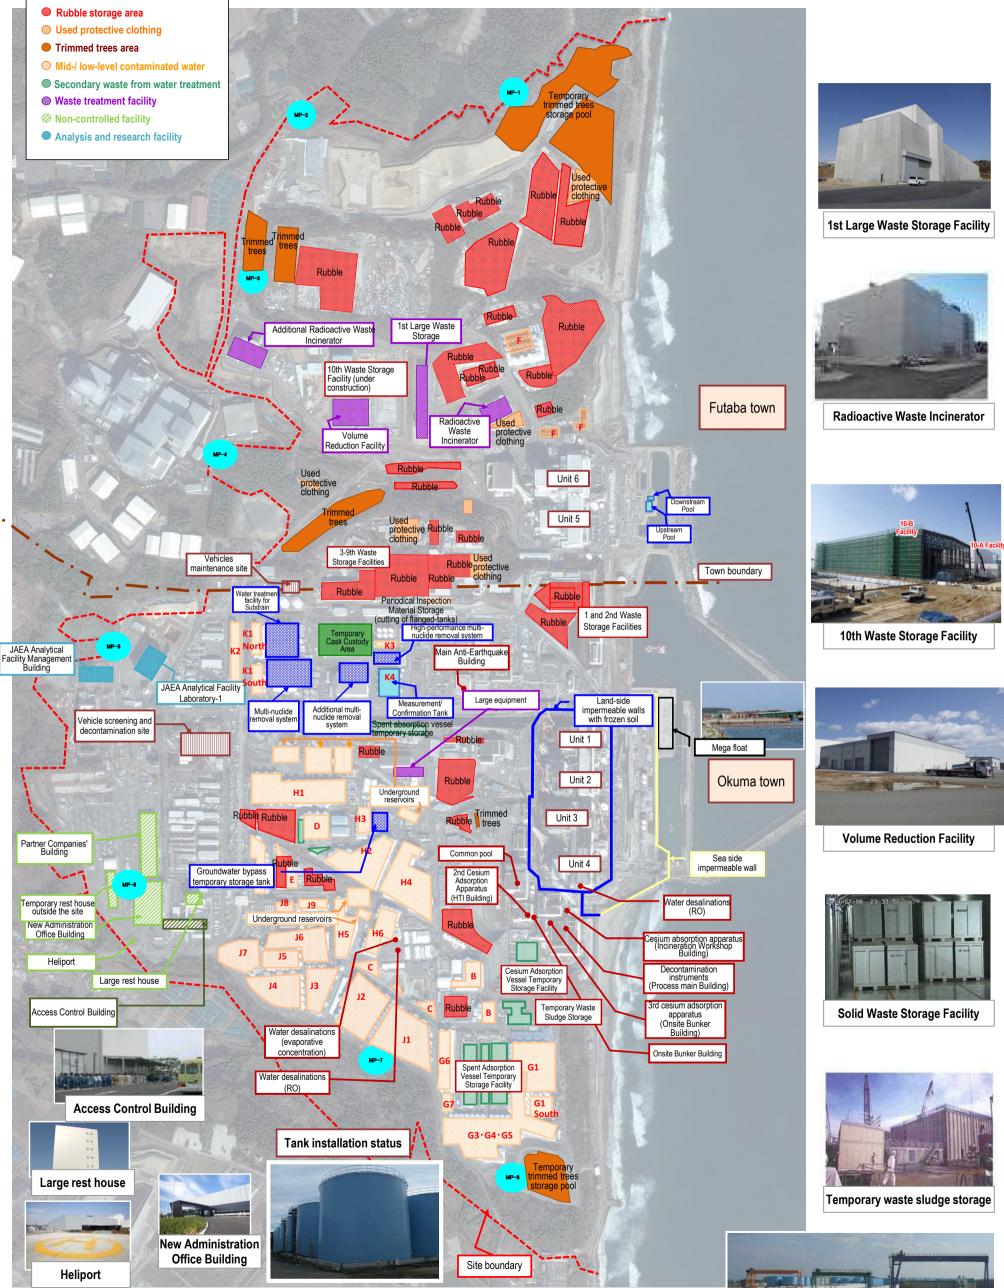
TEPCO Holdings Fukushima Daiichi Nuclear Power Station Site Layout

Spent adsorption vessel temporary storage facility

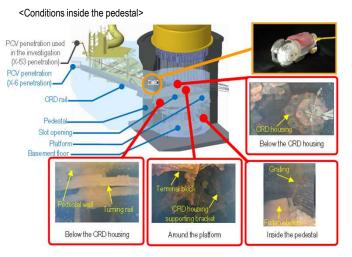
Unit 3 PCV internal investigation

· In July 2017, the inside of the PCV was investigated using the underwater ROV (remotely operated underwater vehicle) to inspect the inside of the pedestal. Analysis of the imagery obtained in the investigation identified damage to multiple structures and the supposed core internals.

· Videos obtained in the investigation were reproduced in 3D. Based on the reproduced images, the relative positions of the structures, such as the rotating platform slipping off the rail with a portion buried in deposits, were visually understood.

-			
Investigations inside the PCV	1st (2015.10-12)	Acquiring images Measuring the air temperature and dose rate Measuring the water level and temperature Sampling stagnant water Installing permanent monitoring instrumentation (2015.12)		
	2nd (2017.7)	 Acquiring images Installing permanent monitoring instrumentation (2017.8) 		
Leakage points from PCV	- Main steam pipe bellows (identified in 2014.5)			
Evaluation of the location of fuel debris inside the reactor by measurement using muons The evaluation confirmed that no large lump existed in the core area where fuel had been placed and that a portion of the fuel debris potentially existed at the bottom of the RPV. (2017.5-9)
