Main decommissioning work and steps

Progress status

I. Confirmation of the reactor conditions

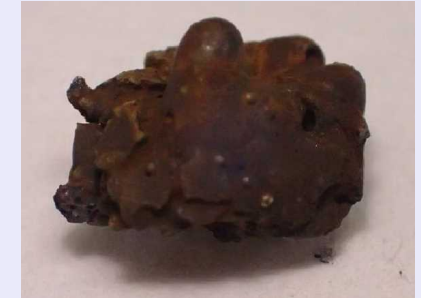
< External appearance of fuel debris sample (approx. 9 × 7 mm) >

Americium and others were detected in the gamma-ray spectrometry measurement and a portion with uranium spreading on the surface was also detected in the SEM-WDX measurement, which showed that fuel components were included.

Regarding the fuel debris sample collected in the Unit 2 trial retrieval, analysis is underway to determine the state of the area where the sample was acquired and estimate the process of fuel debris generation.

Analysis commenced on November 14 at the Fuels Monitoring Facility at the Oarai Nuclear Engineering Institute of the Japan Atomic Energy Agency (JAEA) and was completed up to the point of non-destructive analysis.

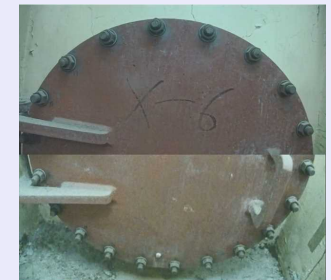
< Photo of X-6 penetration >

Regarding the flange of X-6 penetration, no molten material adhering was detected as in Unit 2 and the external appearance broadly resembled that before the earthquake. The maximum air dose rate in the front room was 124mSv/h, which was lower compared with in Unit 2 and no molten material deposit was detected on the floor.

During the Unit 2 fuel debris retrieval, X-6 penetration was utilized. At Unit 3, the penetration is also expected to be effectively utilized as an access route for investigations inside the Primary Containment Vessel (PCV) and fuel debris retrieval. Before examining future utilization, to confirm the present state, the inside of the front room of the Unit 3 X-6 penetration was investigated.

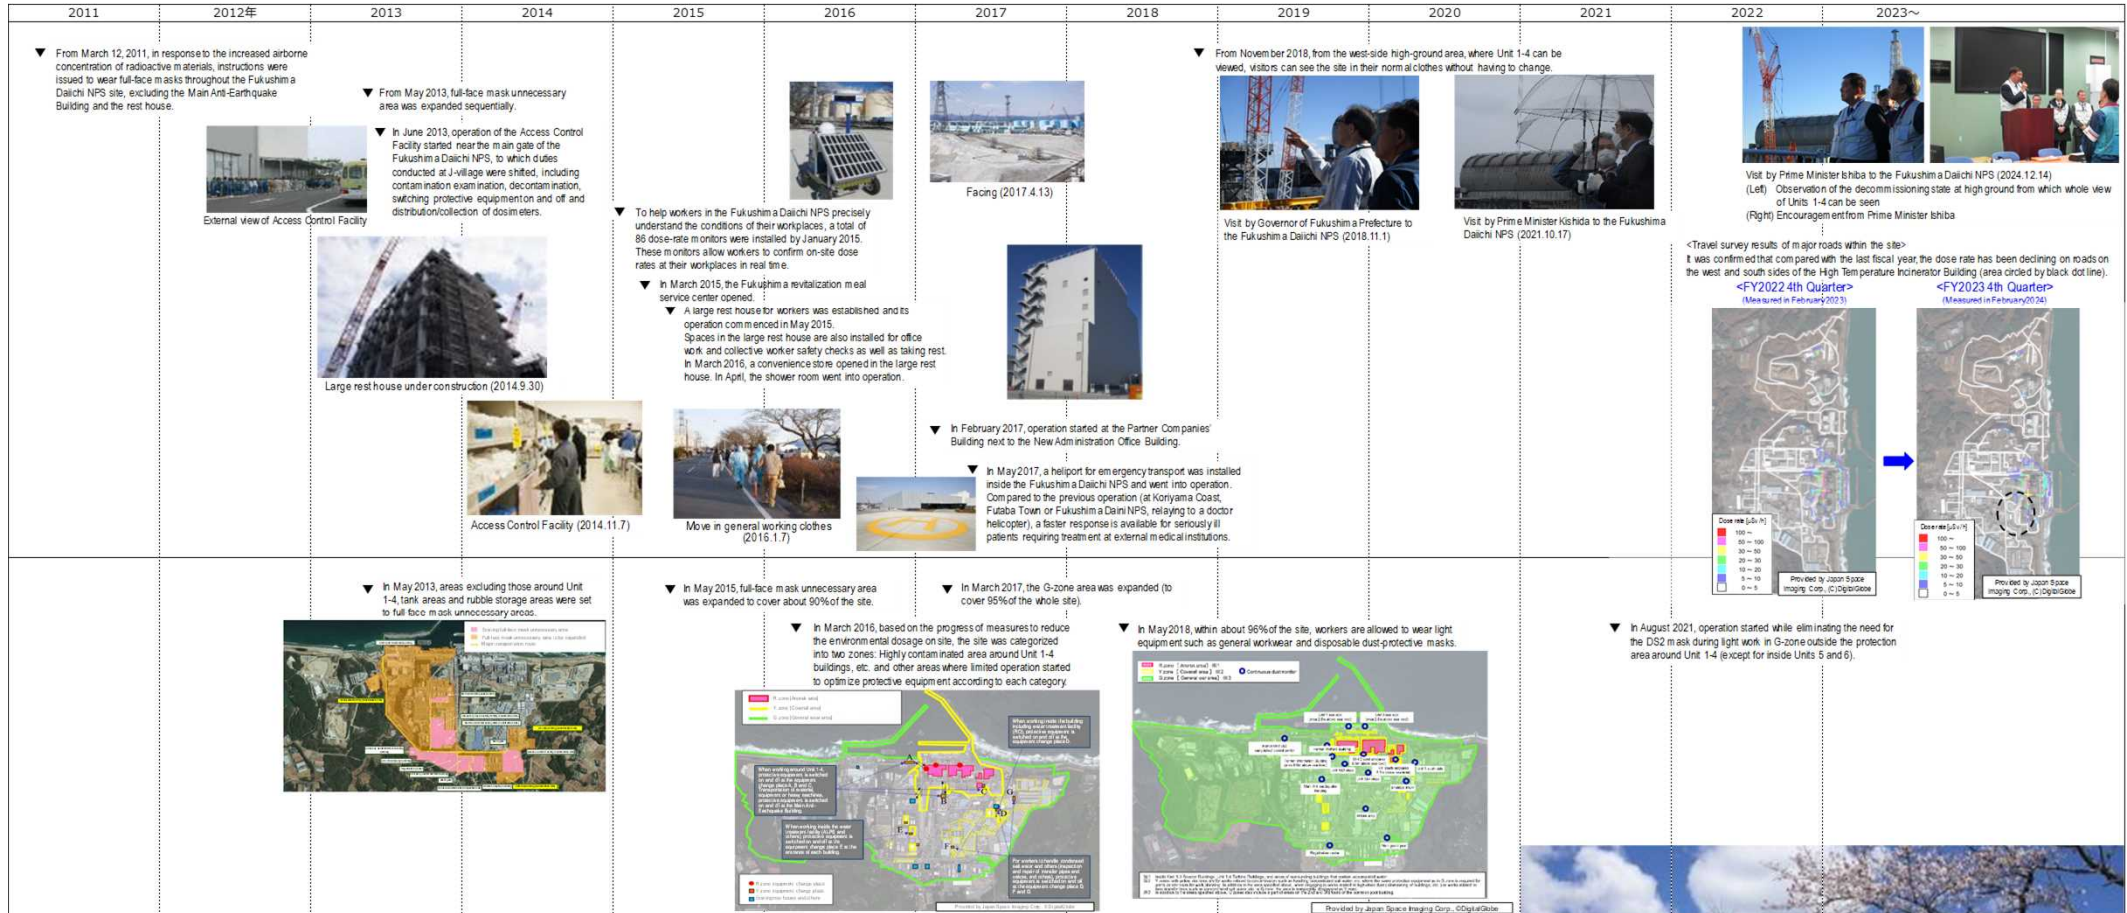
Regarding the site-wide reduction in the radiation dose and prevention of contamination spreading, the radiation dose on site was reduced by removal of rubble, topsoil and facing. Moreover, the operation was improved to use environmentally-improved areas as a Green Zone, within which workers are allowed to wear general work clothes and disposable dust-protective masks which are less of a physical burden.
