Outline of Decommissioning, Contaminated Water and Treated Water Management

Main decommissioning work and steps

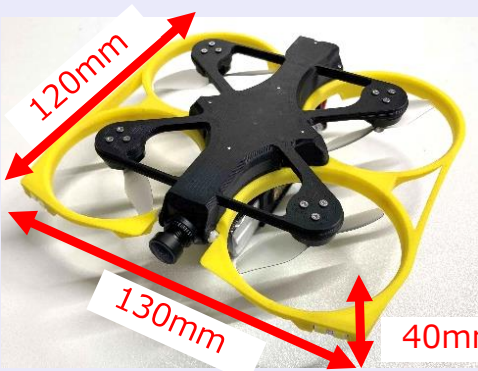
To match the small-diameter X-53 penetration, an investigation inside the PCV using an “ultra-small” but “highly maneuverable” “micro-drone” with high “photographic ability” is planned.

Purpose: Acquiring images by camera (2.7K)
Size: 130×120×40 [mm]
Weight: 95 [g] (including battery)
Flight time: Approx. 13 min
(investigation will be conducted in 10 min)

In this investigation, within the scope where the micro-drone can fly, work to acquire images inside the D/W 1FL and the pedestal is planned. In particular, the main purpose is information collection around X-6 penetration and inside the pedestal which are important for future investigation and horizontal access to fuel debris retrieval. Moreover, as in the drone investigation in Unit 1, work to acquire point cloud data from images and estimate the dose rate using radiation noise is scheduled.

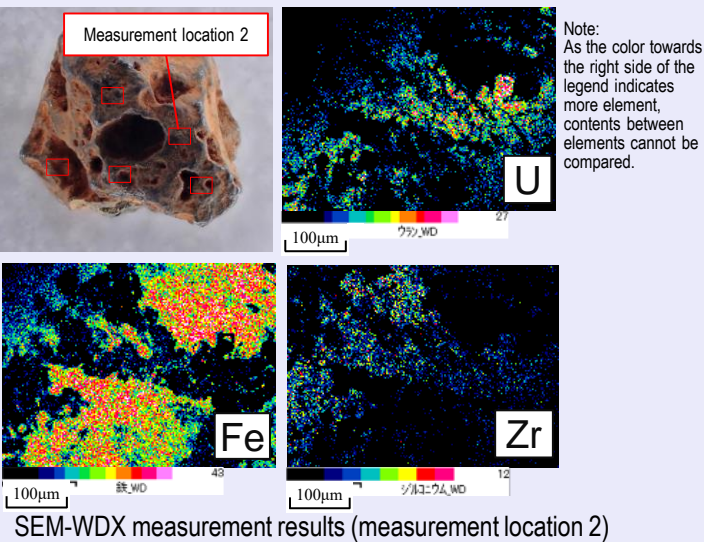
Results of the non-destructive analysis of the fuel debris sample (2nd) (update)

The X-ray CT measurement results confirmed non-uniform CT values and the fact that space-like openings were distributed widely.

The results of the SEM-WDX measurement showed that U was distributed widely on the surface and from any perspective, U, Zr, Fe, Cr, Ni and O were detected, but Si, Ca, Al and others, which were detected in the 1st sampling were not detected.

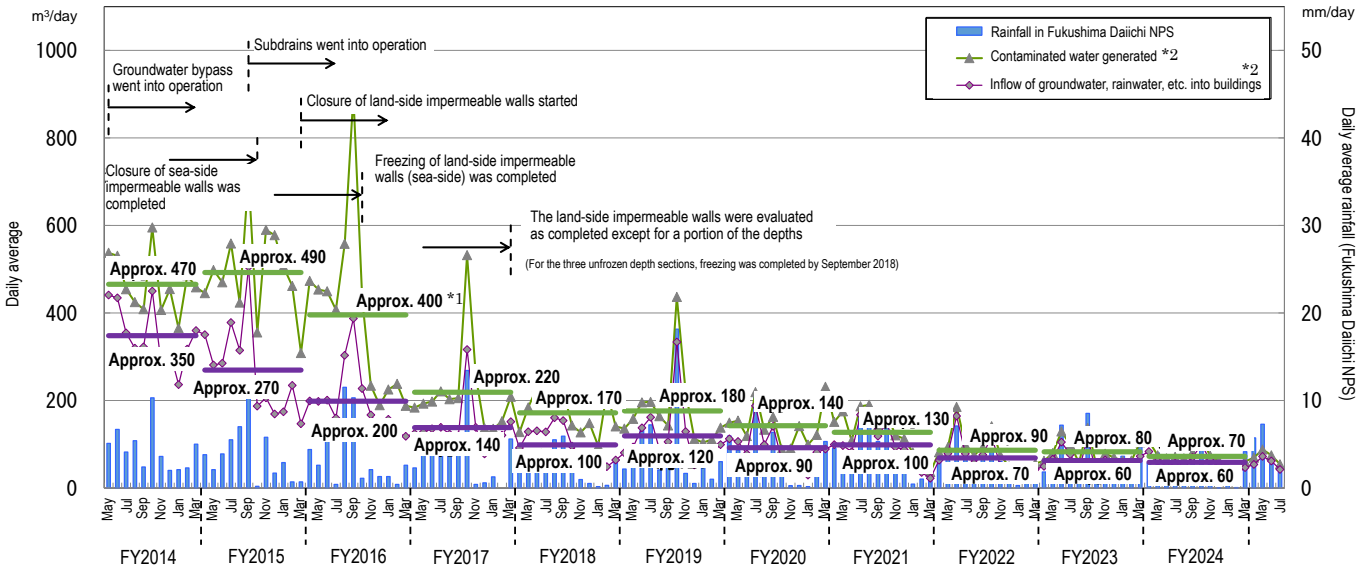
Figure 1: Changes in contaminated water generated and inflow of groundwater and rainwater into buildings

- Status of contaminated water generated
 - Multi-layered contaminated water management measures, including land-side impermeable walls and subdrains, have stabilized the groundwater at a low level and the increased contaminated water generated during rainfall is being suppressed by repairing damaged portions of building roofs facing onsite. Through these measures, the generation of contaminated water has been suppressed and reduced from approx. 540 m³/day (in May 2014) before implementing measures to approx. 70 m³/day (in FY2024). It was confirmed that the milestone of “suppressing the amount of contaminated water generated to 100 m³/day or less during average rainfall within FY2025,” which was achieved in FY2023, has been maintained in FY2024.
 - Measures will proceed to further reduce the amount of contaminated water generated and suppress to approx. 50-70 m³/day by FY2028.

*1 Values differ from those announced at the 20th Committee on Countermeasures for Contaminated Water Treatment (held on August 25, 2017) because the method of calculating the contaminated water volume generated was reviewed on March 1, 2018. Details of the review are described in the materials for the 50th and 51st meetings of the Secretariat of the Team for Countermeasures for Decommissioning and Contaminated Water Treatment.
*2: The monthly daily average is derived from the daily average from the previous Thursday to the last Wednesday, which is calculated based on the data measured at 7:00 on every Thursday

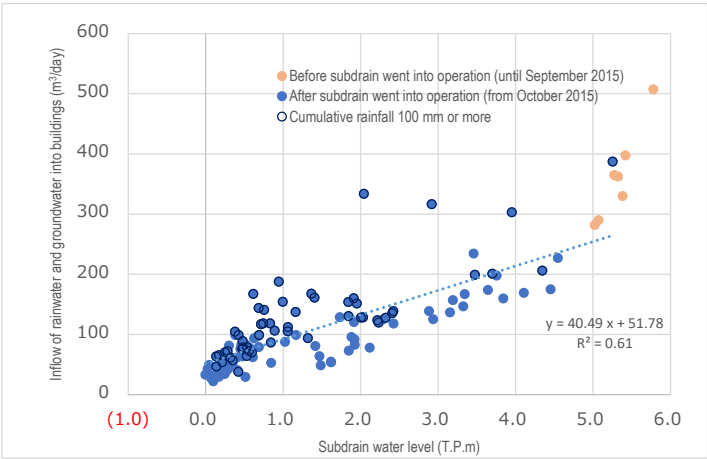
Figure 2: Correlation between inflow such as groundwater and rainwater into buildings and the water level of Units 1-4 subdrains

- Regarding the subdrains of Units 1-4, the pumping amount varied depending on precipitation. The pumping amount in the T.P.+2.5m area remained constant after the facing in this area was completed.

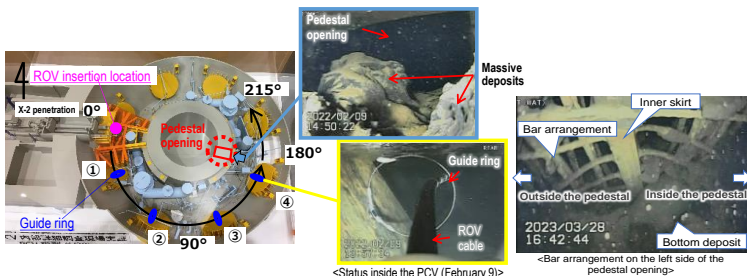
- In February 2022, “the guide ring” was installed to facilitate the investigation. From March 28, 2023, the investigation inside the pedestal by ROV-A2 started and confirmed that a portion of the bar arrangement was exposed. Regarding the soundness of the pedestal, based on the past earthquake resistant evaluation by the International Research Institute for Nuclear Decommissioning (IRID), it was evaluated that even though a portion of the pedestal was lost, there would be no serious risk. However, as the present information is very limited, the investigation will continue to acquire as much information as possible for continued evaluation.
