# Outline of Decommissioning, Contaminated Water and Treated Water Management

## Main decommissioning work and steps

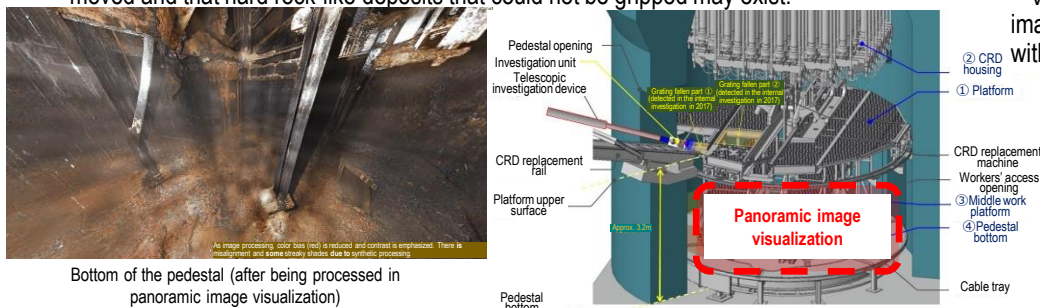
- In February 2019, an investigation touching the deposits at the bottom of the pedestal and on the platform was conducted and confirmed that the pebble-shaped deposits, etc. could be moved and that hard rock-like deposits that could not be gripped may exist.

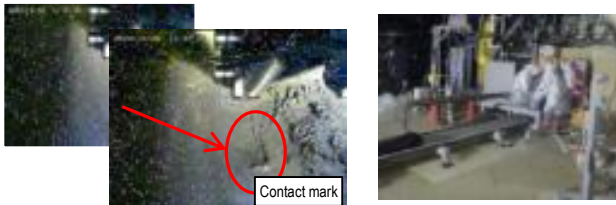
&lt;Conditions of deposits before and after contact&gt;

- In October 2020, a deposits contact investigation at the PCV penetration (X-6 penetration) was conducted. This confirmed that deposits inside the penetration had not deformed and come unstuck.
