## Main decommissioning work and steps

Fuel removal from the spent fuel pool was completed on December 22 2014 at Unit 4 and February 28 2021 at Unit 3. Trial fuel debris retrieval at Unit 2 commenced from September 10 2024 and a milestone of the Mid- and Long-Term Roadmap “Commencing fuel debris retrieval at the first Unit” was achieved.

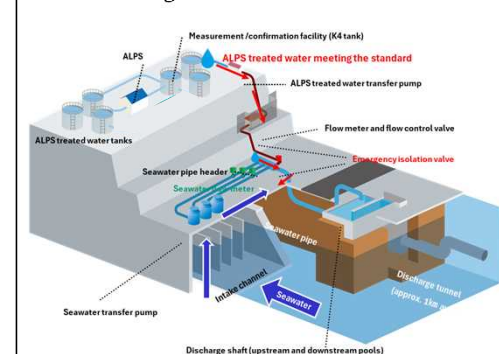
Flow of discharge of ALPS-treated water into the sea

Regarding the discharge of ALPS-treated water into the sea, TEPCO must comply with regulatory and other safety standards to safeguard the public, the surrounding environment and agricultural, forestry and fishery products. To minimize adverse impacts on reputation, ongoing efforts will continue, including enhanced monitoring, ensuring objectivity and transparency by engaging with third-party experts and having safety checked by the IAEA. Moreover, accurate information will be disseminated with full transparency.

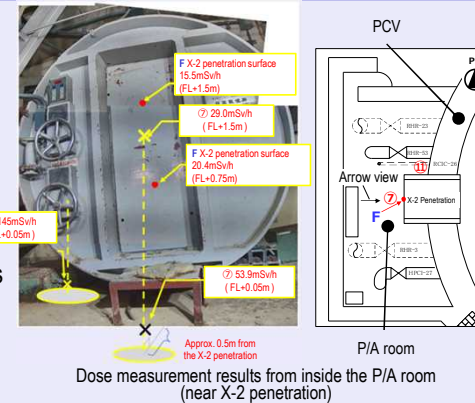
### Unit 3 Investigation results for the inside of the Unit 3 Personal Access Lock and past investigation results for each penetration

For full-scale fuel debris retrieval from Unit 3, we are deliberating accessing the fuel debris from the X-6 penetration, the X-1B penetration and the TIP room. To examine the feasibility of using any other penetrations, from August 19 to September 19, 2025, we investigated the personnel access lock room (P/A room)\*1 outside the Primary Containment Vessel (PCV). Remotely operated quadruped robots (SPOT) and crawler robots (Packbot) were used for the investigation, for visual inspection using cameras, dose measurements and point cloud data acquisition.

By the visual inspection, no molten material adhering to the surface of the X-2 penetration flange in the P/A chamber, nor any signs of leakage or deformations, like those found in the front chamber of the Unit 2 X-6 penetration were confirmed. Moreover, no abnormality such as deformation was found in the P/A chamber. Dose measurement results show hot spots existing on the floor.

In addition to the hotspots identified during this investigation, contamination may also exist elsewhere, so G/I measurement results will be analyzed to create a more detailed radiation source distribution. Dose reduction measures inside the P/A room are necessary if it is to be used for fuel debris retrieval, but there are also obstructions such as a piping system and the air dose rates are high. Accordingly, the process of reducing doses in the P/A room may take considerable time.

\* 1 Before the accident, used as passage through which persons enter into PCV during inspection.

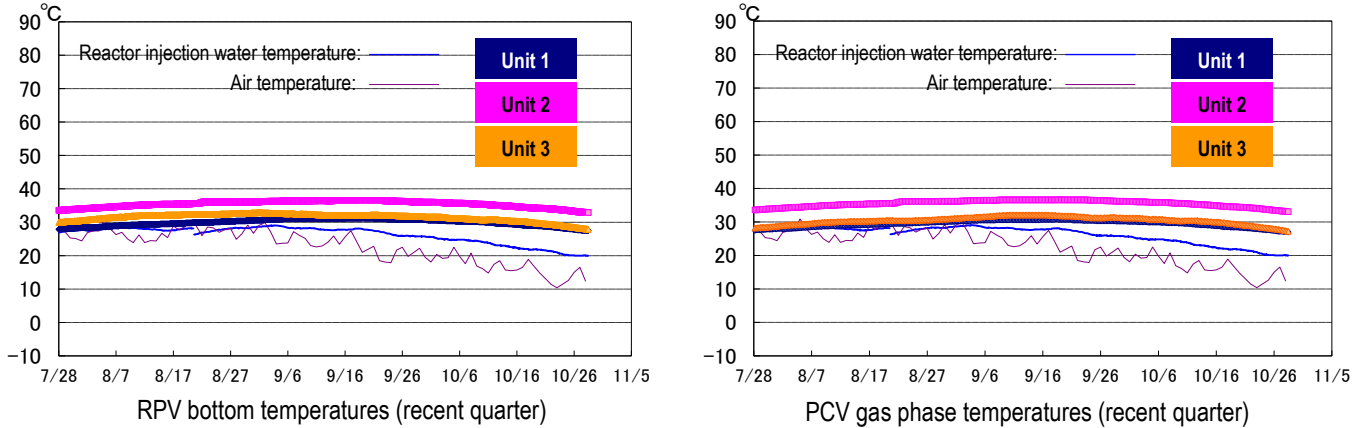
Temperatures inside the reactors

Through continuous reactor cooling by water injection, the temperatures of the Reactor Pressure Vessel (RPV) bottom and the Primary Containment Vessel (PCV) gas phase were maintained as shown below for recent, though they varied depending on the unit and location of the thermometer.

\*1 The trend graphs show part of the temperature data measured at multiple points.  
\*2 A part of data could not be measured due to maintenance and inspection of the facility and other work.

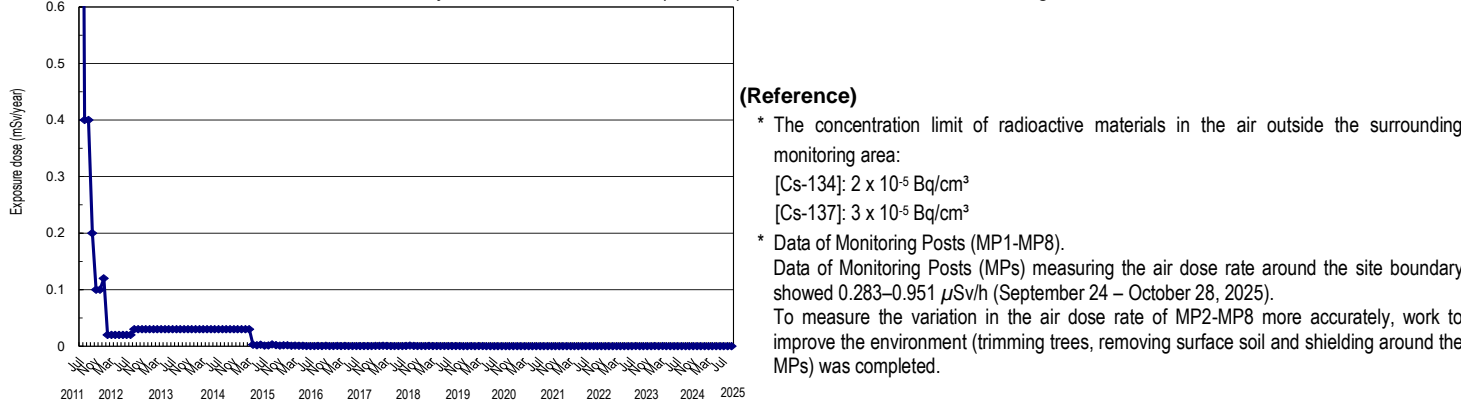
Annual radiation dose at site boundaries by radioactive materials (cesium) released from Reactor Building Units 1-4

As of September 2025, the concentration of radioactive materials newly released from Reactor Building Units 1-4 into the air and measured at the site boundary was evaluated at approx.  $5.8 \times 10^{-12}$  Bq/cm<sup>3</sup> and  $8.9 \times 10^{-12}$  Bq/cm<sup>3</sup> for Cs-134 and -137 respectively, while the radiation exposure dose due to the release of radioactive materials there was less than 0.00003 mSv/year.

Note 1: Different formulas and coefficients were used to evaluate the radiation dose in the facility operation plan and monthly report. The evaluation methods were integrated in September 2012. As the fuel removal from the spent fuel pool (SFP) commenced for Unit 4, the radiation exposure dose from Unit 4 was added to the items subject to evaluation since November 2013. The evaluation has been changed to a method considering the values of continuous dust monitors since FY2015, with data to be evaluated monthly and announced the following month.

Note 2: Radiation dose was calculated using the evaluation values of release amount from Units 1-4 and Units 5 and 6. The radiation dose of Unit 5 and 6 was evaluated based on expected release amount during operation until September 2019 but the evaluation method was reviewed and changed to calculate based on the actual measurement results of Units 5 and 6 from October.

Note 3: Dose assessment has been changed since July 2024 due to the change of standard meteorology, etc. in the implementation plan (effective July 8, 2024).

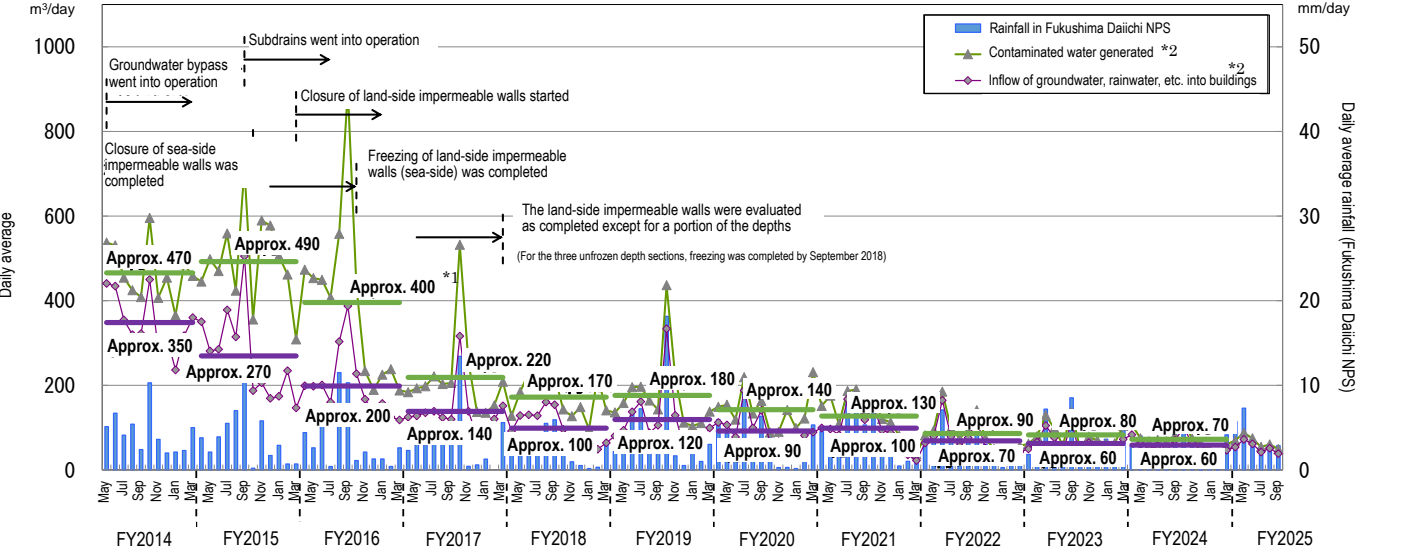
Figure 1: Changes in contaminated water generated and inflow of groundwater and rainwater into buildings

\*1 Values differ from those announced at the 20<sup>th</sup> Committee on Countermeasures for Contaminated Water Treatment (held on August 25, 2017) because the method of calculating the contaminated water volume generated was reviewed on March 1, 2018. Details of the review are described in the materials for the 50<sup>th</sup> and 51<sup>st</sup> meetings of the Secretariat of the Team for Countermeasures for Decommissioning and Contaminated Water Treatment.

\*2: The monthly daily average is derived from the daily average from the previous Thursday to the last Wednesday, which is calculated based on the data measured at 7:00 on every Thursday

- Status of contaminated water generated
  - Multi-layered contaminated water management measures, including land-side impermeable walls and subdrains, have stabilized the groundwater at a low level and the increased contaminated water generated during rainfall is being suppressed by repairing damaged portions of building roofs facing onsite. Through these measures, the generation of contaminated water has been suppressed and reduced from approx. 540 m<sup>3</sup>/day (in May 2014) before implementing measures to approx. 70 m<sup>3</sup>/day (in FY2024). It was confirmed that the milestone of “suppressing the amount of contaminated water generated to 100 m<sup>3</sup>/day or less during average rainfall within FY2025,” which was achieved in FY2023, has been maintained in FY2024.

- Measures will proceed to further reduce the amount of contaminated water generated and suppress to approx. 50-70 m<sup>3</sup>/day by FY2028.

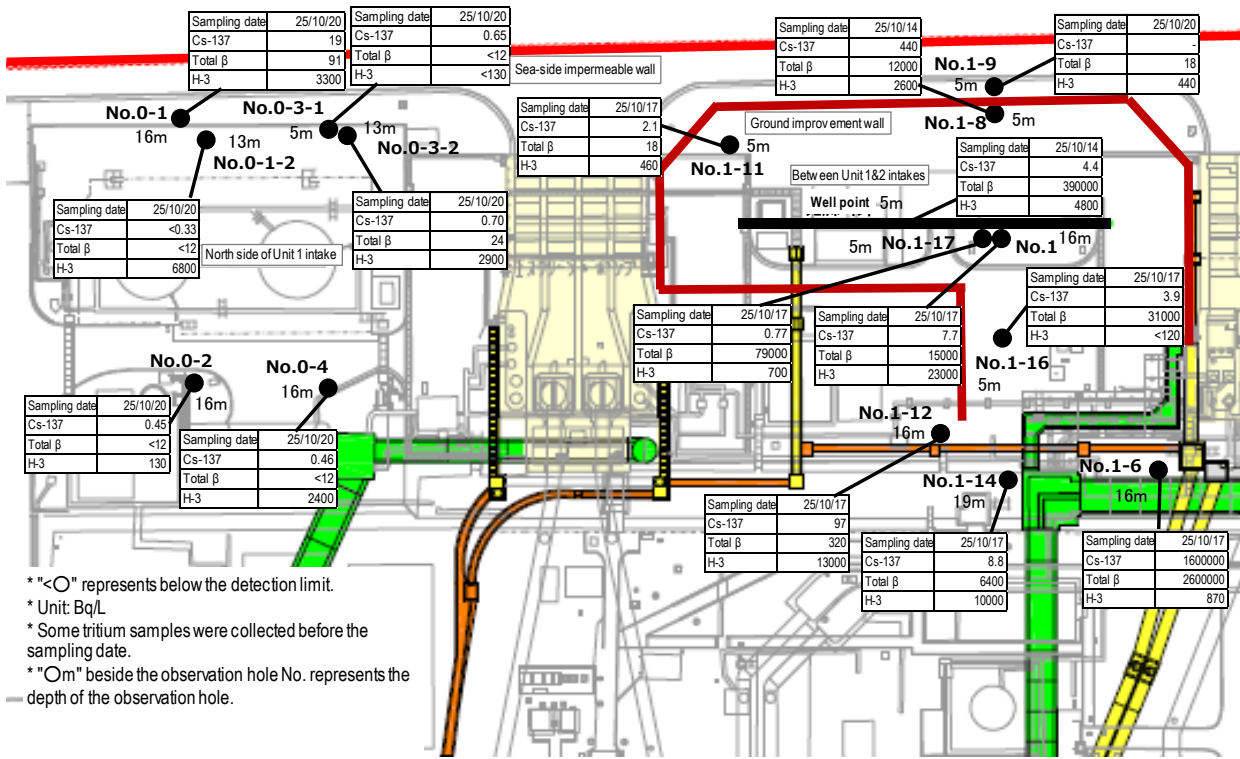
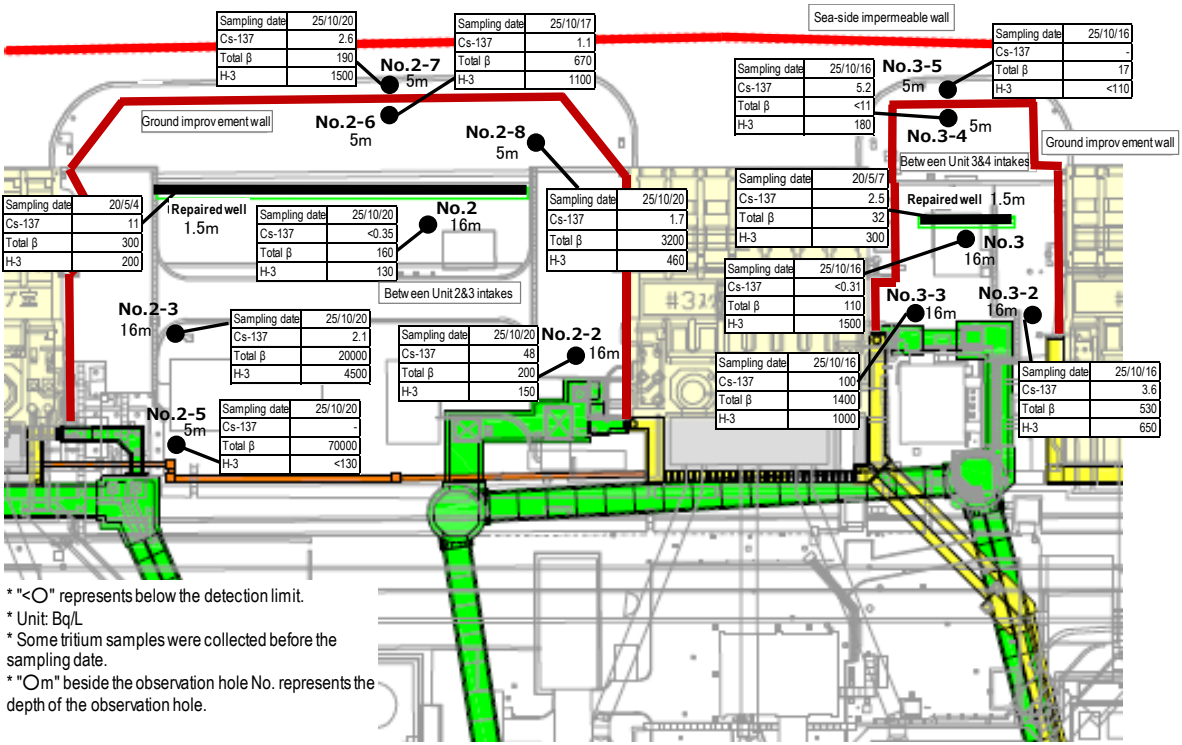
Figure 4: Groundwater concentration on the Turbine Building east side

\* "<O" represents below the detection limit.  
\* Unit: Bq/L  
\* Some tritium samples were collected before the sampling date.  
\* "Om" beside the observation hole No. represents the depth of the observation hole.

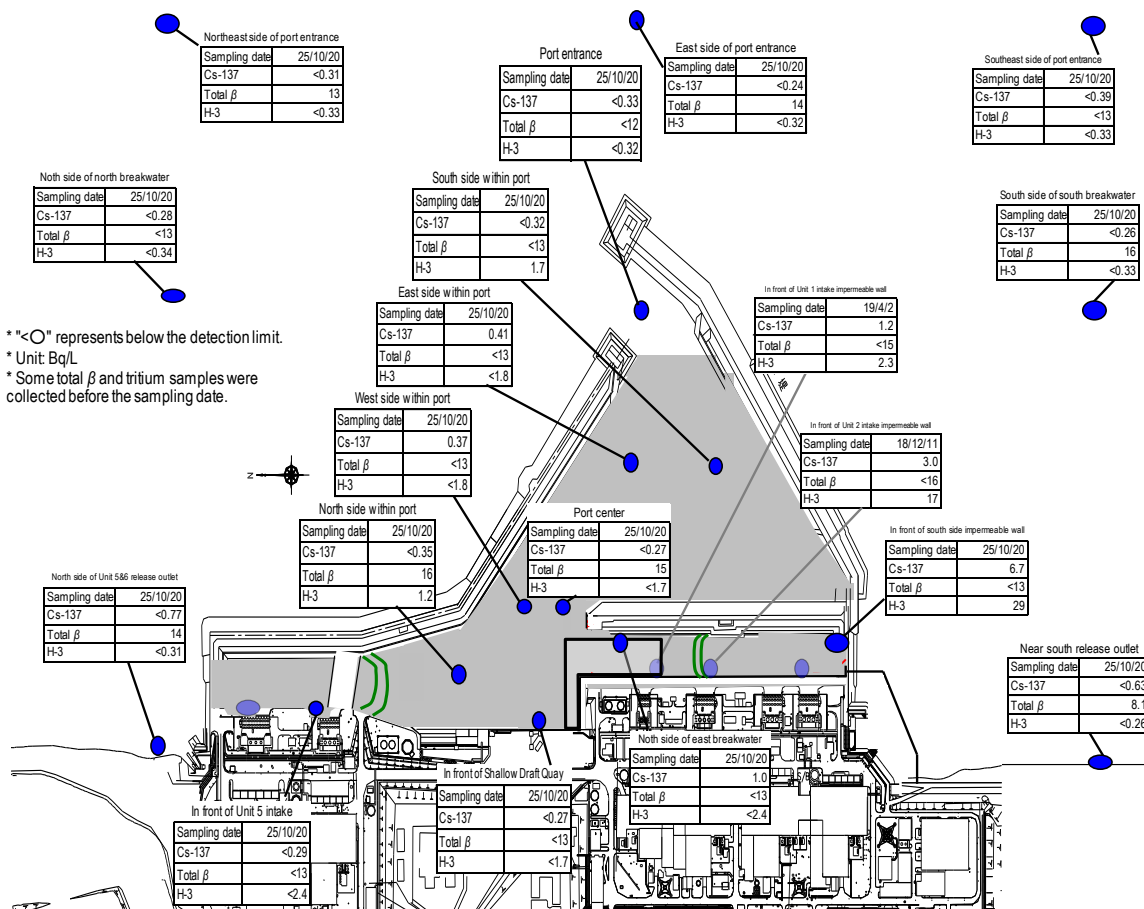
Figure 5: Seawater concentration around the port

- In the open channel area of the seawater intake for Units 1 to 4, the concentration of radioactive materials in seawater has remained below the legal discharge limit and been declining long term, despite the temporary increases in Cs-137 and Sr-90 observed during rainfall. They have also been declining following the completed installation and the connection of steel pipe sheet piles for the sea-side impermeable walls. The concentration of Cs-137 remained slightly higher in front of the south-side impermeable walls and slightly lower on the north side of the east breakwater since March 20, 2019, when the silt fence was transferred to the center of the open channel due to mega float-related construction.

- In the port area, the concentration of radioactive materials in seawater has remained below the legal discharge limit and been declining long term, despite temporary increases in Cs-137 and Sr-90 observed during rainfall. They have remained below the level of those in the Units 1-4 intake open channel area and been declining following the completed installation and connection of steel pipe sheet piles for the sea-side impermeable walls.

- In the area outside the port, regarding the concentration of radioactive materials in seawater, those of Cs-137 and Sr-90 declined and remained low after steel pipe sheet piles for the sea-side impermeable walls were installed and connected. Regarding the concentration of Cs-137, a temporary increase was sometimes observed on the north side of the Units 5 and 6 outlets and near the south outlet due to the influence of weather, marine meteorology and other factors. Regarding the concentration of Sr-90, variation was observed in FY2021 in the area outside the port (north and south outlets). Monitoring of the tendency continues, including the potential influence of weather, marine meteorology and others. During the period for which ALPS treated water was discharged, the tritium concentration increased at the sampling point near the discharge outlet, but this was considered within the assumed range based on the oceanic dispersion simulation results.

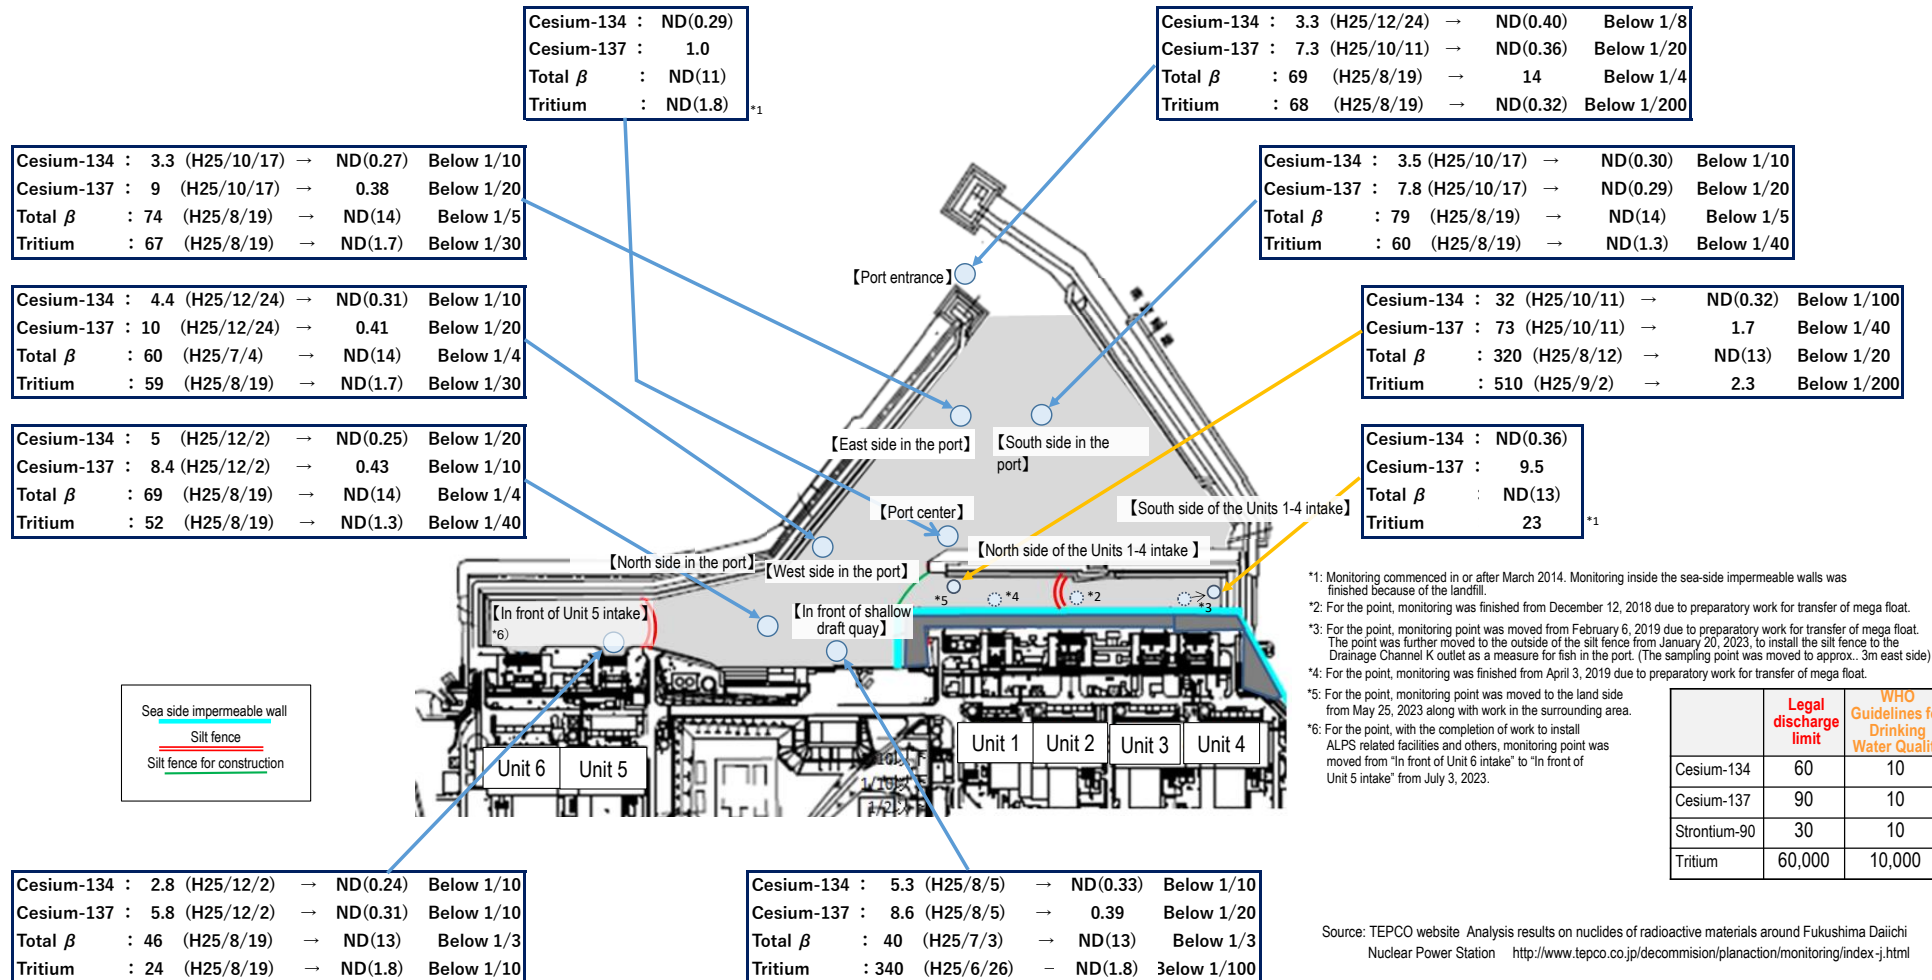
## Status of seawater monitoring around outside of the port (comparison between the highest values in 2013 and the latest values)

Note: The Total  $\beta$  measurement value is the total radioactivity concentration of radioactive materials that emit  $\beta$ -ray (Potassium-40, Cesium-137, Strontium-90, progeny nuclide Yttrium-90, etc.). In general, approx. 12 Bq/L of natural nuclide Potassium-40 is included in seawater.

Unit (Bq/L); ND represents a value below the detection limit; values in ( ) represent the detection limit; ND (2013) represents ND throughout 2013

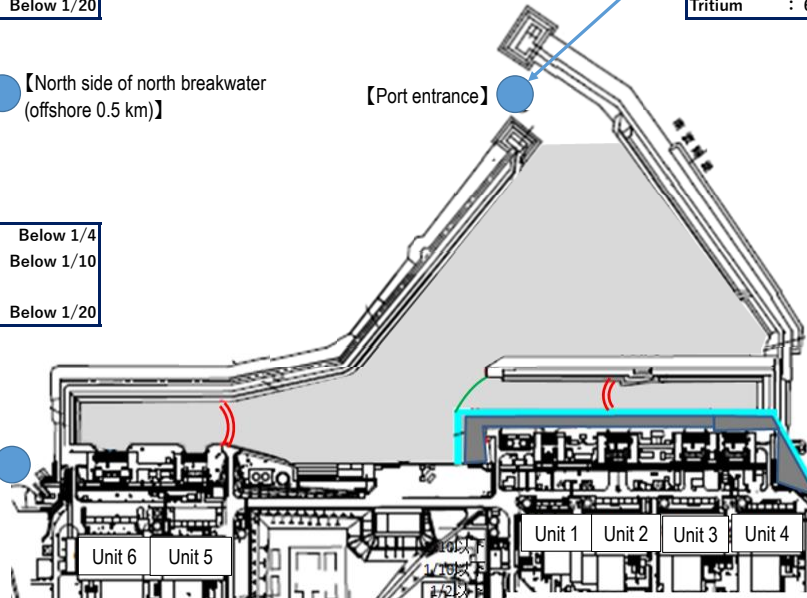
【North side of Unit 5 and 6 release outlet】

Note: The Total β measurement value is the total radioactivity concentration of radioactive materials that emit β-ray (Potassium-40, Cesium-137, Strontium-90, progeny nuclide Yttrium-90, etc.). In general, approx. 12 Bq/L of natural nuclide Potassium-40 is included in seawater.

Cesium-134	: ND (H25)	→	ND(0.84)
Cesium-137	: 3 (H25/7/15)	→	ND(0.76) Below 1/3
Total β	: 15 (H25/12/23)	→	7.7
Tritium	: 1.9 (H25/11/25)	→	ND(0.26) Below 1/2

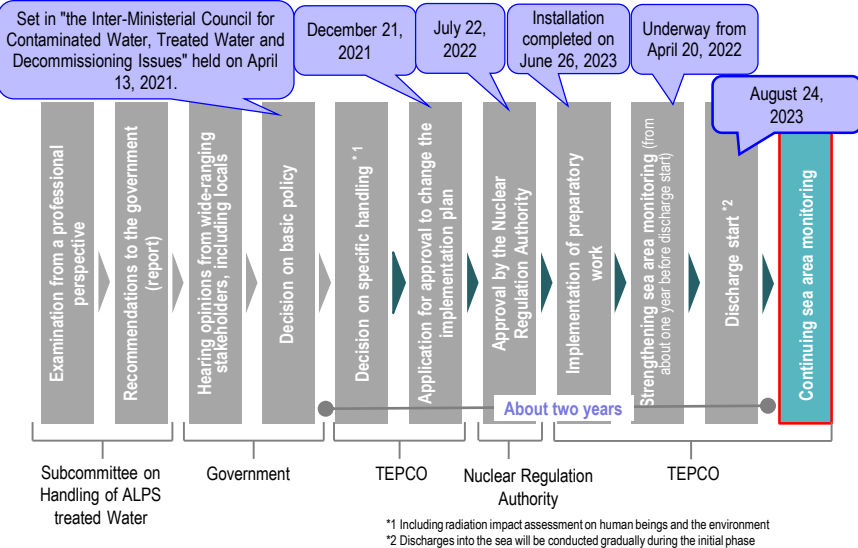
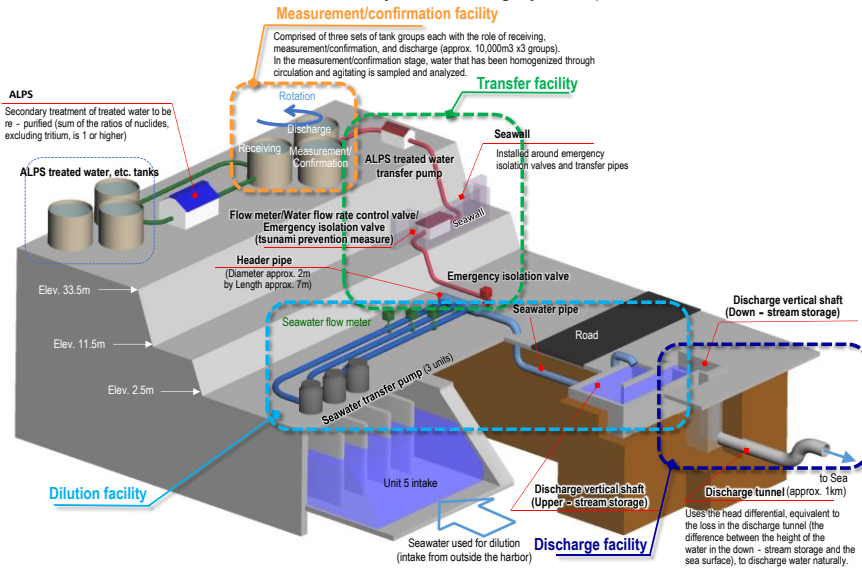
Regarding the discharge of ALPS treated water into the sea, TEPCO must comply with regulatory and other safety-related standards to ensure the safety of the public, surrounding environment and agricultural, forestry and fishery products. To minimize adverse impacts on reputation, monitoring will be further enhanced, objectivity and transparency ensured by engaging with third-party experts and safety checked by the IAEA. Moreover, accurate information will be disseminated continuously and in a highly transparent manner.

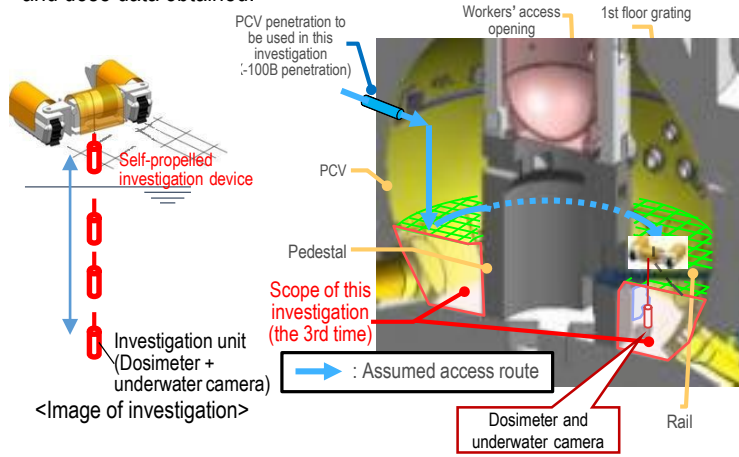
- In April 2015, a device having entered the inside of the PCV via a narrow opening (bore:φ100 mm) collected information such as images and airborne dose inside the PCV 1st floor.
- In March 2017, an investigation using a self-propelled investigation device was conducted to inspect the spreading of debris to the basement floor outside the pedestal, with images taken of the PCV bottom status for the first time. The conditions inside the PCV will continue to be examined, based on the imagery and dose data obtained.

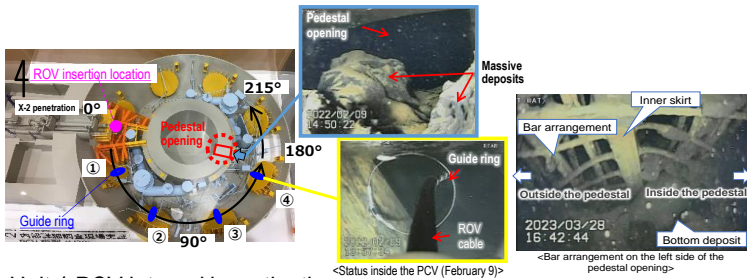
- In February 2022, "the guide ring" was installed to facilitate the investigation. From March 28, 2023, the investigation inside the pedestal by ROV-A2 started and confirmed that a portion of the bar arrangement was exposed. Regarding the soundness of the pedestal, based on the past earthquake resistant evaluation by the International Research Institute for Nuclear Decommissioning (IRID), it was evaluated that even though a portion of the pedestal was lost, there would be no serious risk. However, as the present information is very limited, the investigation will continue to acquire as much information as possible for continued evaluation.

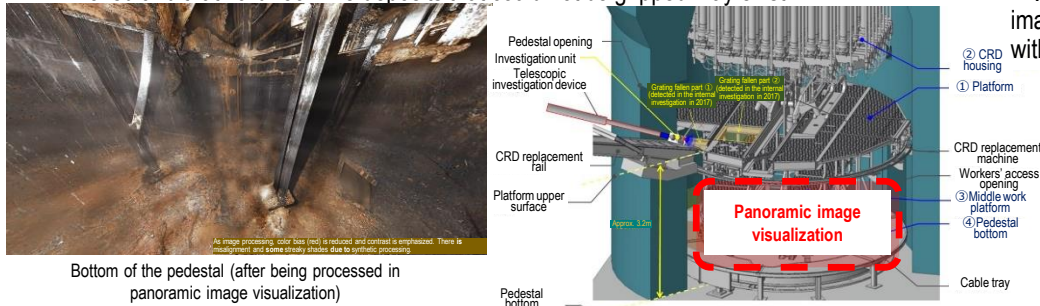
- In January 2017, a camera was inserted from the PCV penetration to inspect the conditions of the rail on which the robot traveled. The results of a series of investigations confirmed some gratings had fallen and deformed as well as a quantity of deposit inside the pedestal.

- In January 2018, the conditions below the platform inside the pedestal were investigated. Based on the analytical results of images obtained in the investigation, deposits, probably including fuel debris, were found at the bottom of the pedestal. Moreover, multiple parts exceeding the surrounding deposits were also detected. We presumed that there were multiple instances of fuel debris falling.

- In February 2019, an investigation touching the deposits at the bottom of the pedestal and on the platform was conducted and confirmed that the pebble-shaped deposits, etc. could be moved and that hard rock-like deposits that could not be gripped may exist.

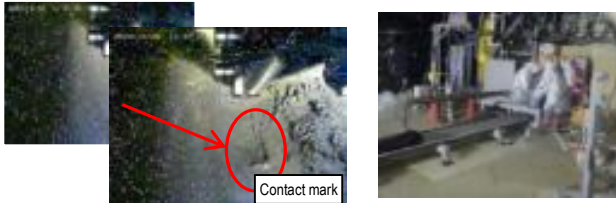
<Conditions of deposits before and after contact>

- In October 2020, a deposits contact investigation at the PCV penetration (X-6 penetration) was conducted. This confirmed that deposits inside the penetration had not deformed and come unstuck.

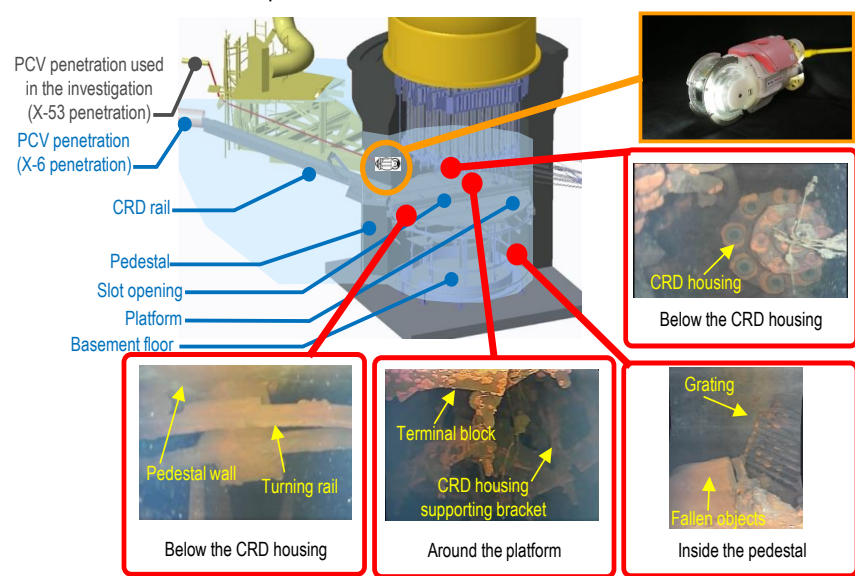
#### <Conditions inside the pedestal>

- In July 2017, the inside of the PCV was investigated using the underwater ROV (remotely operated underwater vehicle) to inspect the inside of the pedestal. Analysis of the imagery obtained in the investigation identified damage to multiple structures and the supposed core internals.

- Videos obtained in the investigation were reproduced in 3D. Based on the reproduced images, the relative positions of the structures, such as the rotating platform slipping off the rail with a portion buried in deposits, were visually understood.

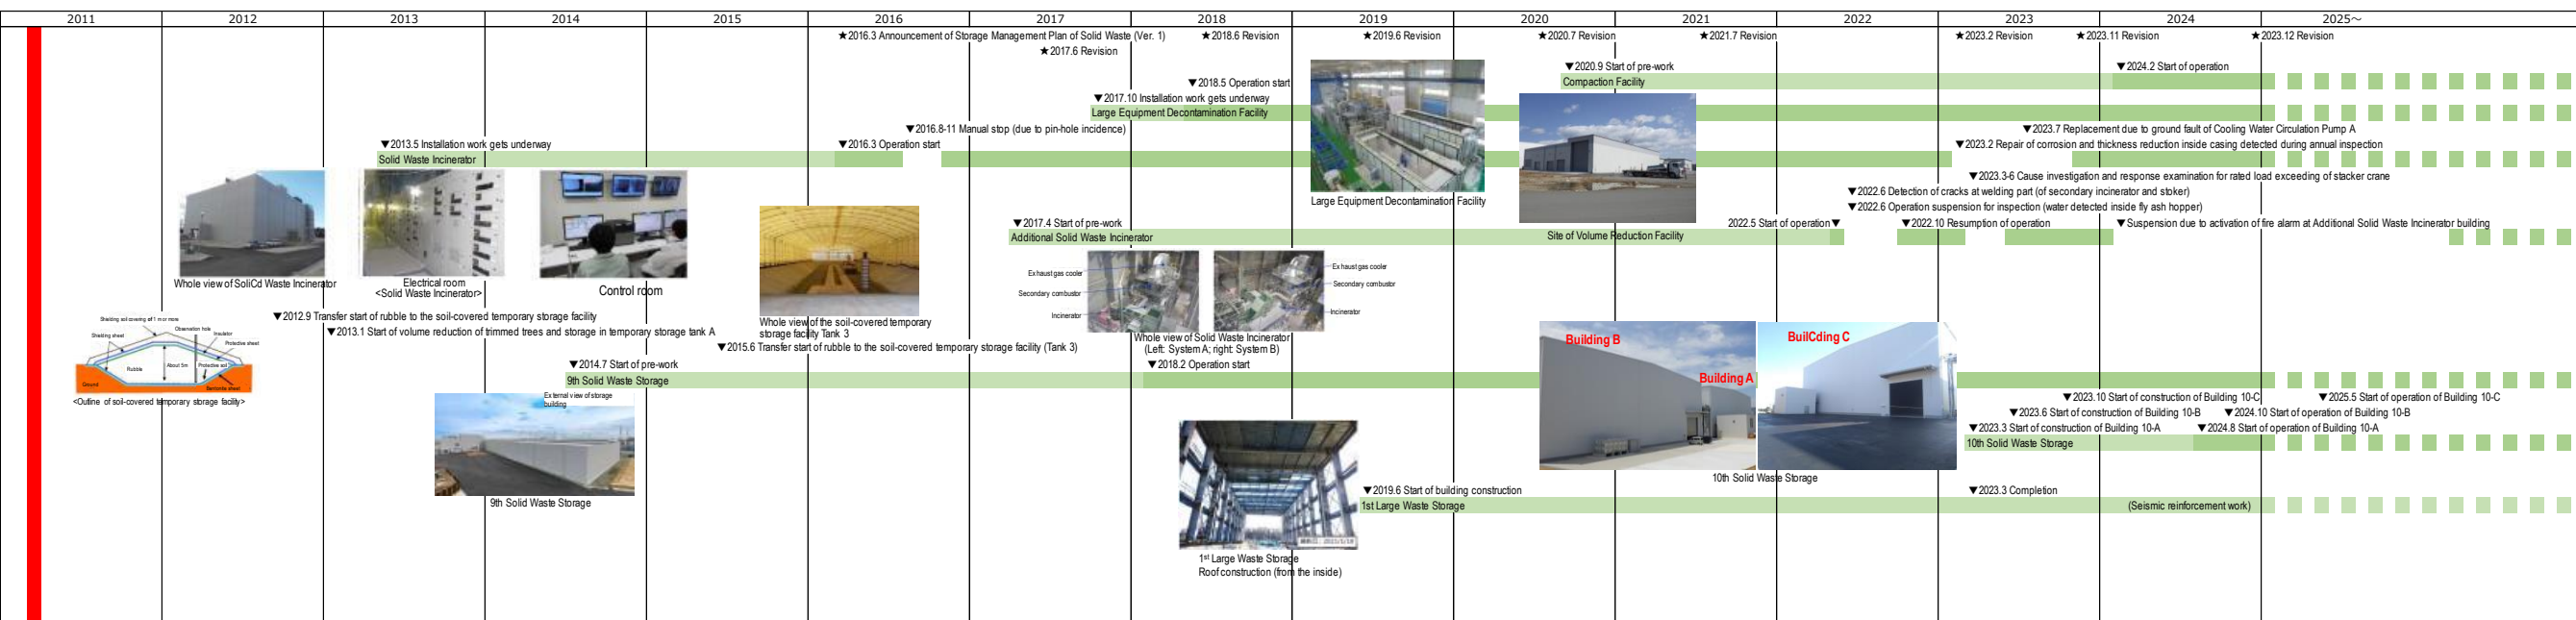
Eliminating temporary outdoor storage of rubble and others \* Except for secondary waste of water treatment and materials for reuse or recycling (within FY2028)

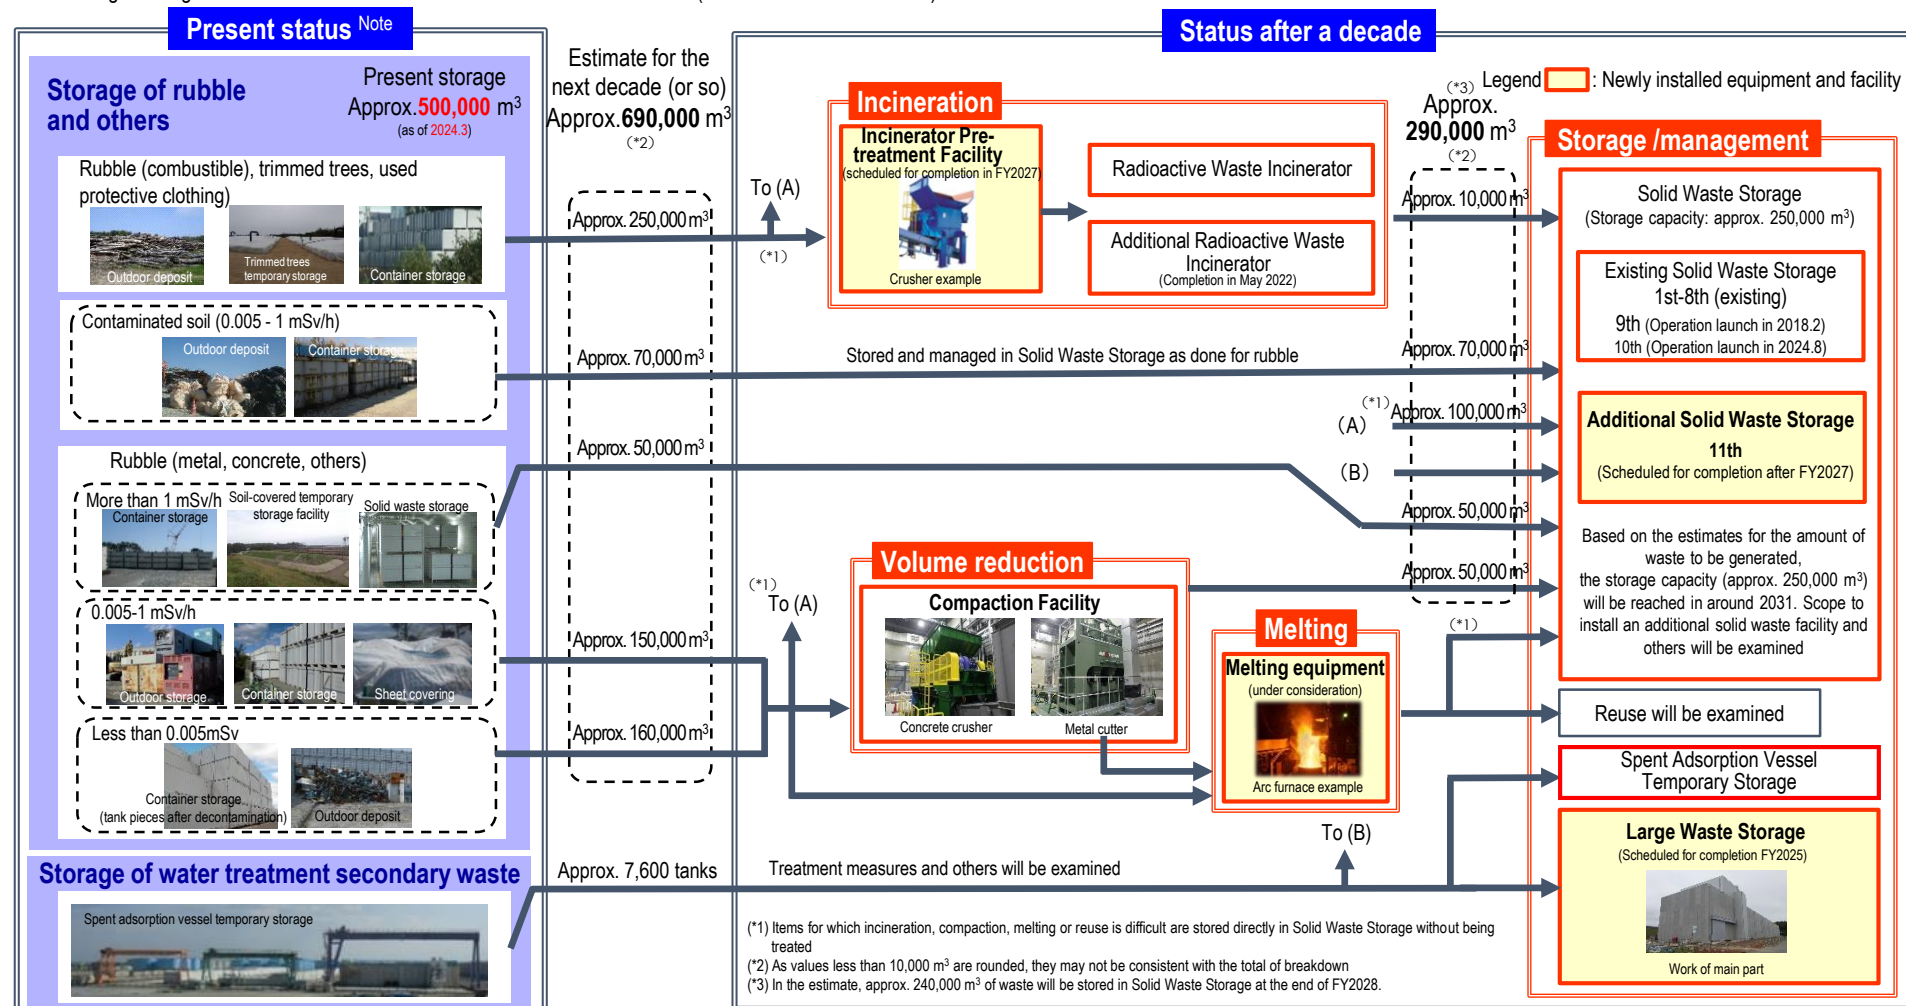
- Solid Waste Storage Management Plan for the Fukushima Daiichi Nuclear Power Station (Revision in December 2024)

- The exposure dose at the site boundaries will be reduced by aggregation to indoor storage and eliminating outdoor storage.
- The exposure dosage in exhaust gas from incinerators and at site boundaries is measured and announced on the website and others.
