Progress Status of Mid-and-long Term Roadmap towards the Decommissioning of Fukushima Daiichi Nuclear Power Units 1-4, TEPCO

1. Past One Month Summary and Future Plans

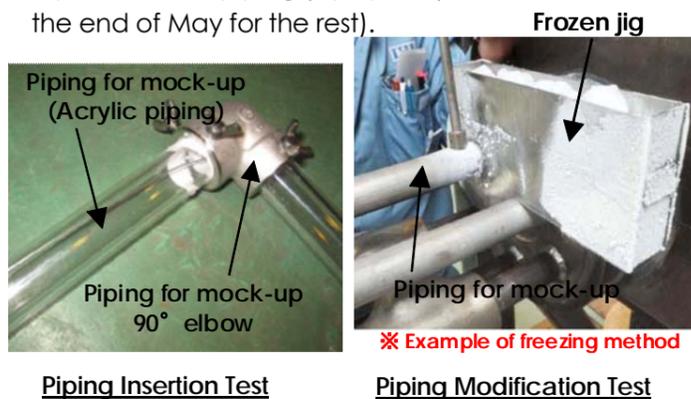
Fig. 1: Mock-up test for installing alternative RPV thermometers

- Installation of Alternative Thermometer at the Unit 2 RPV
 - Alternative to the broken Unit 2's thermometers has been considered. Piping dimensions and piping surface temperatures have been investigated on Mar. 28 (refer to Fig. 1). The results of mock-up tests based on the investigation have shown that we could install an alternative thermometer by application of existing technologies. Decontamination/ shielding will be completed by the end of May and installation will start from Jul.

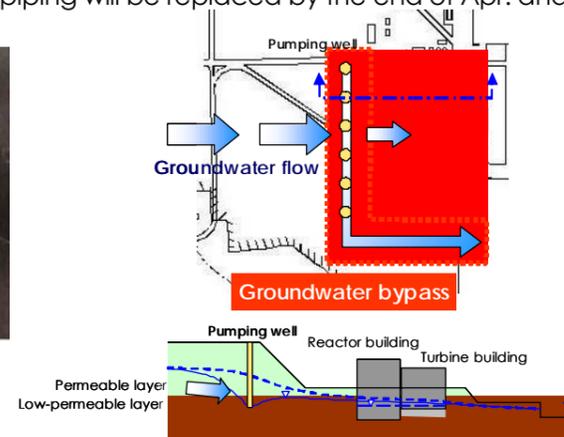
Fig. 2: Groundwater bypass (Image)

- In addition to sub-drain restoration, Groundwater bypass* is considered (refer to Fig. 2).
 - *Means to reduce groundwater leak into Units 1-4 buildings by pumping up groundwater at their upstream area, changing groundwater flow, and lowering groundwater level around the buildings.

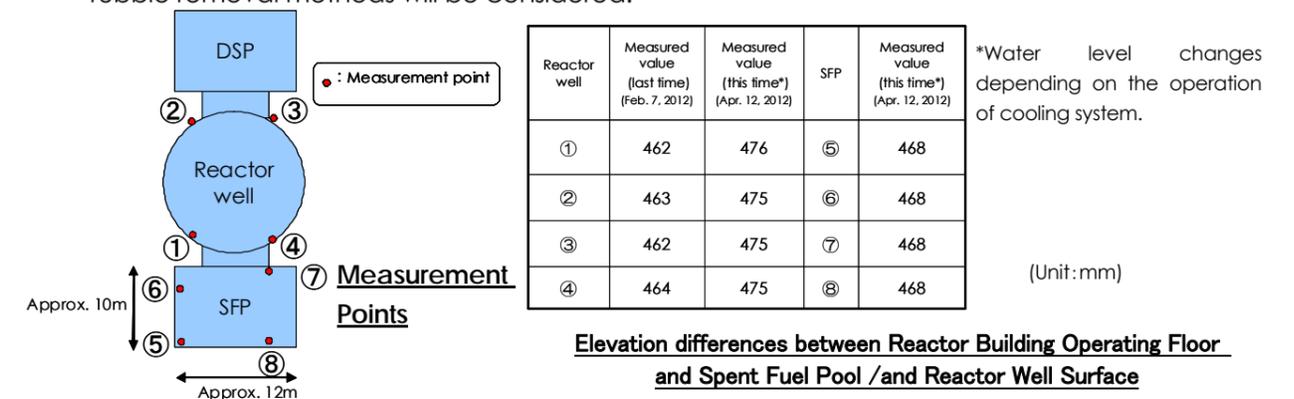
Fig. 3: Investigation results of horizontality of Spent Fuel Pool and Reactor Well

- Confirmation of Unit 4 Reactor Building Soundness
 - In light of starting installation work of the cover for fuel removal at Unit 4 (Apr. 17), the horizontality of spent fuel pool and reactor well was investigated, and the soundness of reactor building was confirmed (Apr. 12) (refer to Fig. 3). The corrosion of spent fuel pool would be prevented by salt removal, hydrazine injection and circulation cooling.

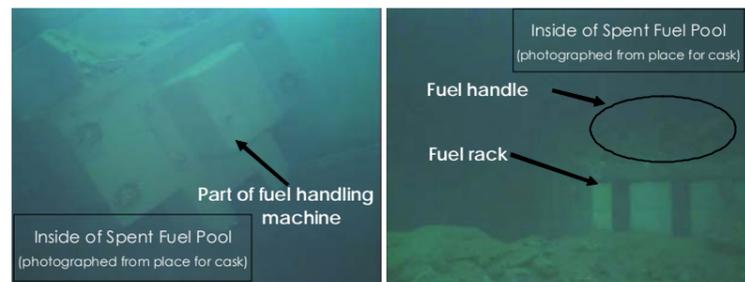
Fig. 4: Investigation of Unit 3 Spent Fuel Pool

- Advanced investigation in Spent Fuel Pool
 - In order to make a plan to remove rubble in the Unit 3 spent fuel pool, using remote controlled underwater camera, the pool was investigated (Apr. 13) (refer to Fig. 4). Although there is fallen rubble and the possibility of some damaged fuels, the low radioactive water level indicates it is hardly possible that many spent fuels were damaged.

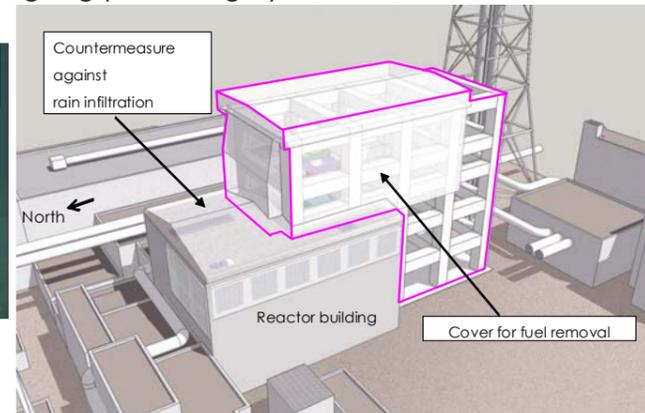
Fig. 5: Image of Unit 4 Cover for Fuel Removal

- Rubble Clearing from the Upper Part of the Reactor Buildings of Units 3 and 4
Rubble removal and assembly base installation work continues. Installation of cover for fuel removal at Unit 4 are started, and ground improvement work is ongoing (refer to Fig. 5).

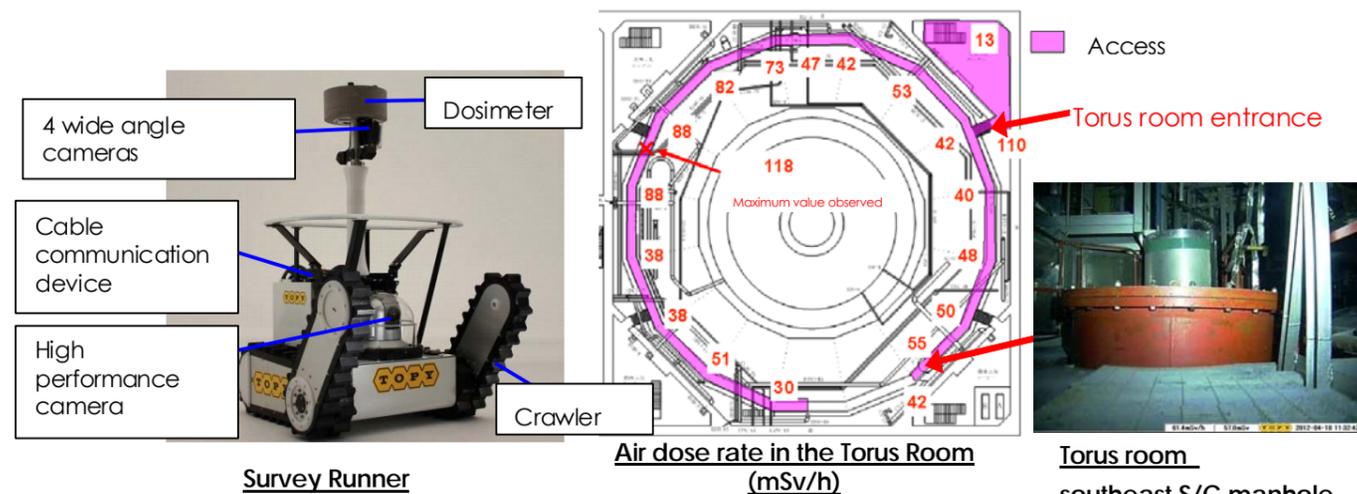
Fig. 6: Outline of investigation at Unit 2 torus room

- Investigated all possible areas in the Torus room by the robot in order to conduct countermeasures against water leakage from PCV, as well as leakage between R/B and T/B on Apr. 18 as referred to in the figure 6.

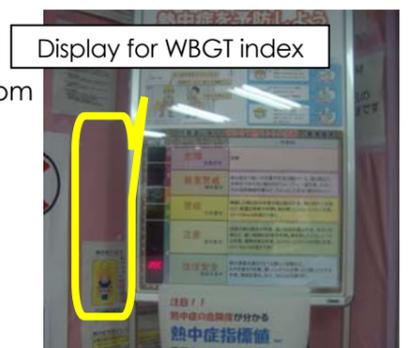
Fig. 7: Countermeasures against heat (Digital displays)

- Consider and implement countermeasures against heat stroke
Countermeasures against heat stroke as below (earlier than that of last year)
 - Set the WBGT* number panel (refer to Fig. 7)

*WBGT: The Wet Bulb Globe Temperature indicates a composite temperature. It is used to estimate the effect on humans by temperature, humidity, wind speed (wind chill) and solar radiation.

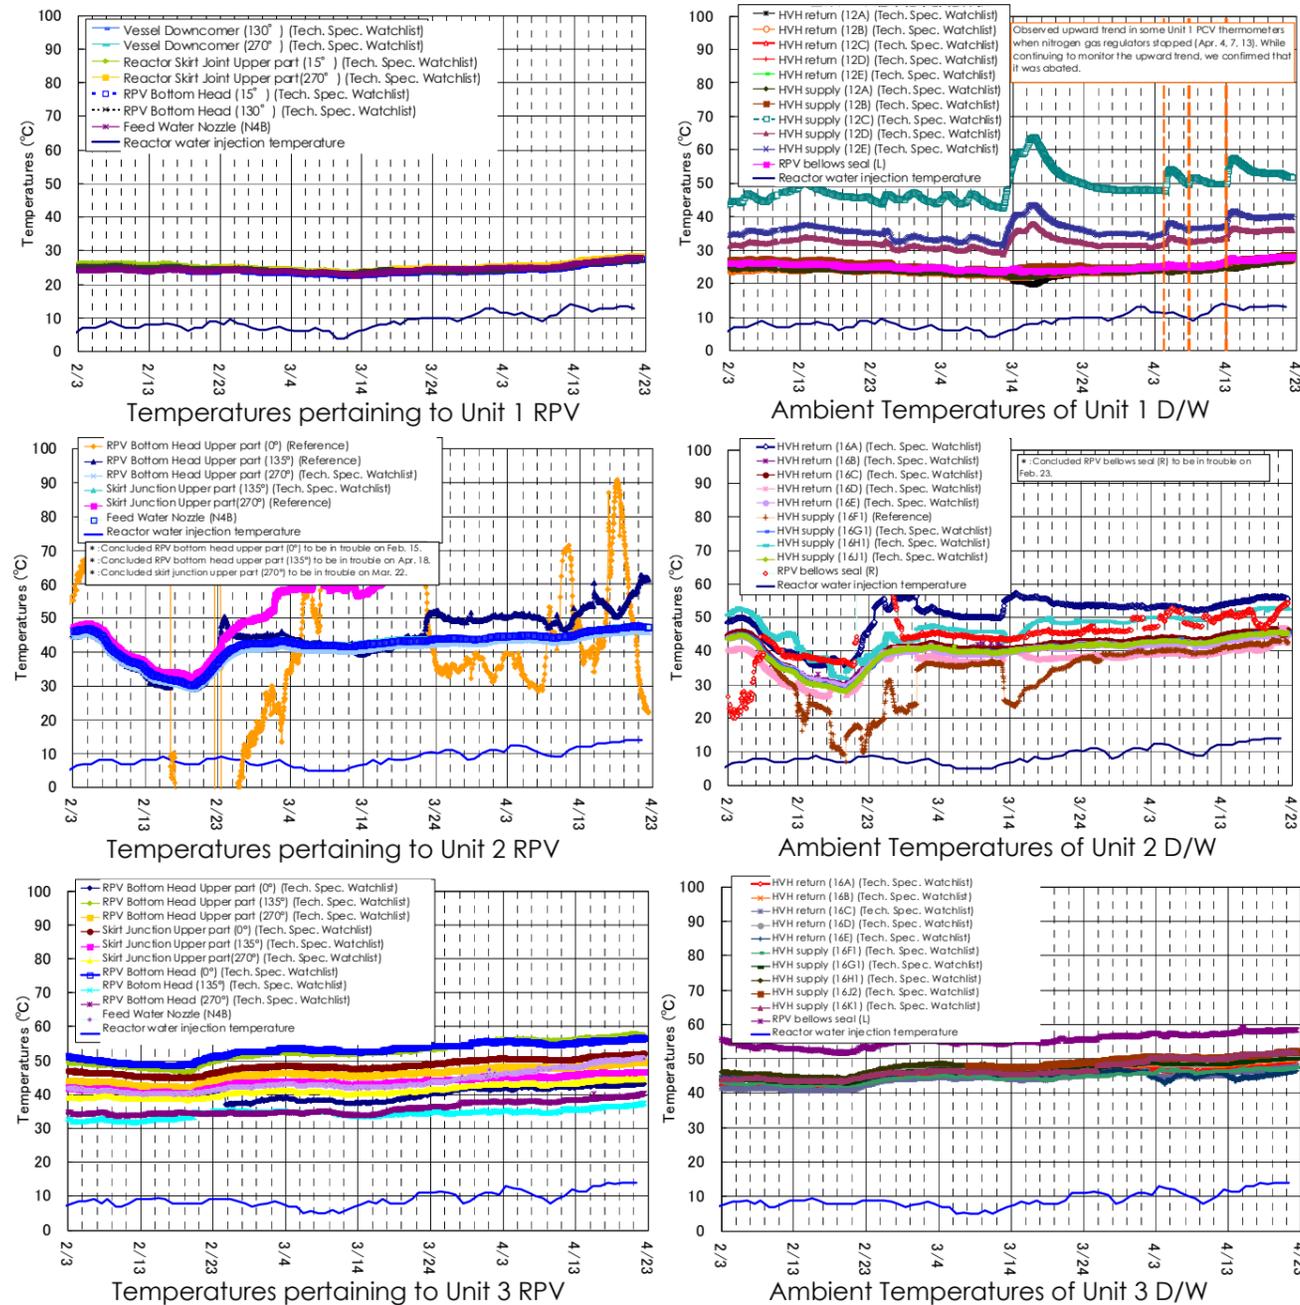
• We have periodically monitored the temperatures at the RPV bottom and PCV gaseous part. The trends of these temperatures except some instruments*1,2, are rising mildly due to the injection water temperature's rise. We expect these trends influenced by the atmospheric temperature will continue.

➤ Units 1~3's cold shutdown conditions have been maintained; the temperatures at the RPV bottom and in the PCV gaseous part have extremely-mild rising trends between approx. 25 and 60 degrees Celsius (as of Apr. 22). In addition, major parameters such as the PCV pressure and radioactive release rate from the PCV showed no significant changes though PCV pressures trend to rise.

- *1 On Apr. 4, 7, 13, an upward trend was observed in some of Unit 1's PCV thermometers when the nitrogen gas regulator stopped. While monitoring the trend, we have confirmed that the upward trend was ended and stabilized.
- *2 On Apr. 14, the temperature reading of RPV bottom head upper part (135°) at the Unit 2 elevated (from 53.8 °C at 8pm to 59.9 °C based on the airborne radioactivity concentration (dust concentration) at the upper parts of the reactor buildings, etc. at 9pm). We measured direct current resistance of this thermometer and found it was out of confidence criteria. We measured its direct current resistance on Apr. 18, again and concluded this thermometer was broken.

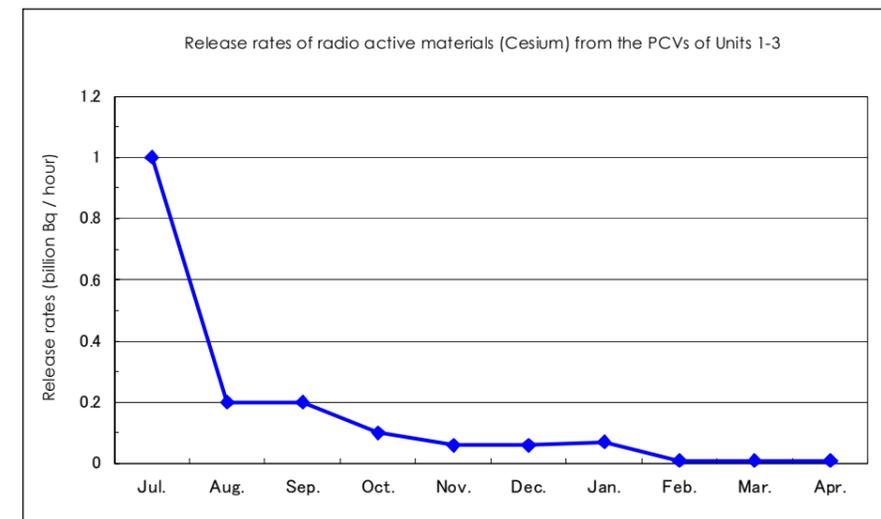
- We estimate that total current release rate of radioactive material (cesium) from the PCVs of Units 1~3 is 0.01 Billion Bq/hour at maximum, calculated from the airborne radioactivity concentration (dust concentration) at the upper parts of the reactor buildings, etc.; approximately 0.0003 Billion Bq/hour at Unit 1, 0.007 Billion Bq/hour at Unit 2 and 0.0002 Billion Bq/hour at Unit 3. The radiation exposure by these emissions per year at the site boundaries is assessed at 0.02 mSv/year, excluding the effects of the radioactive materials so far released.
