Outline of Decommissioning, Contaminated Water and Treated Water Management

Main decommissioning work and steps

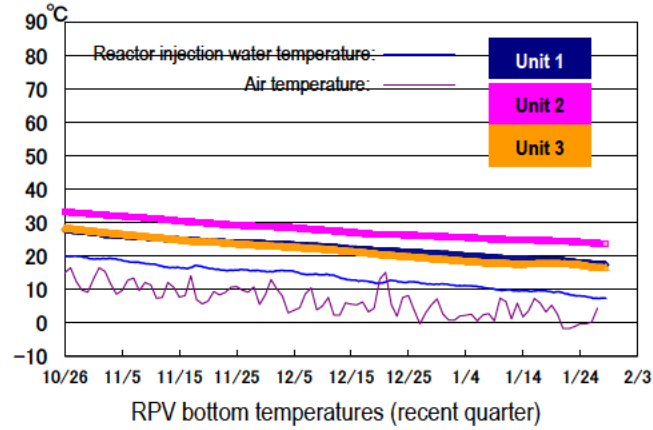
Through continuous reactor cooling by water injection, the temperatures of the Reactor Pressure Vessel (RPV) bottom and the Primary Containment Vessel (PCV) gas phase were maintained as shown below for recent, though they varied depending on the unit and location of the thermometer.

*1 The trend graphs show part of the temperature data measured at multiple points.
*2 A part of data could not be measured due to maintenance and inspection of the facility and other work.

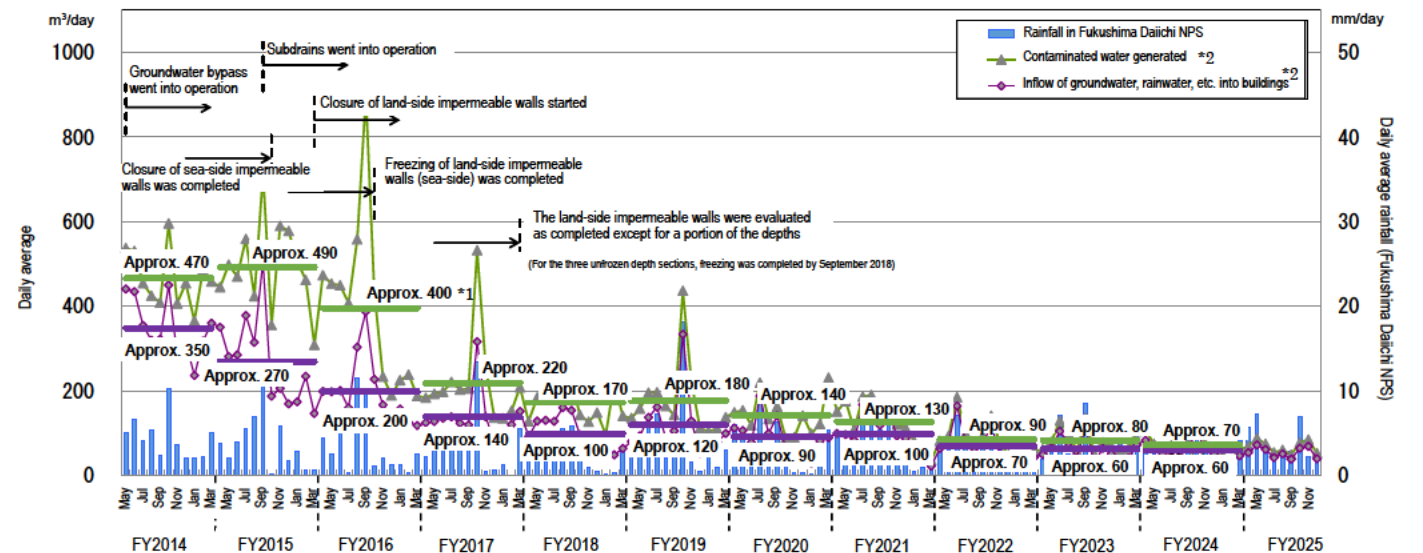
Figure 1: Changes in contaminated water generated and inflow of groundwater and rainwater into buildings

- Multi-layered contaminated water management measures, including land-side impermeable walls and subdrains, have stabilized the groundwater at a low level and the increased contaminated water generated during rainfall is being suppressed by repairing damaged portions of building roofs facing onsite. Through these measures, the generation of contaminated water has been suppressed and reduced from approx. 540 m³/day (in May 2014) before implementing measures to approx. 70 m³/day (in FY2024). It was confirmed that the milestone of “suppressing the amount of contaminated water generated to 100 m³/day or less during average rainfall within FY2025,” which was achieved in FY2023, has been maintained in FY2024.
- Measures will proceed to further reduce the amount of contaminated water generated and suppress to approx. 50-70 m³/day by FY2028.

*1 Values differ from those announced at the 20th Committee on Countermeasures for Contaminated Water Treatment (held on August 25, 2017) because the method of calculating the contaminated water volume generated was reviewed on March 1, 2018. Details of the review are described in the materials for the 50th and 51st meetings of the Secretariat of the Team for Countermeasures for Decommissioning and Contaminated Water Treatment.

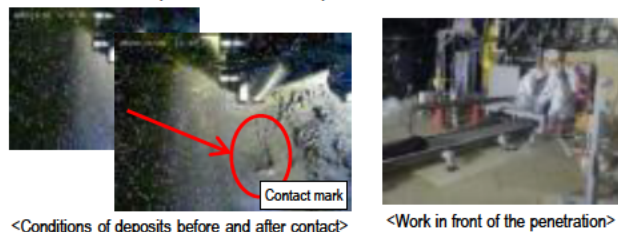
- In October 2020, a deposits contact investigation at the PCV penetration (X-6 penetration) was conducted. This confirmed that deposits inside the penetration had not deformed and come unstuck.
