Outline of Decommissioning, Contaminated Water and Treated Water Management

Main decommissioning work and steps

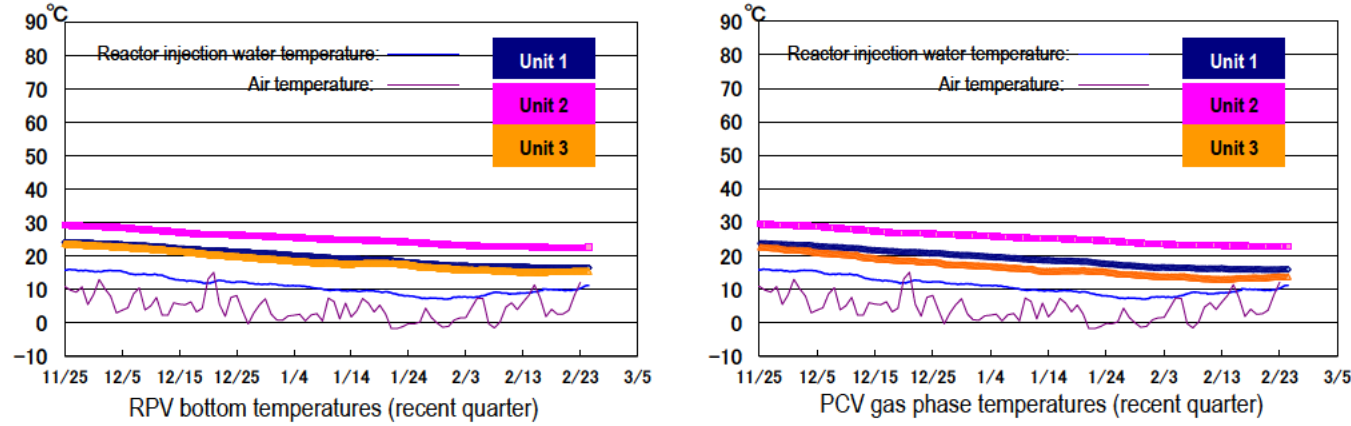
Through continuous reactor cooling by water injection, the temperatures of the Reactor Pressure Vessel (RPV) bottom and the Primary Containment Vessel (PCV) gas phase were maintained as shown below for recent, though they varied depending on the unit and location of the thermometer.

*1 The trend graphs show part of the temperature data measured at multiple points.
 *2 A part of data could not be measured due to maintenance and inspection of the facility and other work.

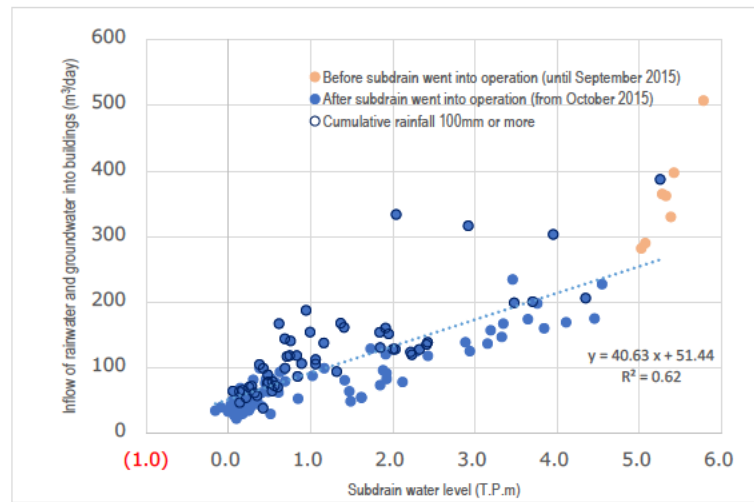
Figure 2: Correlation between inflow such as groundwater and rainwater into buildings and the water level of Units 1-4 subdrains

- At the Water-Treatment Facility Special for Subdrains & Groundwater drains, releases started from September 14, 2015, and up until February 17, 2026, 2,873 releases had been completed. The water quality of all temporary storage tanks satisfied the operational target.

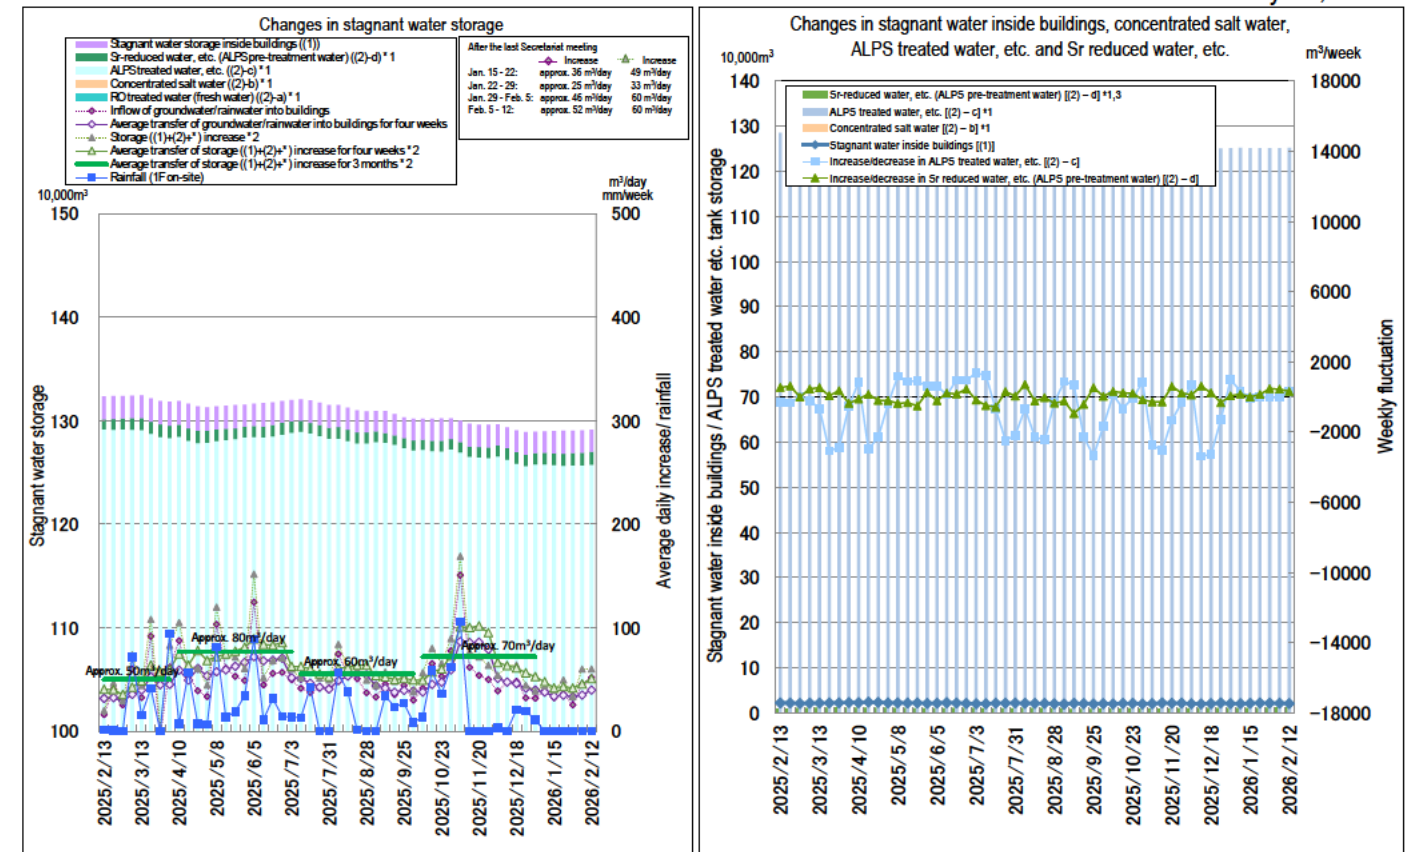
Figure 3: Status of stagnant water storage

(1): Stagnant water storage inside buildings (Units 1-4, Process Main Building, High Temperature Incinerator Building, Waste Liquid Supply Tank, SPT (A), SPT (B), Units 1-3 CST, buffer tank)

(2): Units 1-4 tank storage [(2)-a RO-treated water (fresh water)] + [(2)-b Concentrated salt water] + [(2)-c ALPS treated water, etc.] + [(2)-d Sr-reduced water, etc. (ALPS pre-treatment water)]
 *: Water amount from tank bottom to water-level gauge 0% (DS)
 †: 1: Water amount for which the water-level gauge indicates 0% or more
 ‡: Calculated in the method of contaminated water generated [(Inflow of groundwater/rainwater into buildings) + (other transfer) + (chemical injection into ALPS)], amount of ALPS treated water discharged was not taken into account.
 ††: Amount of Sr-reduced water and others increased and decreased depending on the operation status of facilities due to clog of the cross-flow filter for the multi-nuclide removal system.

- The volume of ALPS treated water, etc. was approx. 1,254,297 m³ as of February 12, 2026.
- The total volume of ALPS treated water discharged into the sea since discharges commenced on August 24, 2023, was approx. 133,321 m³ as of the completion of the sixth discharge in FY2025.

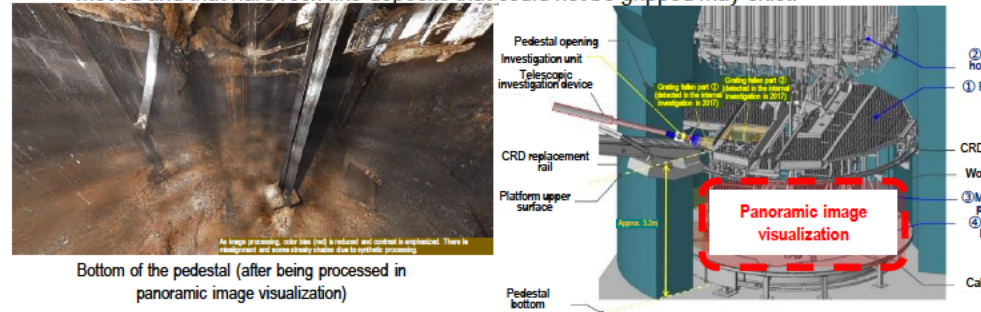
- In February 2019, an investigation touching the deposits at the bottom of the pedestal and on the platform was conducted and confirmed that the pebble-shaped deposits, etc. could be moved and that hard rock-like deposits that could not be gripped may exist.

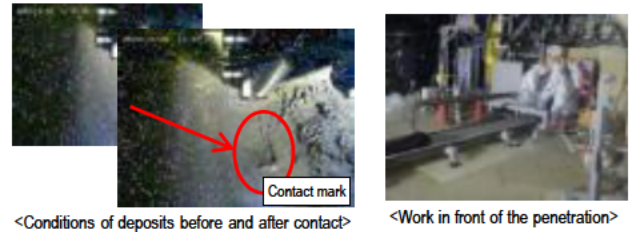
- In October 2020, a deposits contact investigation at the PCV penetration (X-6 penetration) was conducted. This confirmed that deposits inside the penetration had not deformed and come unstuck.
