Outline of Decommissioning, Contaminated Water and Treated Water Management

Main decommissioning work and steps

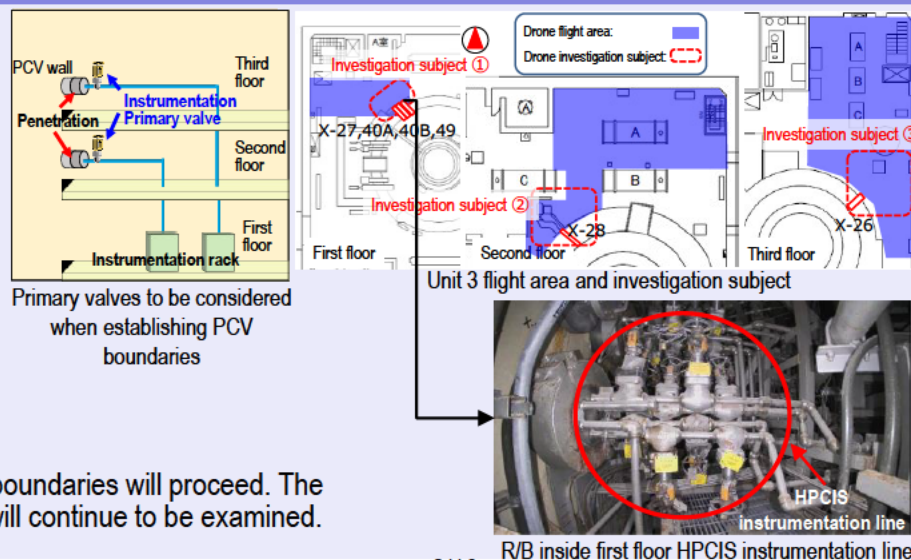
Unit 3 PCV internal investigation using drones

Due to high radiation levels caused by the accident and other factors, investigations have not been fully conducted in some areas inside the Reactor Building (R/B). Therefore, investigations were conducted using small drones (199 × 194 × 58 mm) inside the R/Bs of Units 1 and 3. The investigation of Unit 3 was conducted to confirm the status of valves and other components in order to evaluate shutdown measures, assuming that the removal of instrumentation racks might be necessary when installing fuel debris retrieval equipment.

As a result of the investigation, no significant abnormalities were found in the valves or pipes investigated on the first through third floors, indicating that it may be possible to establish a containment boundary through valve operation. However, challenges regarding accessibility for manual valve operation were identified due to existing shielding structures and scattered rubble.

Going forward, a more detailed study of methods for establishing PCV boundaries will proceed. The use of drones for tasks such as assessing conditions inside the building will continue to be examined.

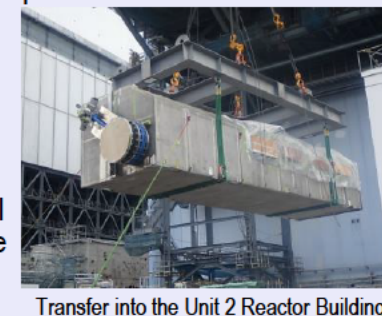
Unit 2 PCV internal investigation/status of fuel debris trial retrieval

As a condensation countermeasure inside the enclosure, caulking was applied to improve water resistance. Following the caulking, a verification test was performed to confirm the effectiveness of the water resistance countermeasure. This completed all performance verification tests at the JAEA Naraha Center for Remote Control Technology. The robotic arm was transported from the center to a storage facility within the Fukushima Daiichi Nuclear Power Station on April 7, 2026, and transfer into the Unit 2 Reactor Building began on April 21.

Installation of the equipment will take 3 to 4 months, and PCV internal investigation and debris sampling are scheduled to begin around summer 2026.

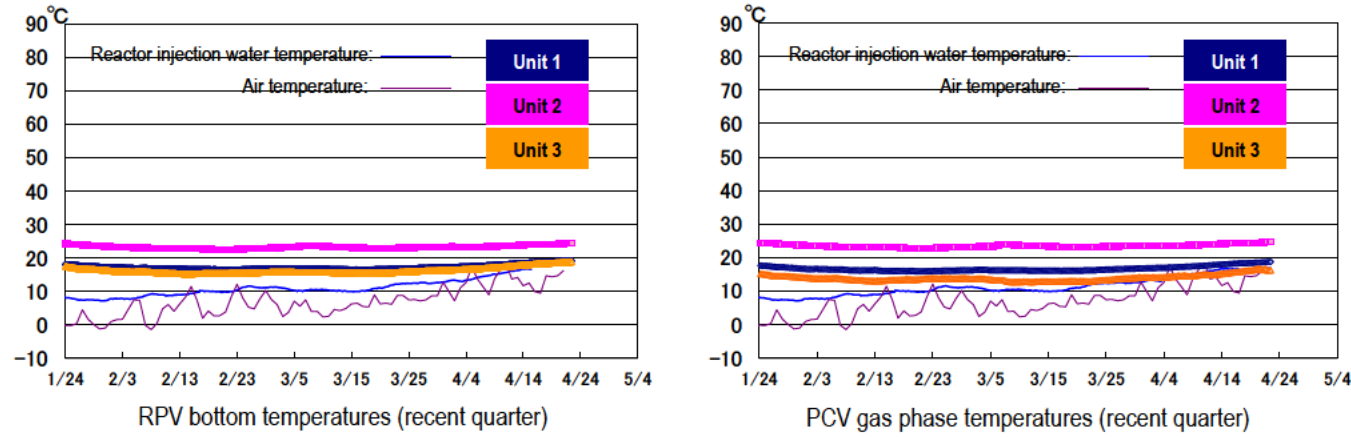
Through continuous reactor cooling by water injection, the temperatures of the Reactor Pressure Vessel (RPV) bottom and the Primary Containment Vessel (PCV) gas phase were maintained as shown below for recent, though they varied depending on the unit and location of the thermometer.

*1 The trend graphs show part of the temperature data measured at multiple points.
*2 A part of data could not be measured due to maintenance and inspection of the facility and other work.

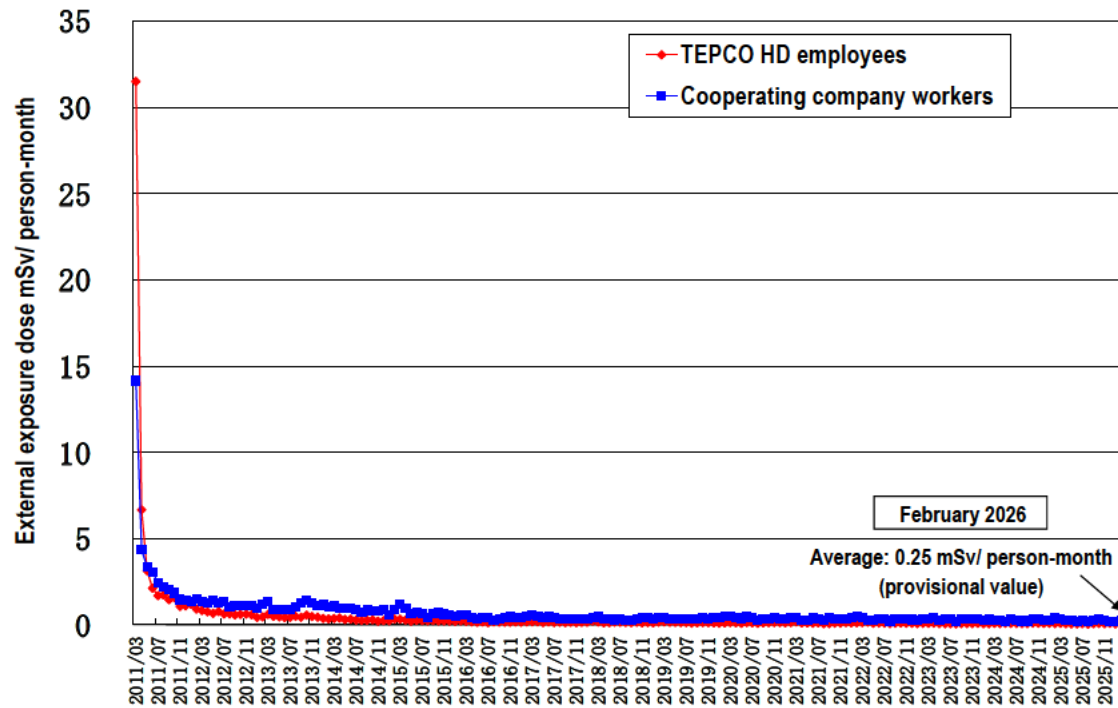
Figure 7: Changes in monthly average exposure dose of individual worker (monthly exposure dose since March 2011)

- For most workers, the exposure dose remained sufficiently within the limit and allowed them to continue engaging in radiation work.

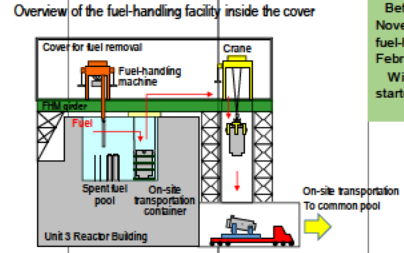
<p>Overview of the fuel-handling facility inside the cover</p>	<p>▼2019.4.15 Start of fuel removal</p> <p>▼2021.2.28 Fuel removal completed (568 assemblies)</p>	<p>Before installing a cover for fuel removal, the process of removing large rubble from the spent fuel pool was completed in November 2015. To ensure safe and steady fuel removal, training via remote control was conducted at the factory using the actual fuel-handling machine to be installed on site (February – December 2015). Installation of the fuel removal cover was completed on February 23, 2018. With fuel removal in mind, rubble retrieval training inside the pool, which was scheduled in conjunction with fuel removal training, started from March 15, 2019 and fuel removal started from April 15, 2019. Fuel removal was completed on February 28, 2021.</p>

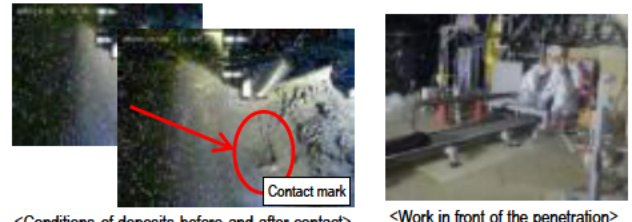
- In October 2020, a deposits contact investigation at the PCV penetration (X-6 penetration) was conducted. This confirmed that deposits inside the penetration had not deformed and come unstuck.
